Bridge #A5392(Routine)

US 71 B, SB LNS over Clear Creek- Washington

Location: 5.47 MI S BENTON CO LINE

Team Lead: Bob McEntyre Inspection Date: November 09, 2021

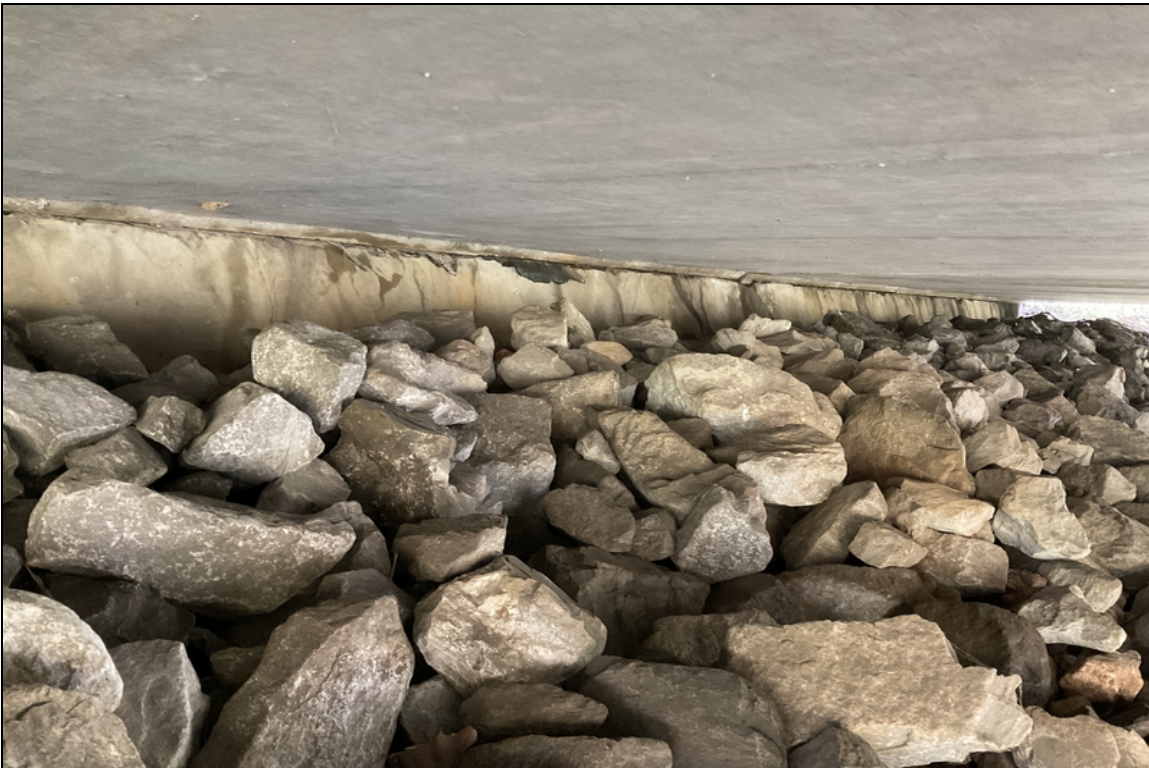
Abutment # 2.

(215)							
-Abutments have staining in the key ways and other random locations with no apparent noteworthy deficiencies during this inspection.							
220	Reinforced Concrete Pile Cap/Footing	LF	36	36	0	0	0

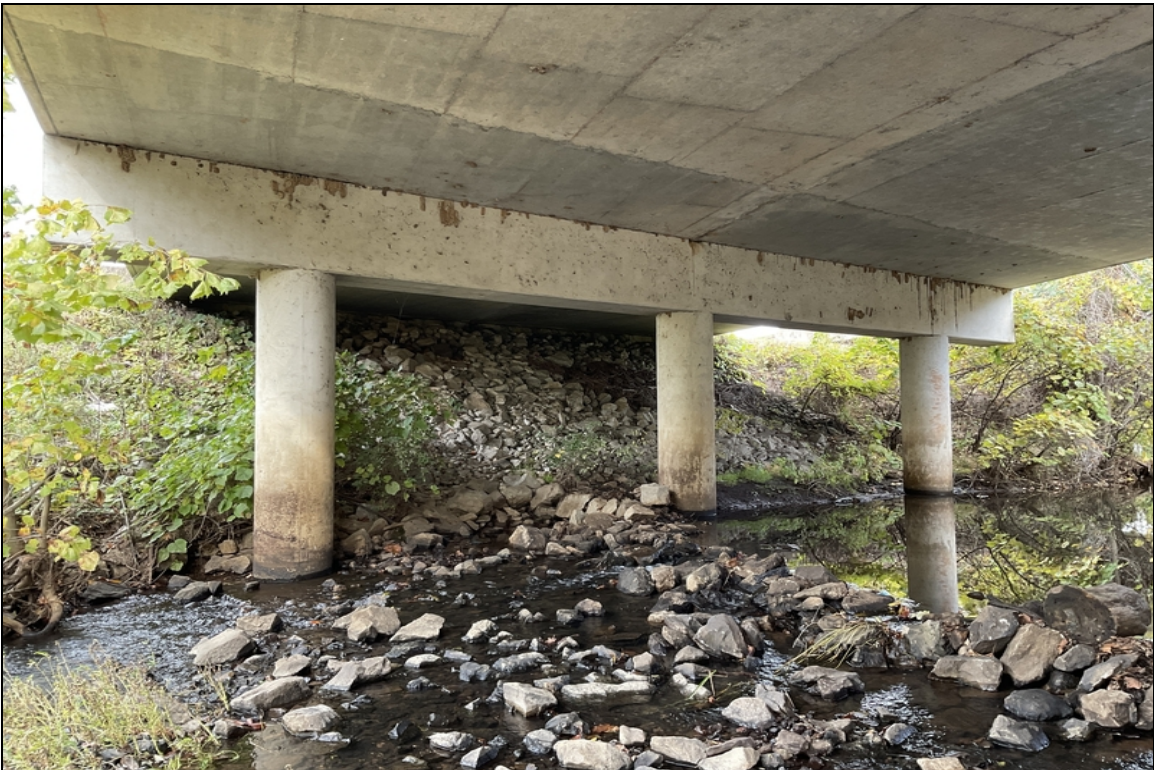
Bent 3.

(220)							
-The top of the footings are exposed at bent # 3, columns # 1 and 2. No apparent undermining or scour problems during this inspection.							
234	Reinforced Concrete Pier Cap	LF	100	99	1	0	0
1080	Delamination/Spall/Patched Area	LF	1	0	1	0	0

(234)							
-The backface of bent # 3 cap has a 4" shallow spall with no exposed reinforcing steel located approximately 5' right of centerline. No other apparent or noteworthy problems during this inspection.

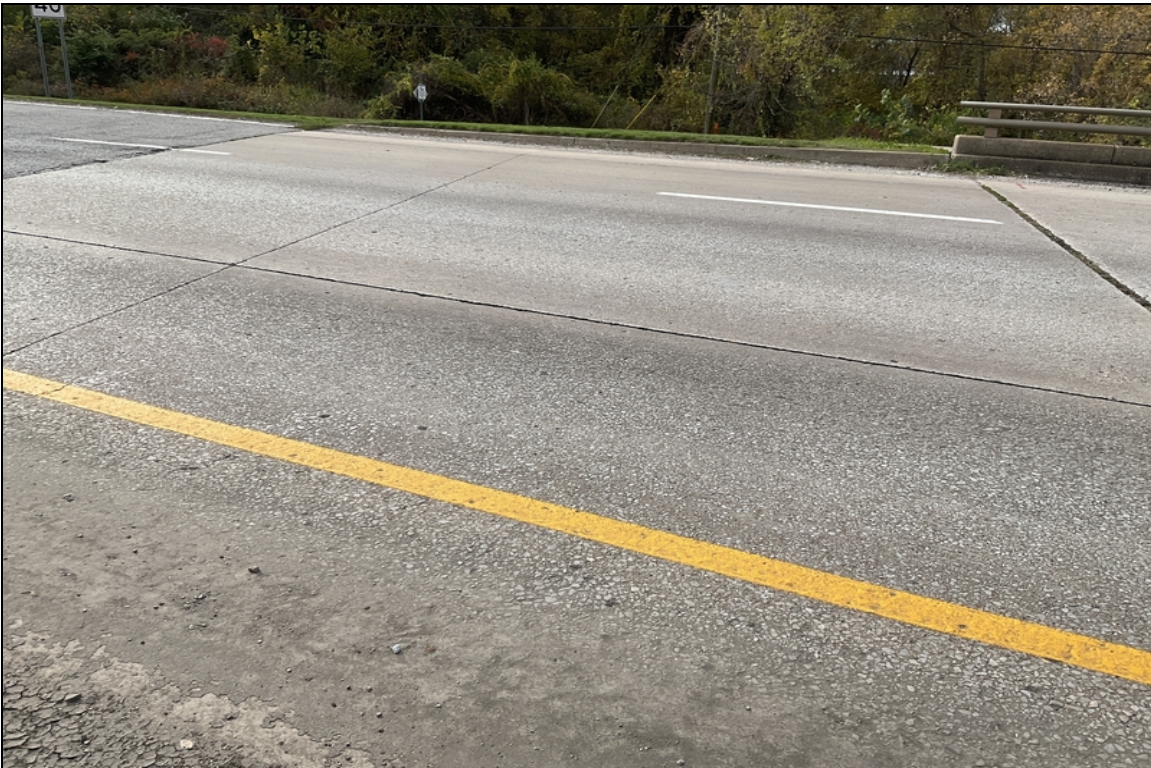
South approach slab.

(321)	-The South approach slab has light abrasion and transverse cracks in the driving lanes and medium scale in the right approach gutter.						
330	Metal Bridge Railing	LF	262	254	3	5	0
1020	Connection	LF	8	0	3	5	0
