Bridge #B5392(Routine)

US 71 B, NB LNS over Clear Creek-Washington

Location: 5.47 MI SO BENTON CO LINE

Team Lead: Bob McEntyre Inspection Date: November 09, 2021

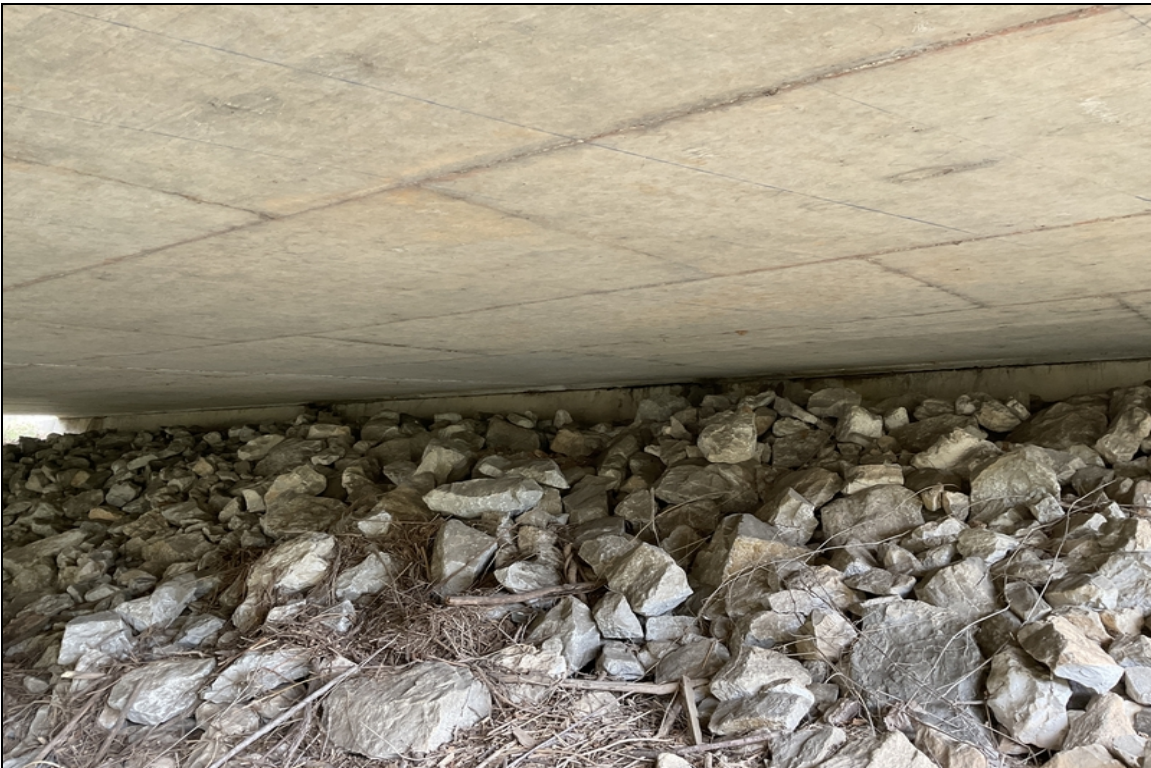
Abutment 2.

(215)							
-Abutment # 1: -The right turn back portion of abutment # 1 is fractured outside the bearing area.  Abutment # 2: One shallow spall at the left of centerline keyway and left end of cap that does not expose reinforcing steel during this inspection.							
220	Reinforced Concrete Pile Cap/Footing	LF	36	36	0	0	0
