Bridge #A0698(Routine)

US 71 B, NB LNS over Mud Creek-Washington

Location: 1.98 MI N INT 71 & 71B

Team Lead: Bob McEntyre Inspection Date: November 08, 2021

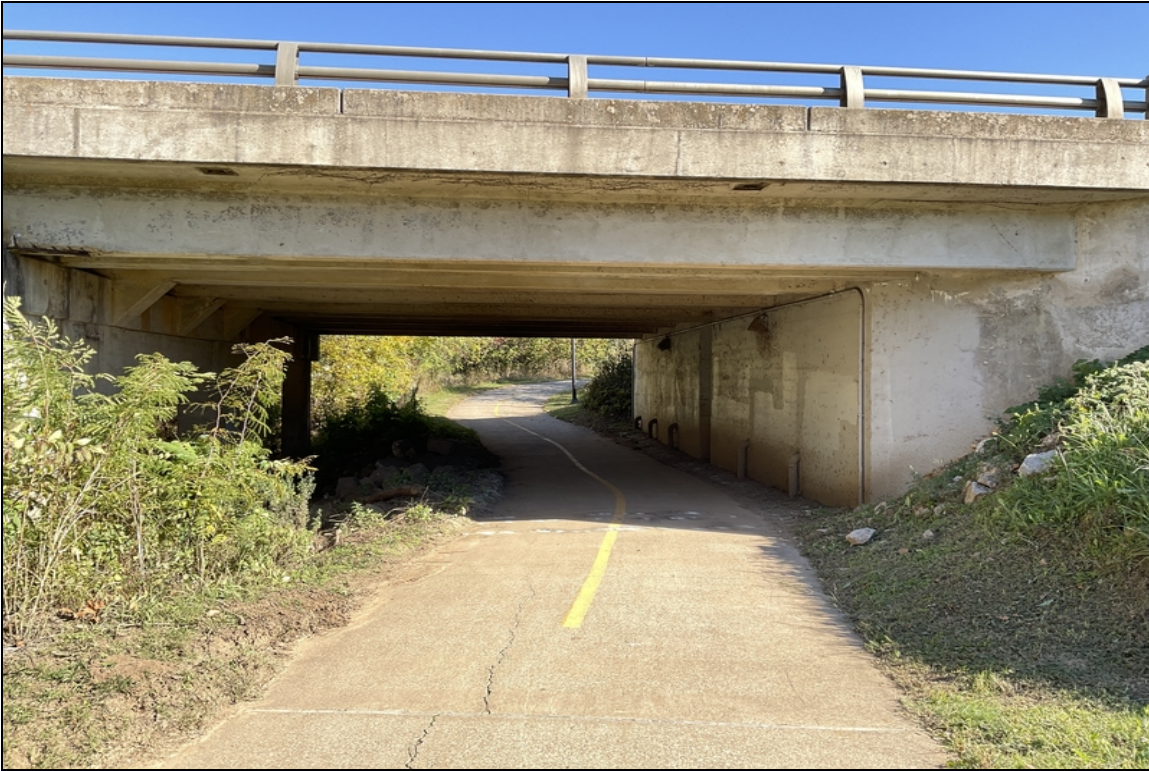
Pedestrian / bicycle trail under span 1.

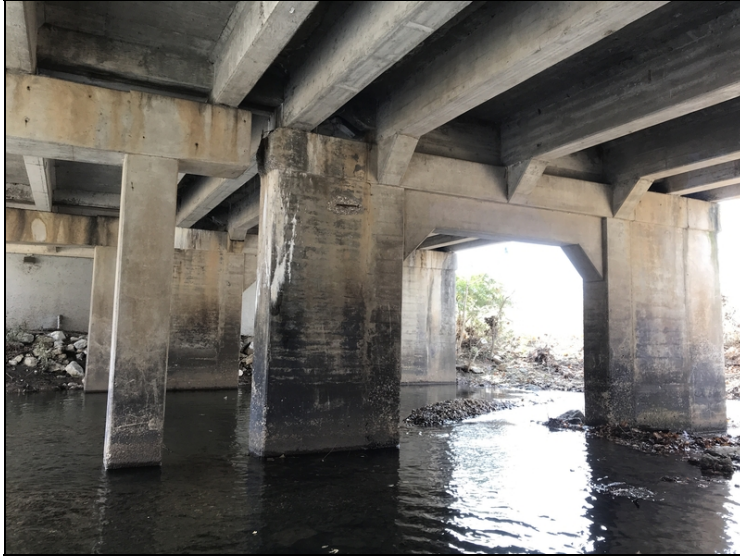
Span # 3 side of Bent # 3 pier wall near centerline of structure.

Bent # 3 cap has soft deteriorated concrete with exposed reinforcing steel near centerline of roadway. Exposed reinforcing steel has active corrosion with flaking rust.

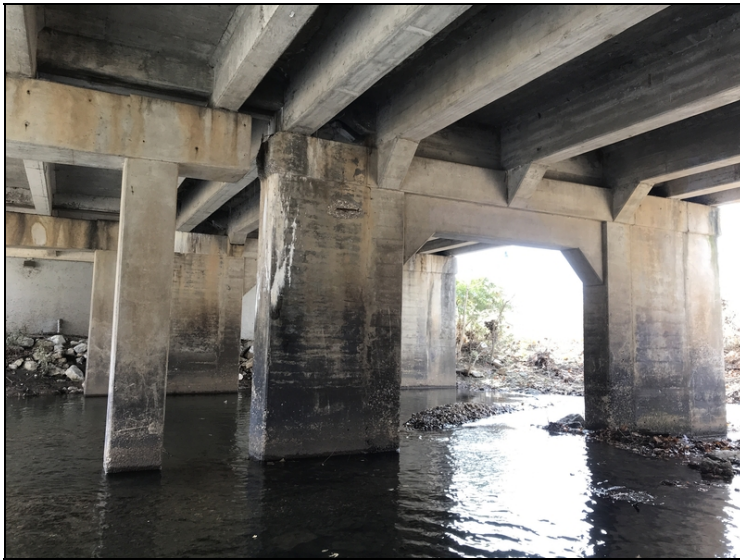
Span # 3 side of Bent # 3 pier wall near centerline of structure.

Patched areas are delaminated and sound hollow in the left side of Bent # 3. Spalls with exposed reinforcing steel have active corrosion with up to 1/8" section loss visible during this inspection. The Bent # 3 pier wall under Bay # 5 has light map cracking with efflorescence and discoloration of the concrete where water discharges on the substructure through the leaking deck joint.

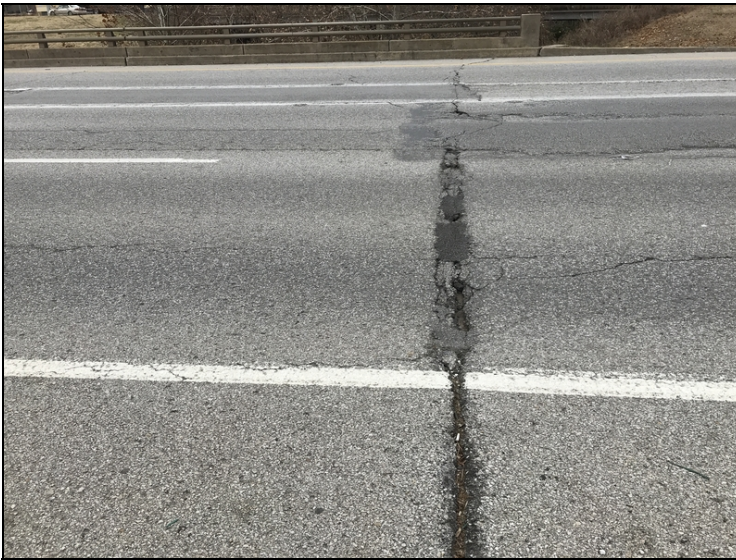
Expansion joint over Bent # 4.

Map cracking with efflorescence visible from the undersurface of deck. The undersurface of Bays # 1 & 2 in Spans # 1 & 2 have map cracking with heavy efflorescence visible from the undersurface of the deck. Form work is still in place and repairs are still holding for the deck of Span # 3, adjacent to the North abutment. Span # 3 between girders # 4 & 5 at Bent # 4 has basketball sized spalls with exposed reinforcing steel. Spalls with exposed reinforcing steel in the overhang areas adjacent to the deck drains and in the deck expansion dams over the intermediate bents.

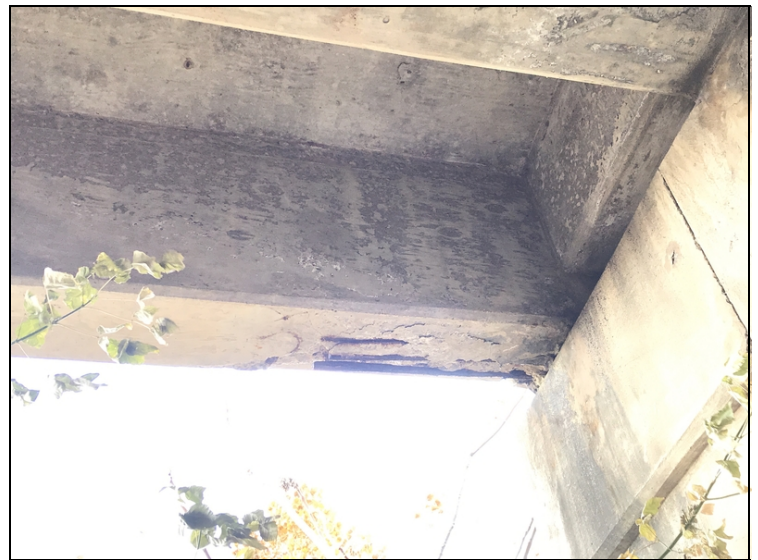
Span # 1. Bent # 2. Girder # 1.

Span # 1, girder # 1 at bent # 2 has an area of spalling in the undersurface of girder that exposes 3 of the primary longitudinal reinforcing bars. The exposed bars appear to be short pieces of reinforcing steel that terminate approximately 30" from the bent. The interior of girder at bent # 2 has light scaling.

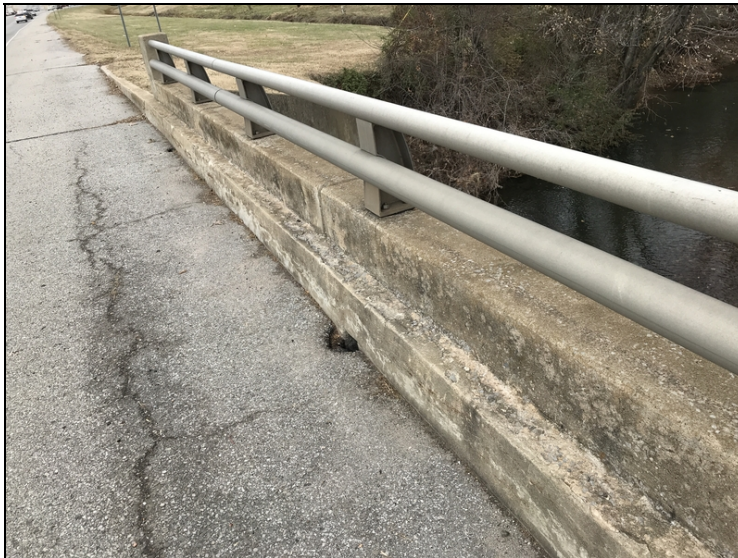
Bridge railing. Typical.

Concrete curb has light scale with shallow spalling with exposed reinforcing steel that has very little concrete cover from the construction process.
