Asset #A0704(Routine)

## State Highway 10 over Greasy Creek - Logan Co.

Location: 5.50 MI E SEBASTIAN CO LI

Team Lead: Bob McEntyre, Inspection Date: 07/19/2022

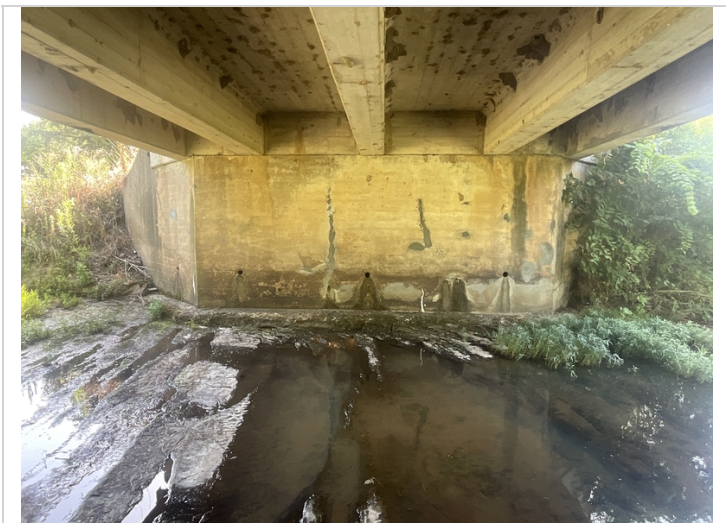
Abutment 2

(220) -The top of abutment # 2 footing is exposed during this inspection. The footing has soft deteriorated concrete with up to 2" of section loss around the edges. No exposed reinforcing steel or apparent scour problems at this inspection.							
234	Reinforced Concrete Pier Cap	LF	95	62	29	4	0
1080	Delamination/Spall/Patched Area	LF	16	0	16	0	0
1090	Exposed Rebar	LF	1	0	0	1	0
1120	Efflorescence/Rust Staining	LF	3	0	0	3	0
1130	Cracking (RC and Other)	LF	13	0	13	0	0

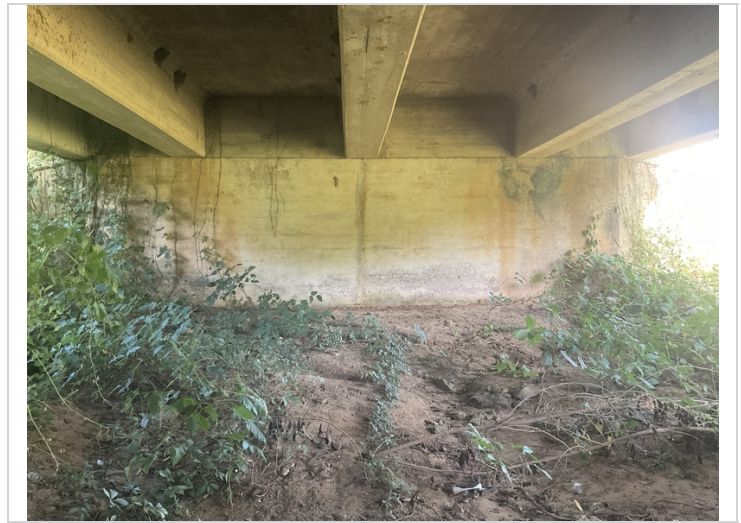
Abutment 1

ELEMENTS	DESCRIPTION	UNITS	TOTAL	CS1	CS2	CS3	CS4
1190	Abrasion/Wear (PSC/RC)	LF	22	0	17	5	0
(215) -Abutment # 1 under beam # 2 has a large 36 inch delaminated area under the beam. Maintenance Forces have grouted over a portion of the delaminated area in the past. The grouted repair has failed and is delaminated. -Maintenance forces have made a few grouted patches in both abutments. -Abutment stem walls have a few vertical full height cracks. -Abutment # 2 left monolithic wing wall has a moderate width vertical crack in upper portion of wall adjacent at the abutment juncture. The right wing wall has vertical and diagonal cracking and concrete deterioration below the weep hole. -Concrete deterioration is visible between the weep holes in abutment # 2 stem wall.							
220	Reinforced Concrete Pile Cap/Footing	LF	45	0	0	45	0
1190	Abrasion/Wear (PSC/RC)	LF	45	0	0	45	0

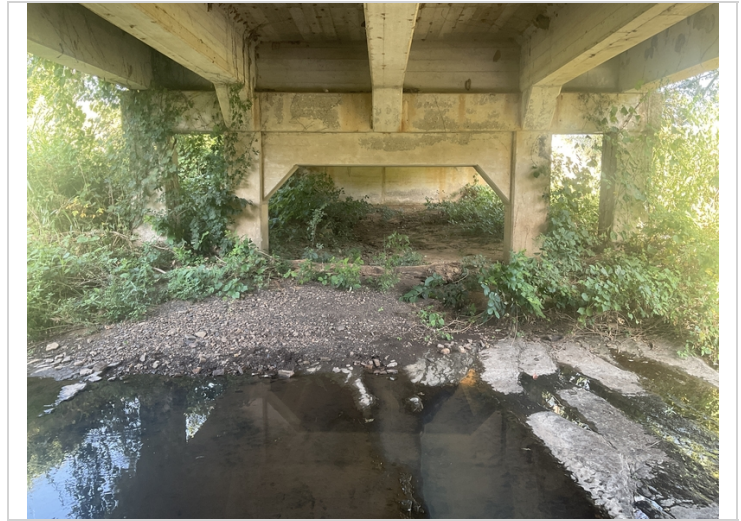
Bent 2

(234) -Bent # 2 cap has shallow spalling with exposed reinforcing steel in the beam # 2 haunch. -Bent # 2 cap has light scale due to leaking deck joint.							
330	Metal Bridge Railing	LF	144	144	0	0	0
