Asset #05180(Routine)

US Highway 64 over Gar Creek - Frank. Co.

Location: 0.30 MI E JCT SH 219

Team Lead: Eric West, Inspection Date: 05/25/2022

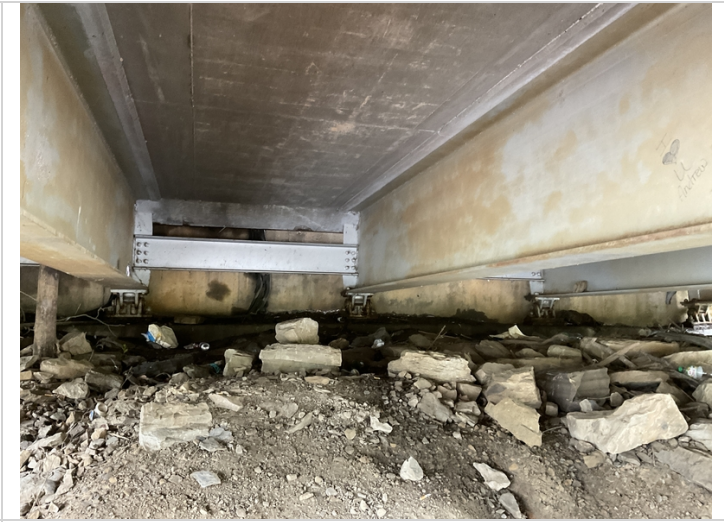
ELEMENTS	DESCRIPTION	UNITS	TOTAL	CS1	CS2	CS3	CS4
(215) -Abutments have debris accumulation with stains due to missing deck joint seals. -Top of backwalls have transverse hairline cracks that are visible from the driving surface of the deck.							
234	Reinforced Concrete Pier Cap	LF	63	62	1	0	0
1080	Delamination/Spall/Patched Area	LF	1	0	1	0	0

Abutment #2 typical.

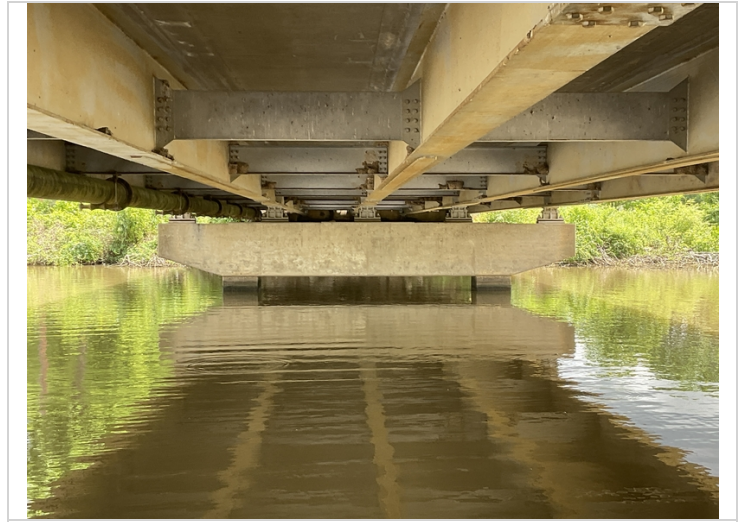
Bent #3 typical.

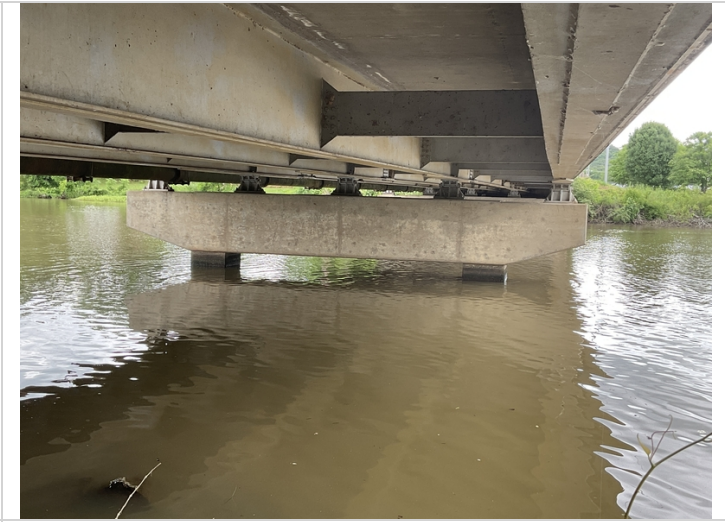
(234) -Bent #2 Rt end of the cap has a 6" vertical delamination.							
302	Compression Joint Seal	LF	67	0	0	0	67
2330	Seal Damage	LF	67	0	0	0	67
(302) -The expansion joints at the abutments are open. Compression joint seals are missing from structure.							
311	Movable Bearing	EA	15	5	0	10	0
1000	Corrosion	EA	10	0	0	10	0
515	Steel Protective Coating	SF	45	15	0	8	22
3440	Effectiveness (Steel Protective Coatings)	EA	30	0	0	8	22

Bent #2 typical.

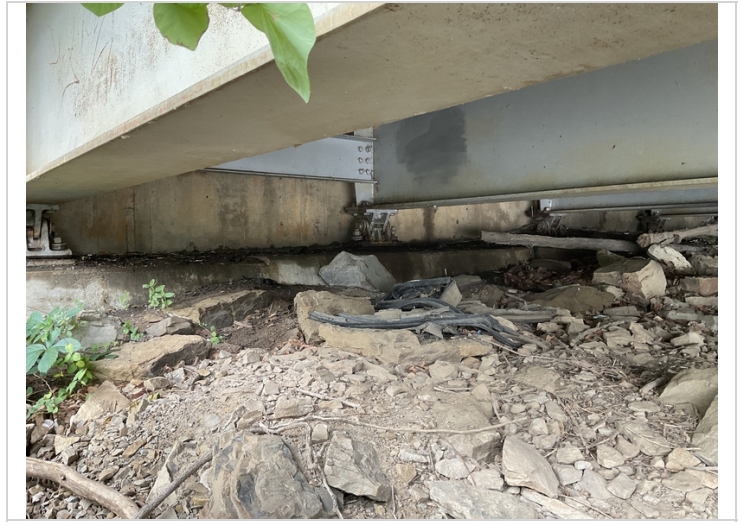
Abutment #1 typical.
