Asset #02146(Routine)

US 71 - Polk Co. over Buffalo Creek

Location: 0.50 MI S OF Cove Ark.

Team Lead: Eric West, Inspection Date: 08/16/2021

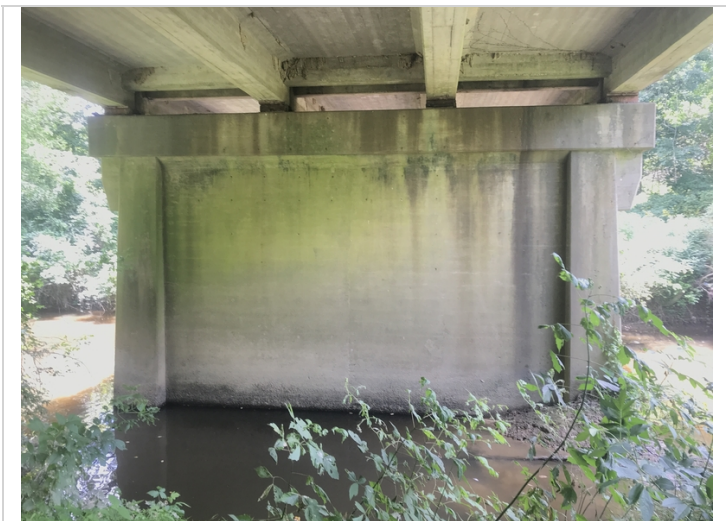
(210) -Bent #2 pier wall back face has a 16" delaminated/spall under girder #2 and a diagonal crack Rt of centerline. -Bent #3 has a vertical crack at the centerline. -The previously documented 10" spall at the base of the web wall in bent # 3 was not visible during this inspection.							
215	Reinforced Concrete Abutment	LF	112	109	1	2	0
1080	Delamination/Spall/Patched Area	LF	1	0	1	0	0
1090	Exposed Rebar	LF	2	0	0	2	0

Bent # 3 typical.
