Asset #A0931 (Routine)

US 71 - Polk Co over Railroad - KCS

Location: So. City Limits Hatfield

Team Lead: Eric West, Inspection Date: 06/29/2021

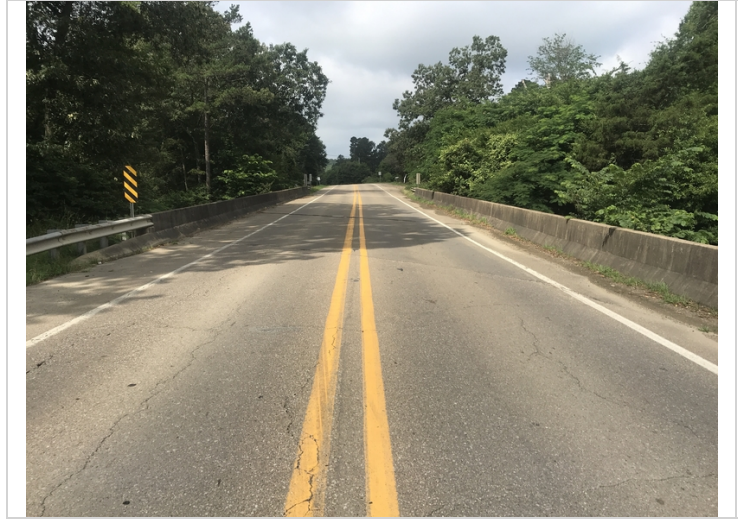
Roadway

- The asphalt driving surface is breaking apart over the expansion joints.
- The asphalt driving surface has areas of longitudinal, transverse, and map cracking.
- The end of span # 1 deck over bent # 2 has spalling in the right lane along the expansion joint in an area approximately 1' long visible from the driving surface.
- The end of span # 2 deck over bent # 3 has spalling in the right lane along the expansion joint in an area approximately 4' long visible from the driving surface.

(510-16) -Deteriorating asphalt along the deck joints with potholes over the intermediate bents.

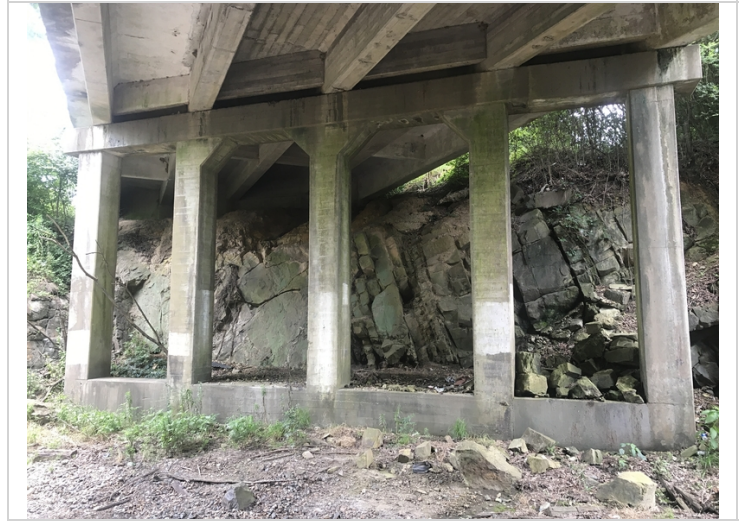
205	Reinforced Concrete Column	EA	20	16	2	2	0
1080	Delamination/Spall/Patched Area	EA	3	0	2	1	0
1130	Cracking (RC and Other)	EA	1	0	0	1	0
<p>(205) -Bent # 2, column # 2 has a 6" spall approximately 5' below the cap and column # 3 has an 8" spall with no exposed reinforcing steel located approximately 3' above strut. -Bent # 3, column # 3 has a vertical crack in the top of the column. -Bent # 3, column # 4 has a shallow softball sized spall and a 12" delamination approximately 5' below the cap. Abutment columns: No noteworthy deficiencies at this inspection.</p>							
210	Reinforced Concrete Pier Wall	LF	82	79	2	1	0
1090	Exposed Rebar	LF	1	0	0	1	0
1120	Efflorescence/Rust Staining	LF	1	0	1	0	0
1130	Cracking (RC and Other)	LF	1	0	1	0	0
<p>(210) -Bent # 2, strut has vertical cracking with efflorescence adjacent to column # 3. -Bent # 2, strut has spalling with exposed reinforcing steel below column # 2. -Bent # 2, strut has a baseball sized spall with no exposed reinforcing steel at base of column below column # 5.</p>

Bent #2 typical.
