Asset #05519(Routine)

SH 265 - Wash. Co. over Spring Creek

Location: 8.91 MI N JCT SH 16 & 265

Team Lead: Rhett Franks, Inspection Date: 12/02/2021

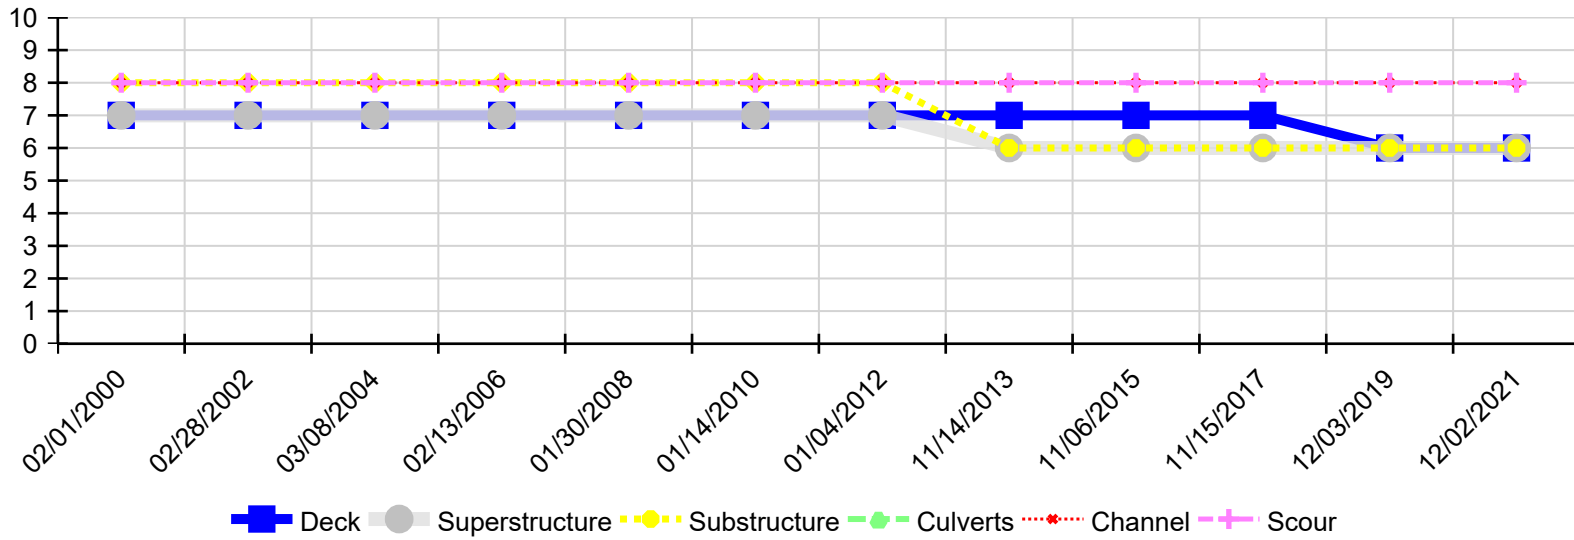
Condition History

Inspection Date	Deck	Superstructure	Substructure	Culverts	Channel	Scour
12/02/2021	6	6	6	N	8	8
12/03/2019	6	6	6	N	8	8
11/15/2017	7	6	6	N	8	8
11/06/2015	7	6	6	N	8	8
11/14/2013	7	6	6	N	8	8
01/04/2012	7	7	8	N	8	8
01/14/2010	7	7	8	N	8	8
01/30/2008	7	7	8	N	8	8
02/13/2006	7	7	8	N	8	8
03/08/2004	7	7	8	N	8	8
02/28/2002	7	7	8	N	8	8
02/01/2000	7	7	8	N	8	8
