**Bridge #07058(Routine)**  
**US 71 - Washington over Hutchins Creek**  
**Location: 6.83 Mi N Crawford Co Lin**

**Team Lead: Eric West Inspection Date: June 01, 2022**

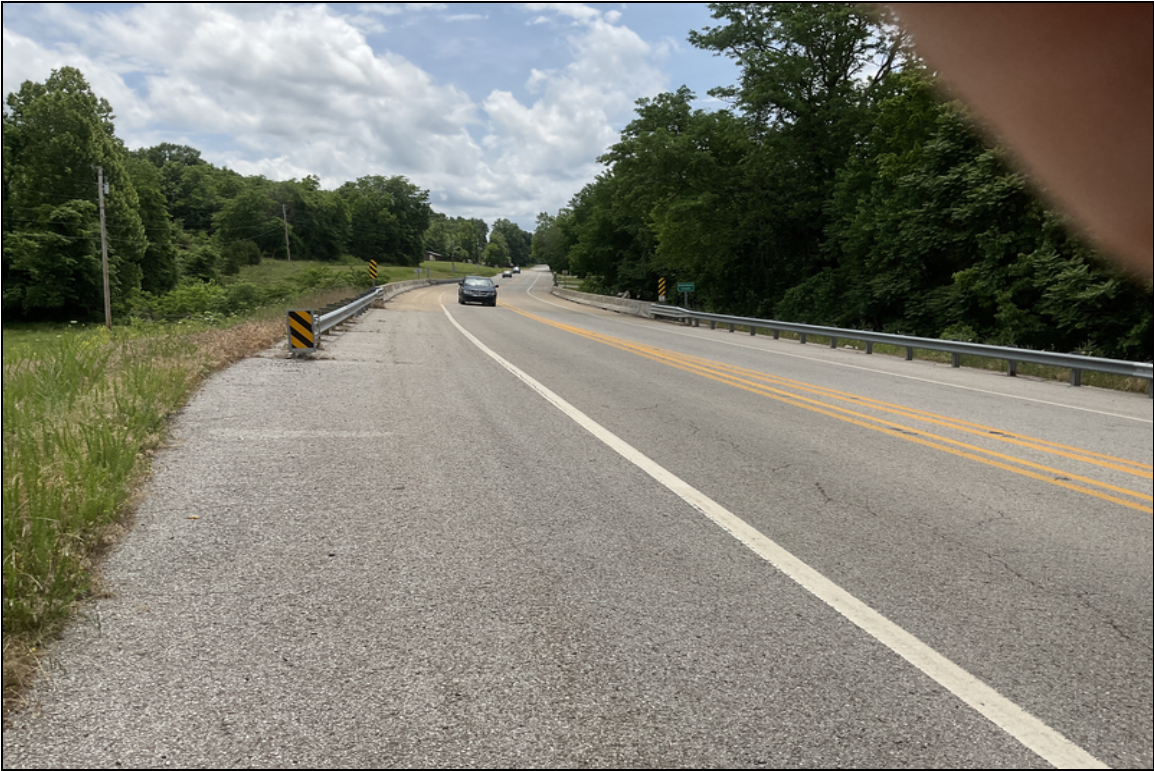
Roadway

(12)							
-The driving surface of the deck has short duration longitudinal cracks. The cracks are most prevalent at the transverse saw joints. -The right lane has a full length longitudinal crack located approximately 2' left of white line. -The right shoulders of Spans # 1 and # 2 have transverse hairline cracking the full width of the shoulder visible from the driving surface. -The Left and Right overhang portion of the deck has transverse cracking with light efflorescence visible from the undersurface that correspond with the parapet joints. -The left gutter has light dirt and debris accumulation.							
107	Steel Open Girder/Beam	LF	825	825	0	0	0
515	Steel Protective Coating	SF	9083	908	8175	0	0
3430	Oxide Film Degradation Color/Texture Adherence(Steel Protective Coatings)	SF	9083	908	8175	0	0
