Asset #00879(Routine, Underwater type 2)

State Highway 45 over Cedar Creek - Seb. Co.

Location: 0.7 Mi S Jct Hwy 253

Team Lead: Bob McEntyre Inspection Date: 09/25/2024

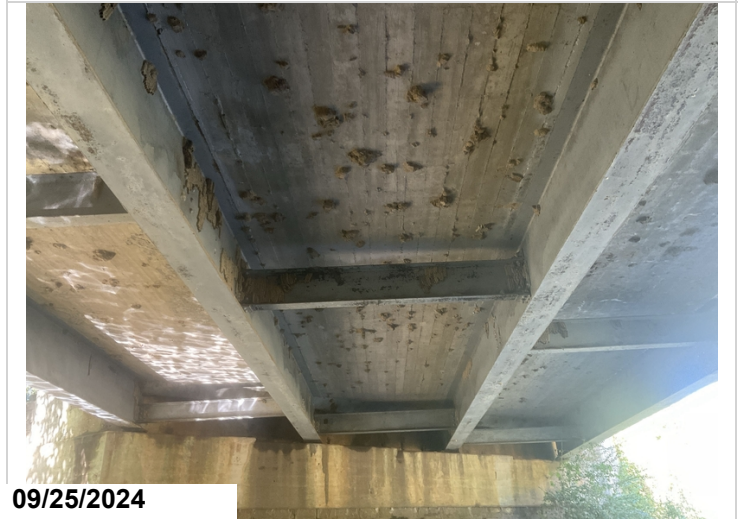
09/25/2024 - RSM & SPC: The deck is in fair overall condition. The driving surface is not visible due to an asphalt wearing surface. The undersurface of the deck in the exterior bay has areas of random cracking with efflorescence. The undersurface of the deck overhangs have cracking with efflorescence and spalls with exposed reinforcing steel.

Typical undersurface

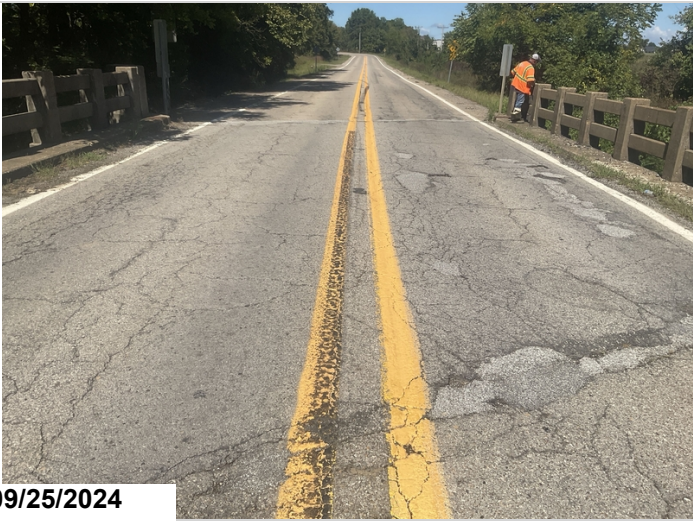
Driving surface.

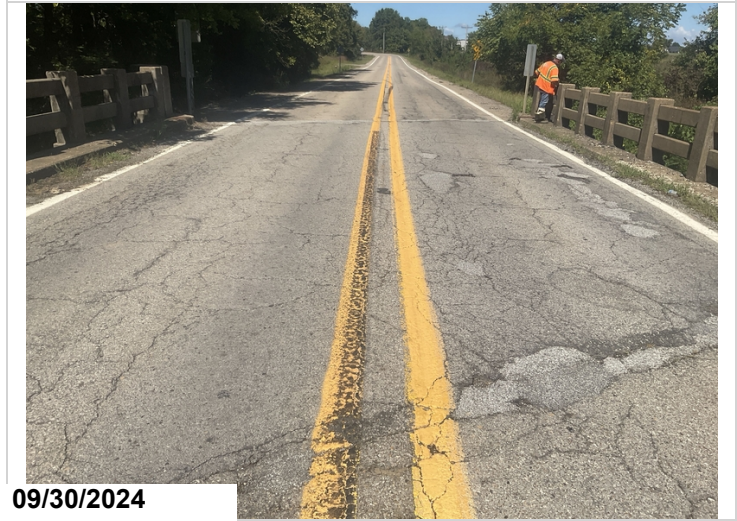
Driving surface.

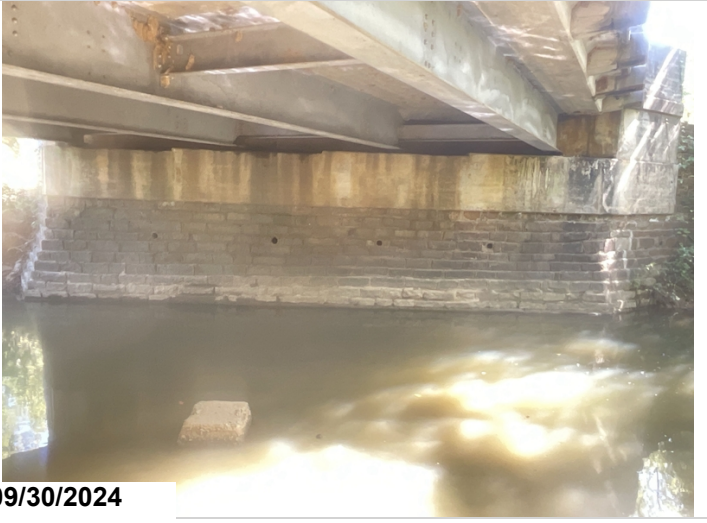
Abutment # 1: General view.

09/25/2024 - RSM & SPC: Substructure is in fair overall condition. The left and right sides of stone masonry abutment # 1 has settlement cracks that follow the masonry joints and propagate into the Southwest and Southeast wing walls. The crack in the Southwest wall propagates from base of abutment diagonally up the masonry joints extending approximately 9' in length to the top of the wing wall. The crack is up to 1/2" wide in locations. The concrete backwalls have some shallow spalling with exposed reinforcing steel. Stone Masonry stem walls have minor grout deterioration along the base. Abutment # 2 Backwall on the left side is fractured under the end post from apparent traffic impact.
