Asset #M1090(Routine)

US Highway 62 over Ditch - Wash. Co.

Location: 0.93 M E OF OKLAHOMA SL

Team Lead: Eric West, Inspection Date: 05/18/2023

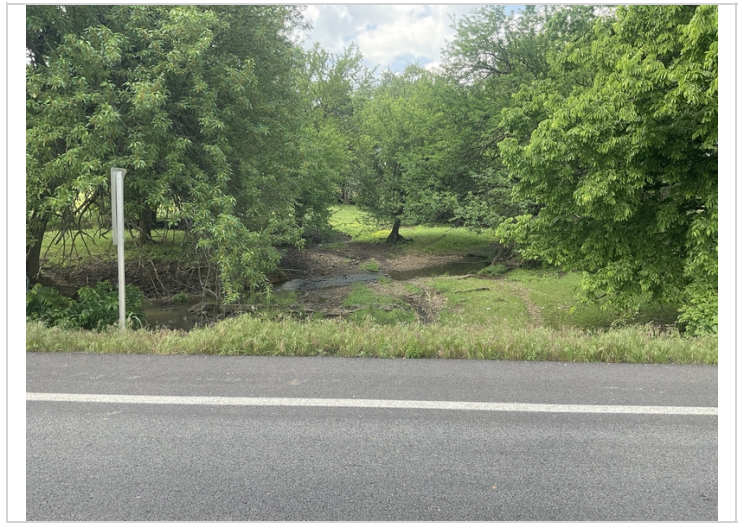
Upstream

61 - Channel/Channel Protection (6 - Bank is beginning to slump. River control devices and embankment protection have widespread minor damage. There is minor stream bed movement evident. Debris is restricting the channel slightly.)
-The upstream channel has streambed material accumulation that is directing stream flow into the Southeast wing wall causing minor erosion behind the wing wall.
