Bridge 00411 Inspection Report

Route:64 Section:02 Log:17.54

IDENTIFICATION	
(1) State Names	5 - Arkansas
(8) Structure Number	00411
(5) Inventory Route	1
(2) Highway Agency District	04 - District 04
(3) County Code	33 - Crawford County

INSPECTIONS *			
(90) Inspection Date			11/03/2025
(91) Frequency			24
(92) Critical Feature Inspection	Done	Freq. (Mon)	Date
A: Fracture Critical Detail	No		
B: Underwater Inspection	No		
C: Other Special Inspection	No		
<p>* The inspection date and frequency information in this box contains the current NBI date and frequency information. Please refer to the report header for the date this inspection was conducted.</p>

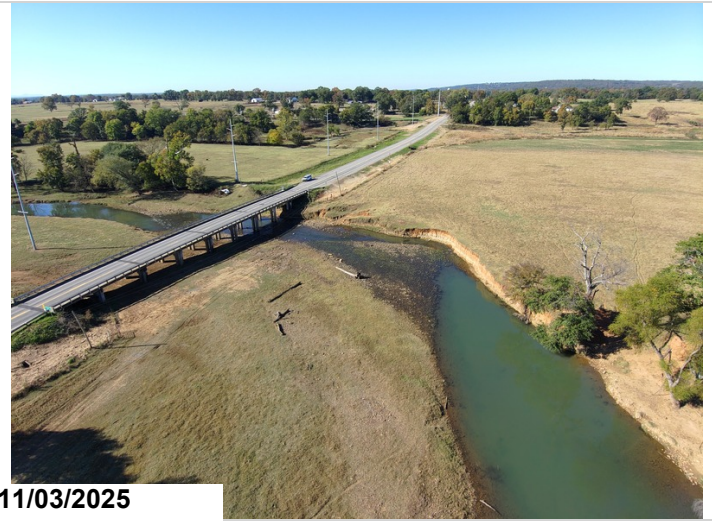
Embankment erosion upstream. Drone photo.

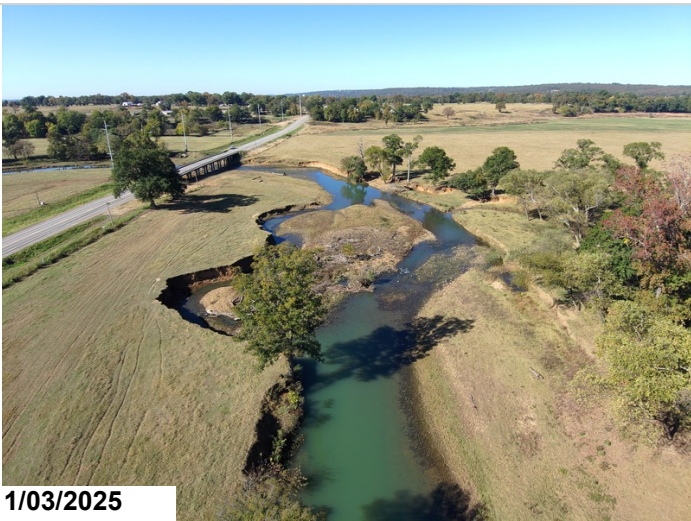
Embankment erosion upstream. Drone photo.

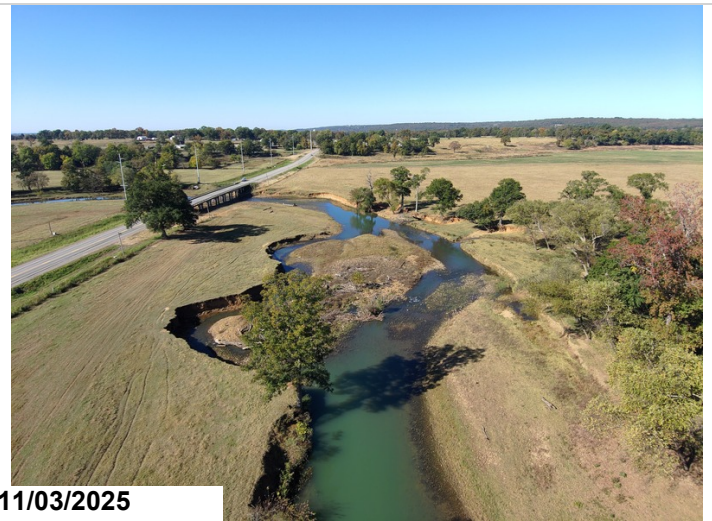
Embankment erosion upstream. Drone photo.

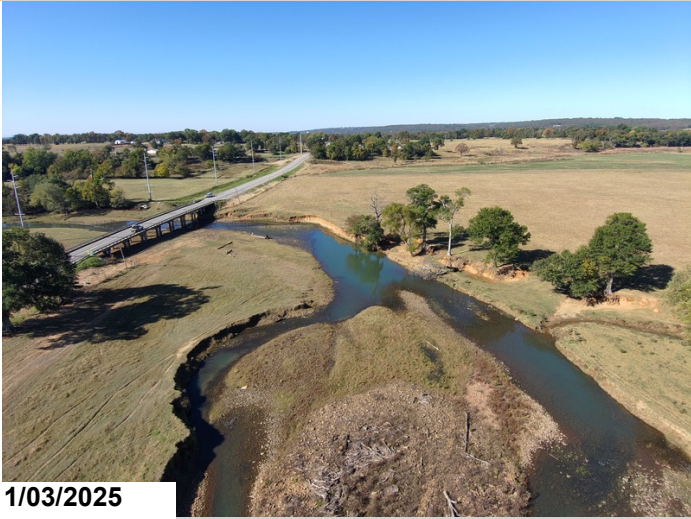
Embankment erosion upstream. Drone photo.

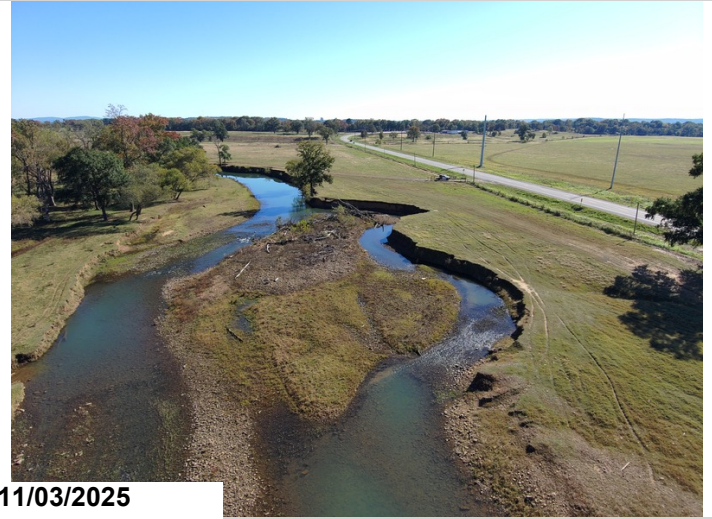
Embankment erosion upstream. Drone photo.

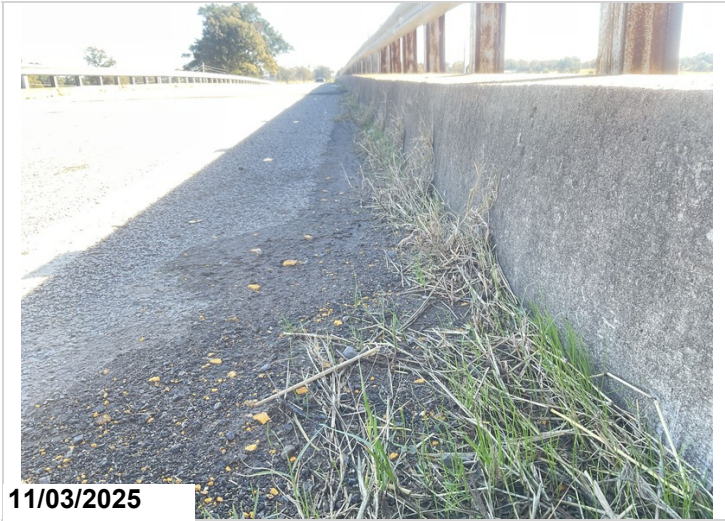
Shoulders have dirt and gravel accumulation with vegetation growing.

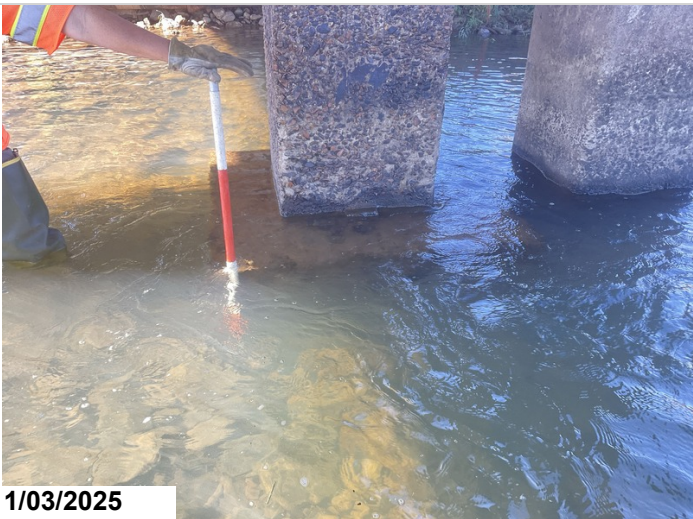
Visual observation during relatively low and clear water conditions indicate that bent # 3 footings are exposed at all 4 columns. Columns # 2 and 3 have up to approximately 24" of the vertical face of footing exposed.

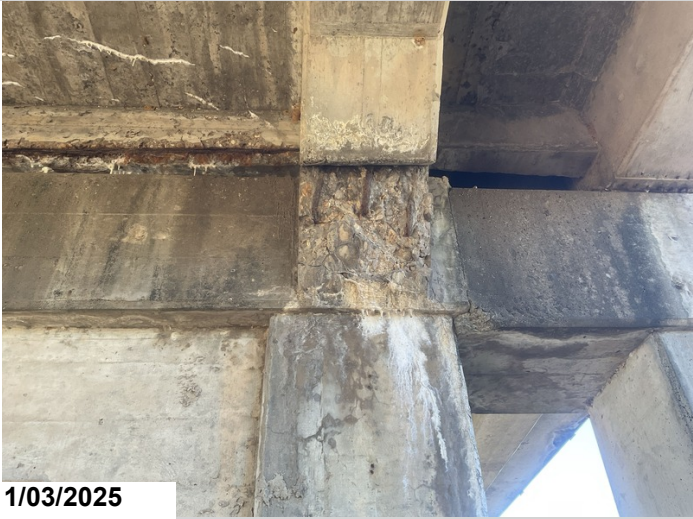
Bent # 8 Cap, Ahead Side: Cap haunch under girder # 2 has spalling with exposed reinforcing steel. Cap over Column # 4 has shallow spall with no exposed rebar under the bearing masonry plate over column # 4. Exposed steel 2LF CS3, Spall/delam 1LF CS3.

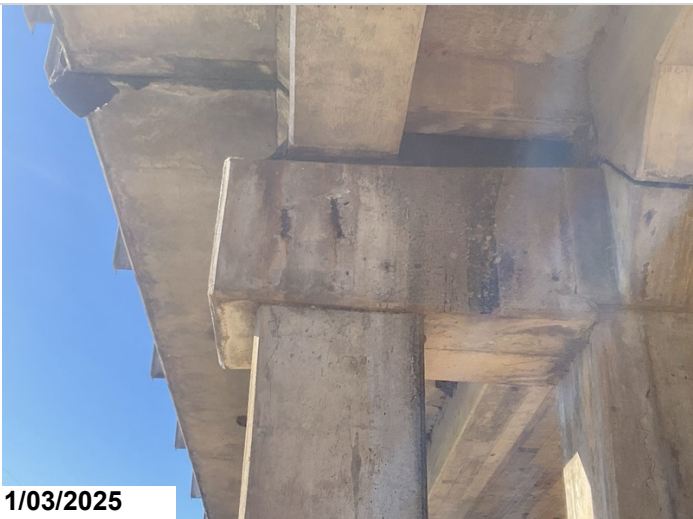
Bent # 6 Cap, Ahead Side, Over Column # 4: Two 6" shallow spalls with exposed reinforcing steel. Exposed steel 1LF CS3.

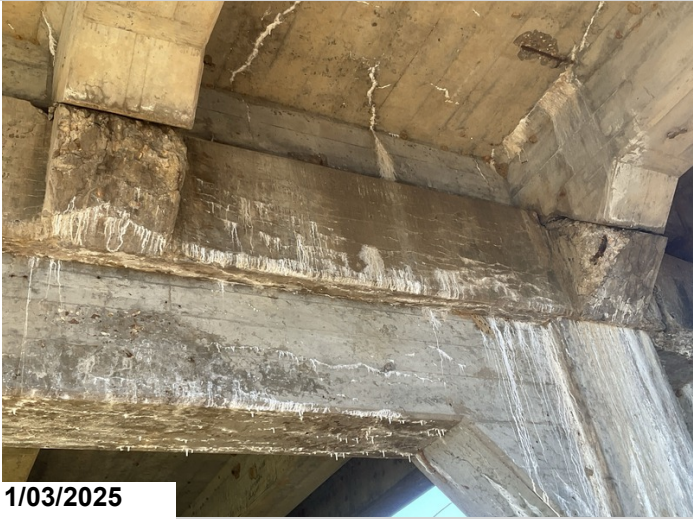
Overall, the Substructure is considered in poor condition base on concrete deterioration, mapcracking and sheared off cap haunch at bent # 2. Intermediate bent columns have areas of concrete deterioration / heavy abrasion with exposed reinforcing steel and concrete section loss.

Bent # 2, Cap, Ahead Side: Haunches under Girders # 2 and 3: Mapcracking with spalling and exposed steel. Spall/delam 1LF CS3, Exposed steel 2LF CS3, Cracking 1LF CS3.

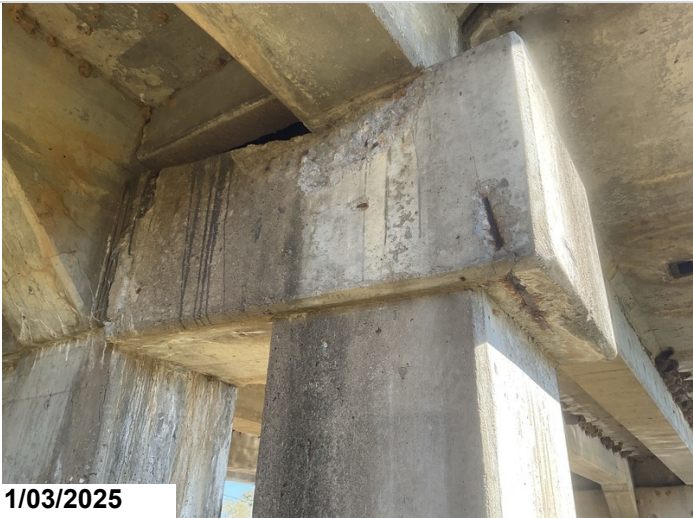
Bent # 2 Cap, Left Back Side: Spall/ delaminated areas and exposed steel. Spall/delam 1LF CS2, 2LF CS3, Exposed steel 1LF CS3.

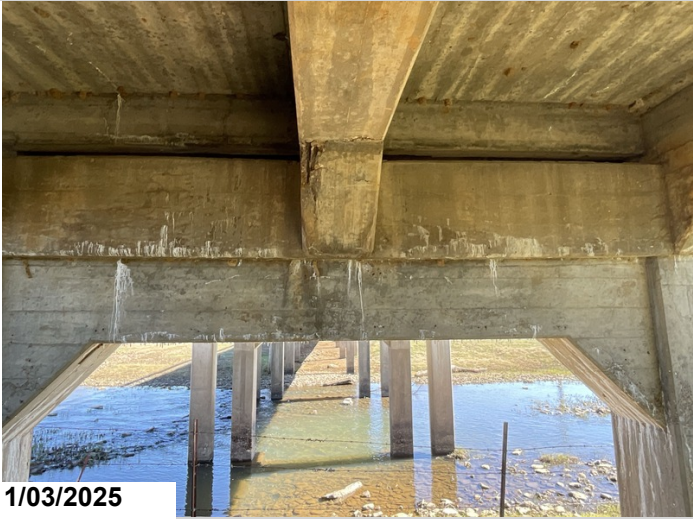
Bent # 2 Cap, Back Side: Mapcracking with efflorescence cracking 11LF CS3.

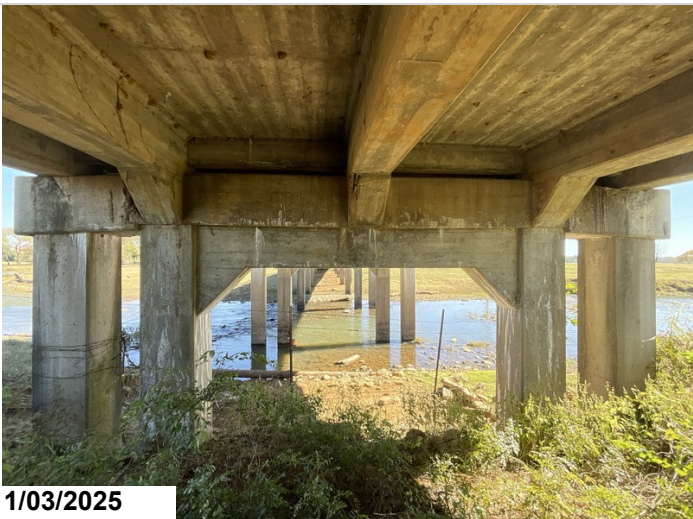
Bent # 2 Cap, Back Side: Mapcracking with efflorescence and spalling with exposed steel.

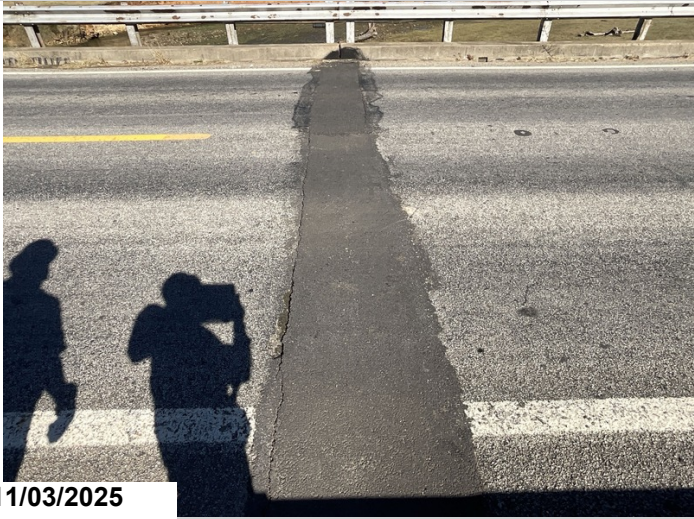
Bent # 6 Expansion Joint: Asphalt patch over joint.

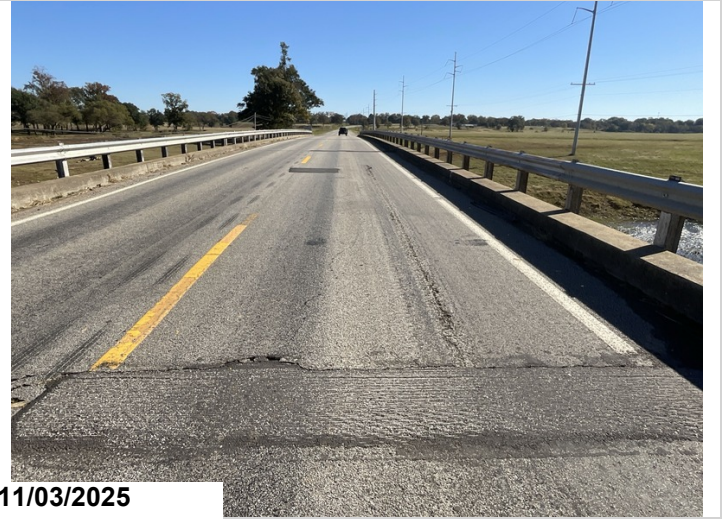
Right Lane: Asphalt patches over expansion joints.

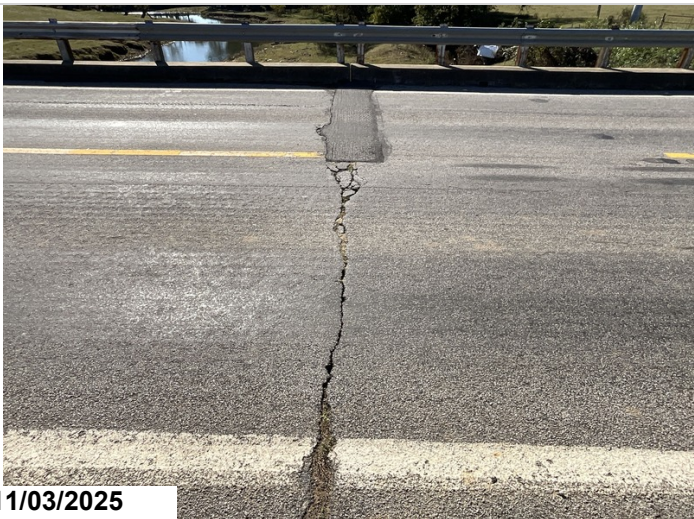
Deck is in satisfactory condition. Driving surface has an asphalt wearing surface that is breaking apart over the intermediate expansion joints creating potholes in the driving surface. Deck undersurface has transverse and map cracking with efflorescence and a few shallow spalls with exposed reinforcing steel in random locations.

Bent # 2 Expansion Joint: Asphalt breaking apart.

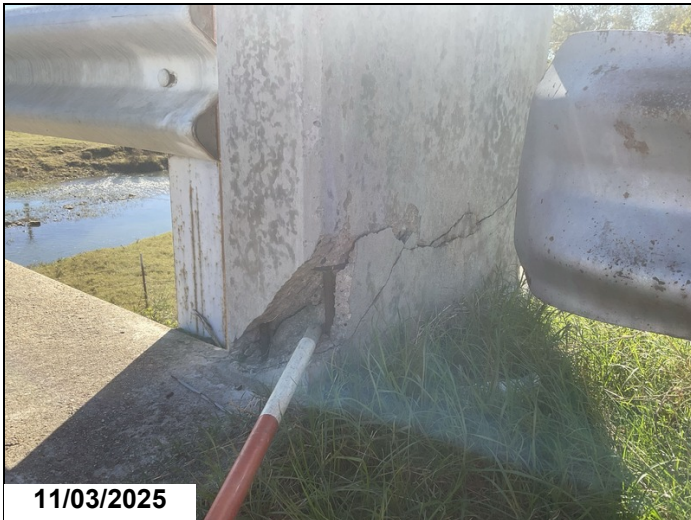
Abutment # 1, Right End Post: Fractured at the base with spalling that exposes reinforcing steel. Damage 1LF CS4.

Abutment # 1 right end post is fractured at the base with spalling that exposes reinforcing steel.

Abutment # 1, Right End Post: Fractured at the base with spalling that exposes reinforcing steel.

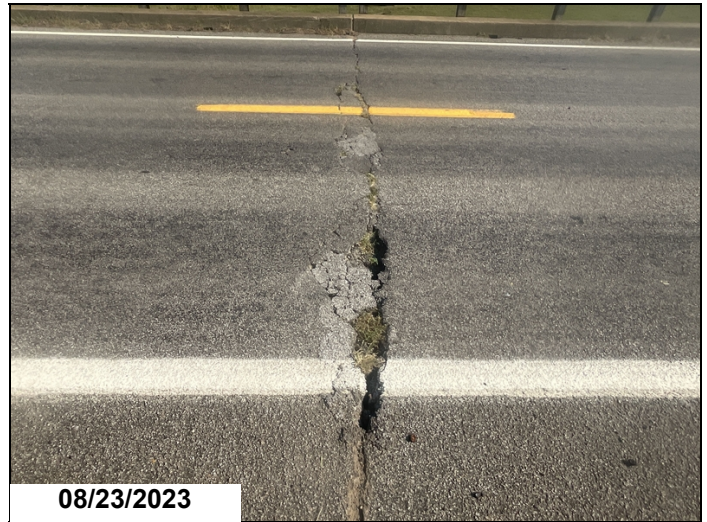
The asphalt wearing surface is breaking apart over the intermediate bents creating potholes in the driving surface.

Asphalt over bent # 5 coming apart with potholes forming in the driving surface.

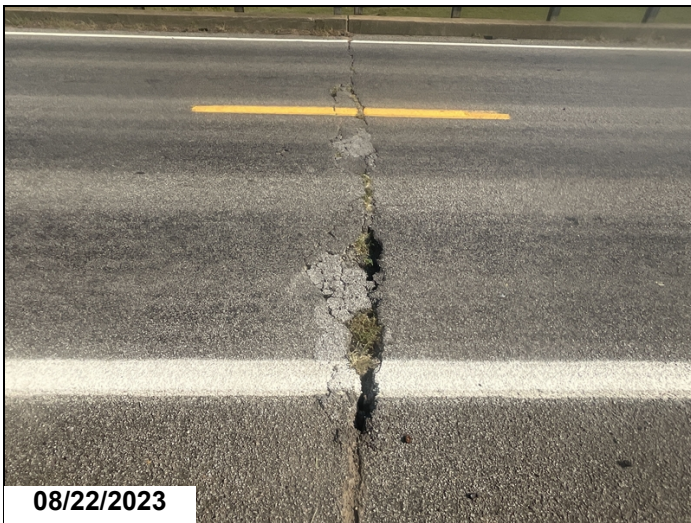
Asphalt over bent # 5 coming apart with potholes forming in the driving surface.

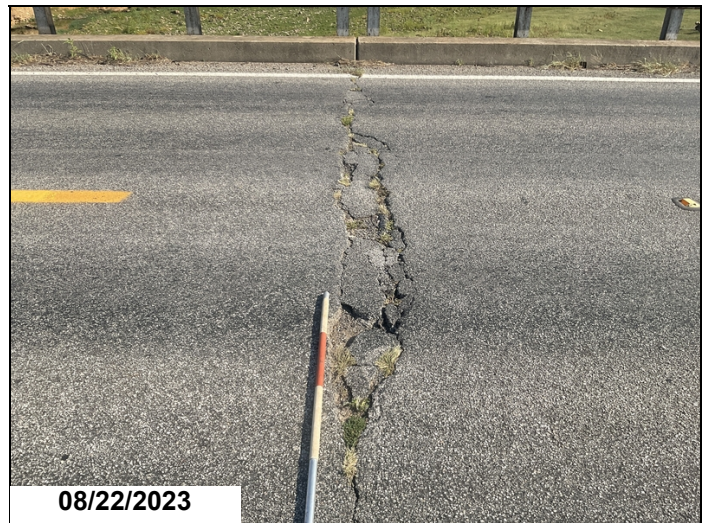
Asphalt over bent # 4 coming apart with potholes forming in the driving surface.

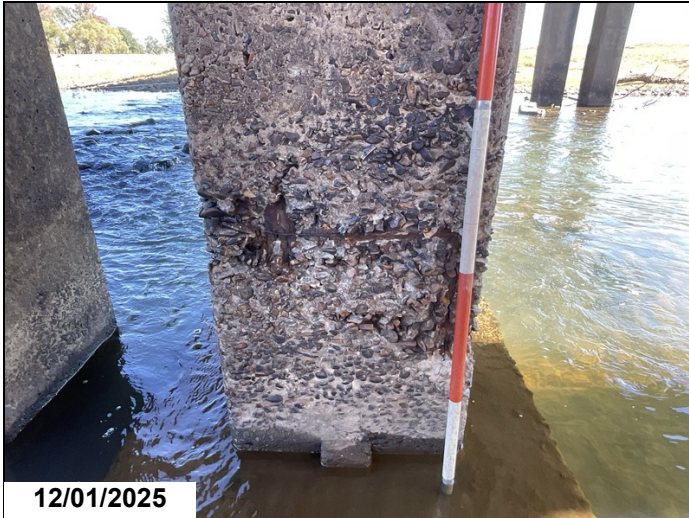
Bent # 3, Column # 2 has areas of heavy abrasion and concrete deterioration at the base of the concrete column. Bent # 5, columns # 1, 2, & 4 have heavy abrasion, concrete deterioration, and section loss. Columns # 1 & 4 have exposed reinforcing steel. Column # 4 has up to 4 inches of concrete section loss at the water elevation.

Bent # 3, Column # 2, Back Side: Full width x 15" high area of concrete deterioration with exposed reinforcing steel and up to 2" of concrete section loss. Exposed steel has section loss.

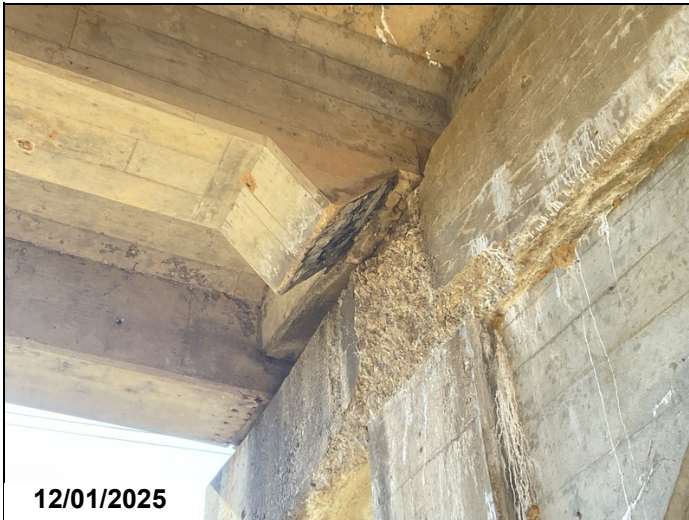
08/23/2022 - RSM - Priority changed from "G" to "D" due to spalling / concrete deterioration with some loss of bearing area to girder # 4 over the missing cap haunch.

Bent # 2 concrete haunch incorporated into the cap on the ahead side under girder # 4 has sheared off the face of the cap in the past. There is no exposed rebar in the face of cap where the concrete haunch was originally constructed. There is up to 2" of concrete section loss to the cap where the haunch fell off.

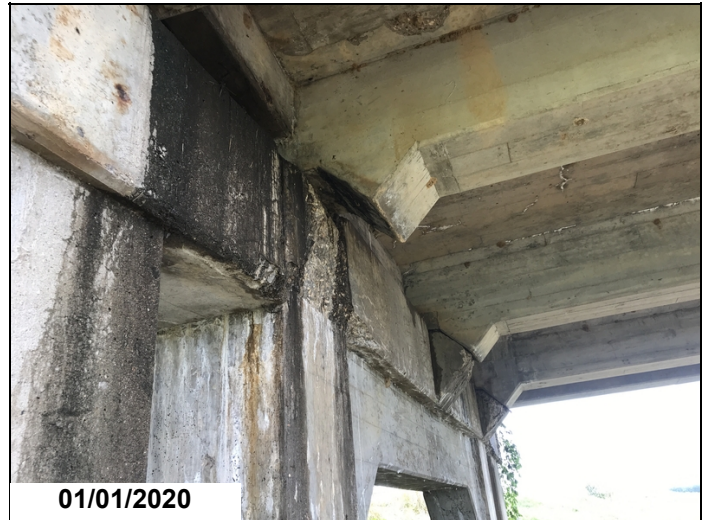
Bent # 2, Span # 2, Haunch in bent cap under Girder # 4 has sheared off the face of the cap. There is no exposed reinforcing steel in the face of cap where the concrete haunch was originally constructed.

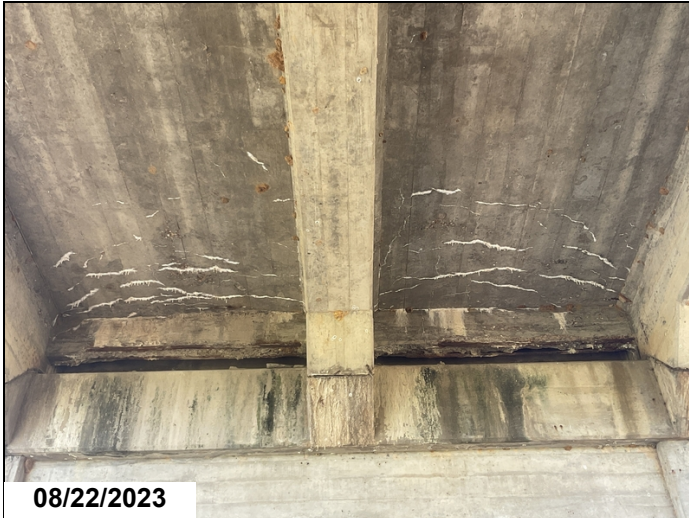
The deck haunches over the bents with expansion joints have areas of spalling with exposed reinforcing steel.

The asphalt driving surface has transverse open cracks over the bents that have expansion joints. Open cracks are leaking water and debris on the bent caps of Bents # 2, 4, 6, & 8.

Span # 4 over bent # 4-Spalling with exposed reinforcing steel in expansion dam.

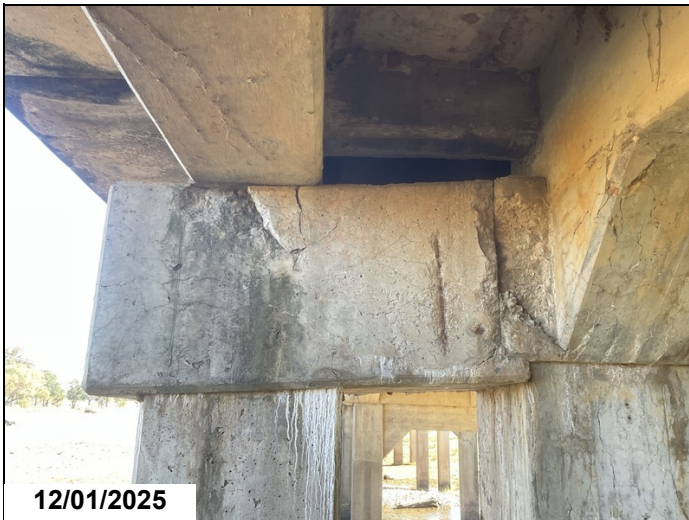
Bent # 2 cap has significant map cracking with efflorescence and water leaking out of the cracks in the cap. The top of cap in bays # 1 and 4 (widened portion of cap) has soft deteriorated concrete.

Top of cap has an 1/8" wide longitudinal crack near the center of cap between girders # 2 and 3 and 3 & 4 (original portion of cap) with delaminated areas along the crack.

The backface of cap has large spalled areas under girders # 1 and # 5 with several delaminated areas.

Bent # 2 Cap, Left Back Side: Spall/ delaminated areas and exposed steel.

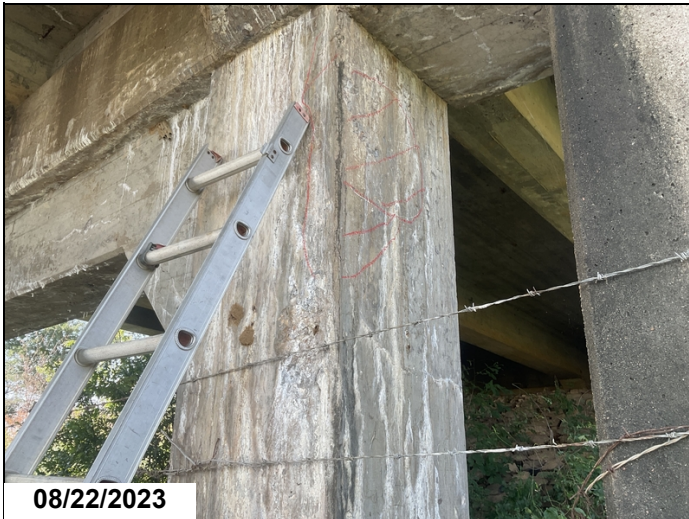
Bent # 2 columns # 2 and 3 have map cracking and delaminated areas with efflorescence. Column # 2 has numerous vertical cracks with efflorescence with a 30" delaminated area in the exterior face near cap juncture.

Bent # 2, column # 2 has numerous vertical cracks with efflorescence and a 30" delaminated area in the exterior face near cap juncture.

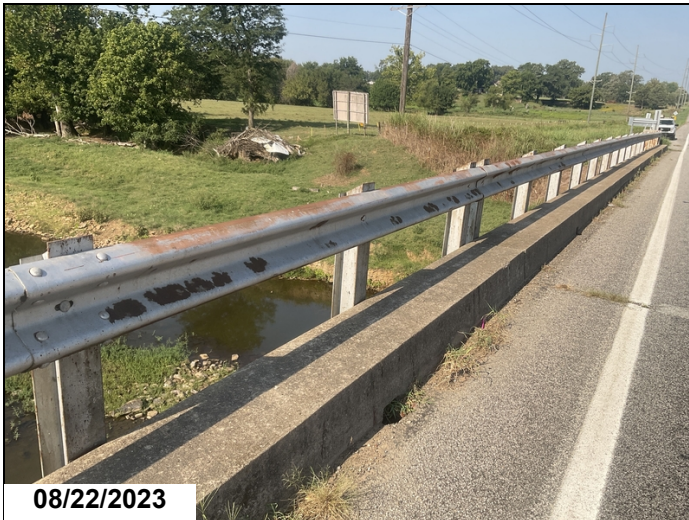
The paint system is failing on the bridge rail posts and the bridge rail with flaking paint and rust forming.

Bridge railing protective coating failing.

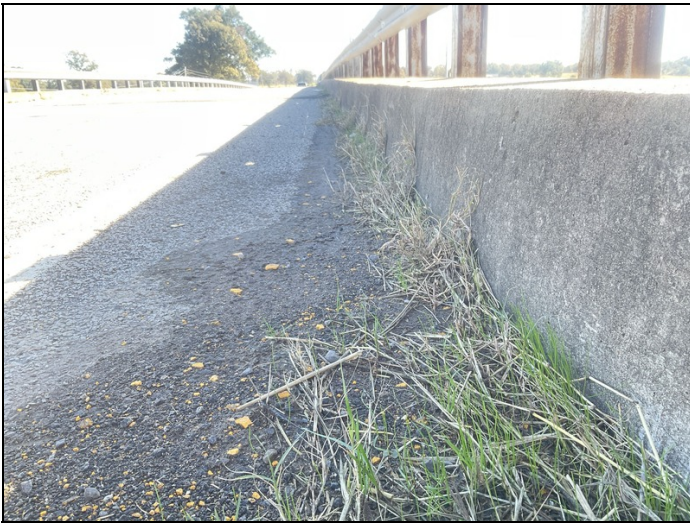
Shoulders have dirt and gravel accumulation with vegetation growing.

A-55 - Deck Washing Needed (Yes)

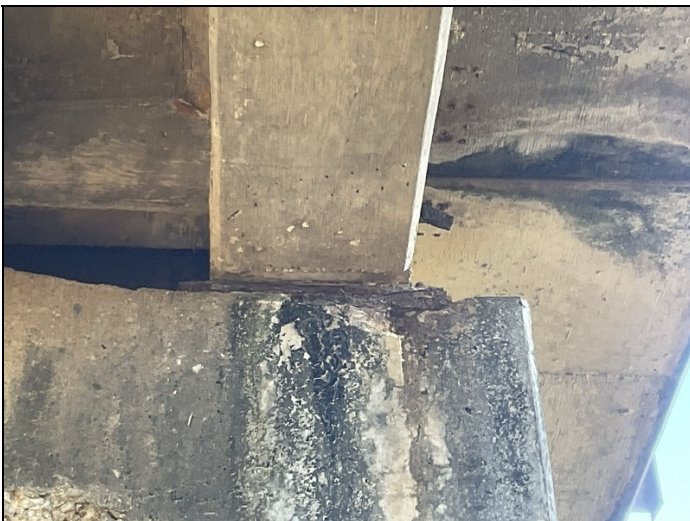
Moveable bearings have corrosion with flaking rust.

Bents # 2 Ahead Side, Bearing # 1: Bearing has corrosion with flaking rust/ section loss. Cap has shallow spalling with minor loss of bearing area to the masonry plate of bearing. Corrosion 1EA CS3.

A-57 - Girder End and Bearing Painting Needed (Yes)
