Asset #A3288(Routine)

I 55-12SB-LM 44.54 over UPPER SANDY BAYOU

Location: 0.1 MI NO JCT SH 181

Team Lead: Richard Jones, Inspection Date: 07/19/2022

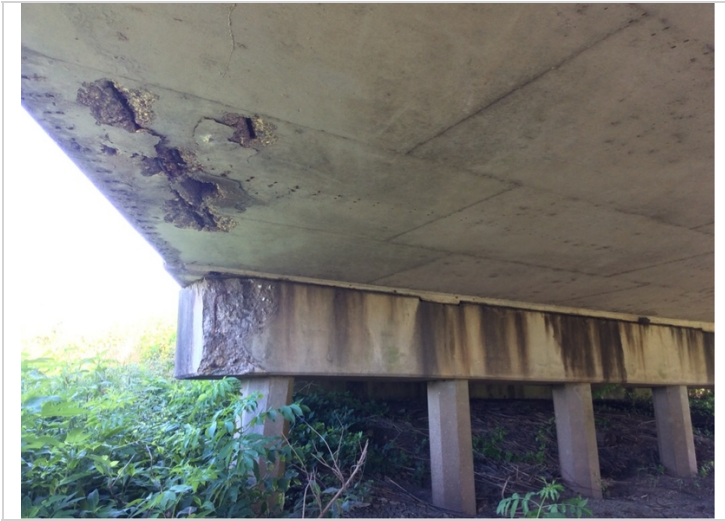
Deck received a LMC overlay around 2015 under job BB1003.
Concrete approach slabs have several cracks. Some of the cracks at bent 5 approach slab were sealed in the past.
Concrete rails have vertical cracks.
Poured joint seals have lost adhesion with a few areas missing.
Span 3 has a 4' spall along joint over bent 4.

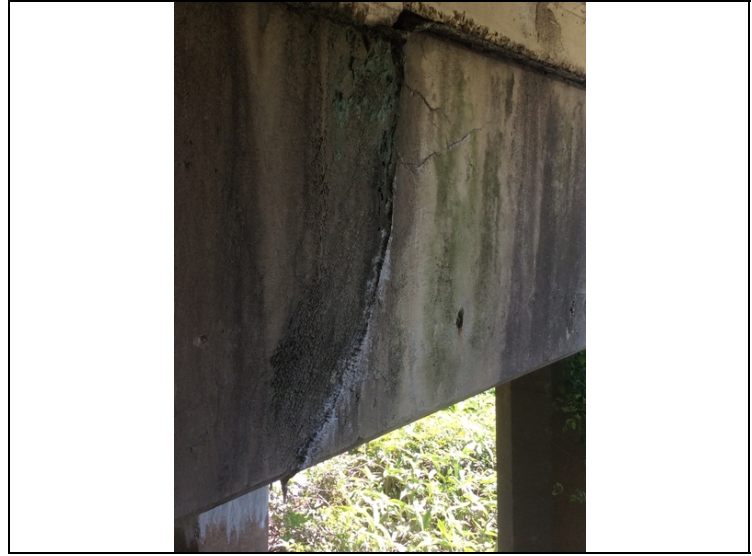
Bent 4 Lt

Caps and abutments have a few minor cracks or spalls near key ways. Some cracks have efflorescence.
Bent 2 cap has a moderate vertical crack with efflorescence at key way near pile 7.
Bent 4 has a deep spall with exposed rebar on corner on Lt end. Ahead face of cap has a moderate vertical crack with efflorescence at keyway.
