Asset #B3288(Routine)

I-55NB-12-LM 44.55 over UPPER SANDY BAYOU

Location: 0.1 MI NO JCT SH 181

Team Lead: Richard Jones, Inspection Date: 07/19/2022

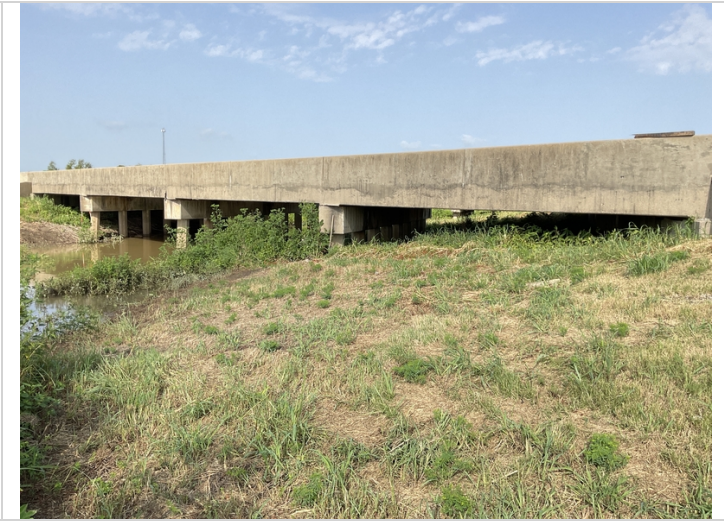
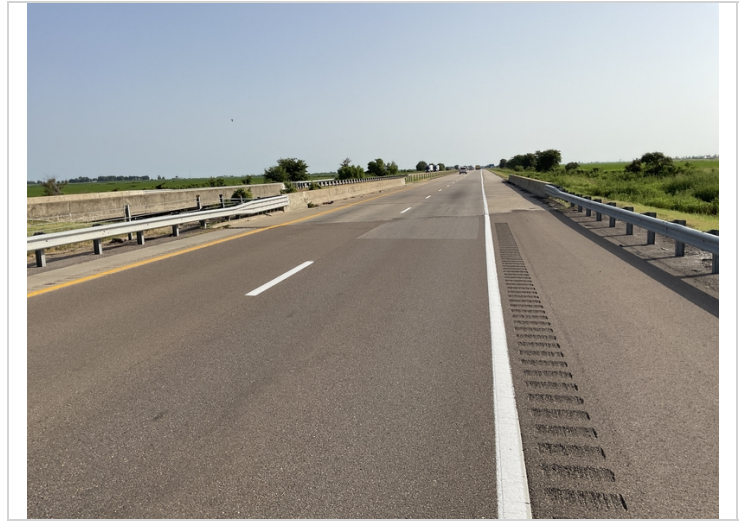
Date Reported: 09/06/2012
Priority: C - Important
Type of Work: Repair (General)
Status: Monitor
Component: Substructure

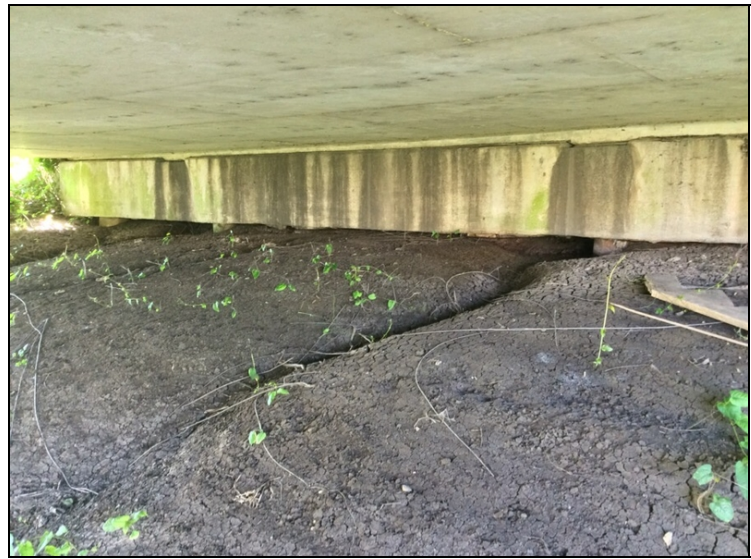
Comment: Caps and abutments have a few minor cracks or spalls near key ways. Some cracks have efflorescence. Bent 1 and 5 abutments have some undermining up to 1' below and 2' back under. Bent 2 cap has a moderate vertical crack with efflorescence over pile 2. (possible settlement crack)
