Asset #06064(Routine)

SH 275 S-3 LM5.54 over MORO CREEK

Team Lead: Rickie Bratton, Inspection Date: 06/02/2022

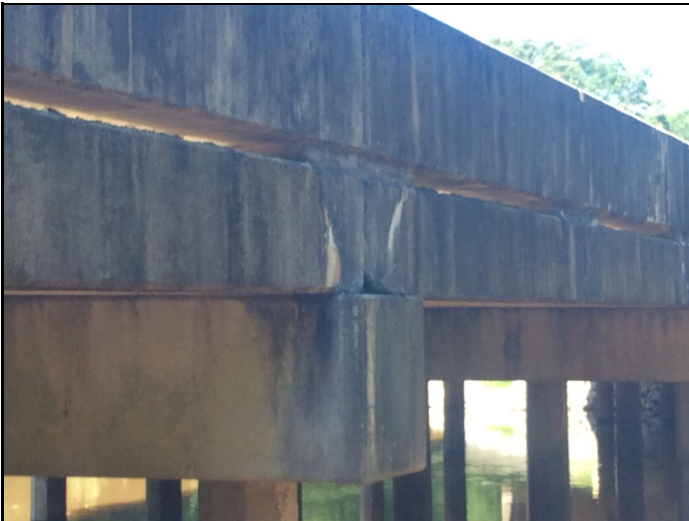
Deficiency Description

Bent 2 Rt. side, concrete deck @ all bents all spans has minor shear cracking on the outside of deck with some efflorescence.
