**Asset #02783**(Routine, Underwater type 2)**SH 14/Stone County over ROCKY BAYOU****Location: 2.5 MI E JCT SH 5 SO****Team Lead: Floyd Haley Inspection Date: 05/02/2024**

Asset #02783(Routine, Underwater type 2)

SH 14/Stone County over ROCKY BAYOU

Location: 2.5 MI E JCT SH 5 SO

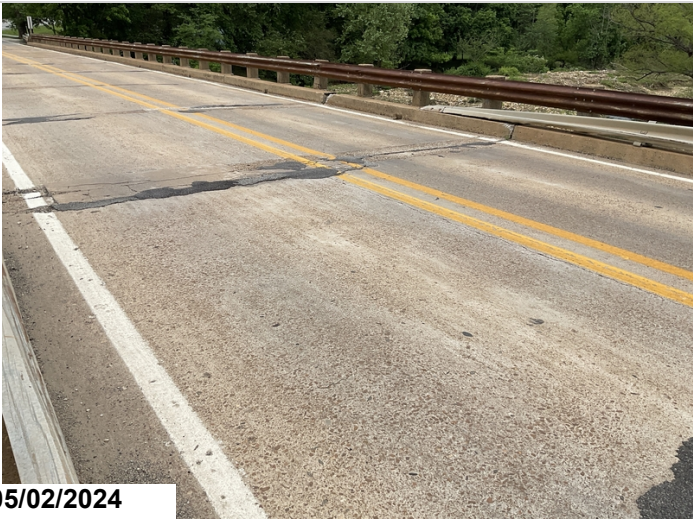
Deck is in overall Fair condition with transverse & longitudinal cracking & areas of spalling/patches @ joints.

Typical deck.

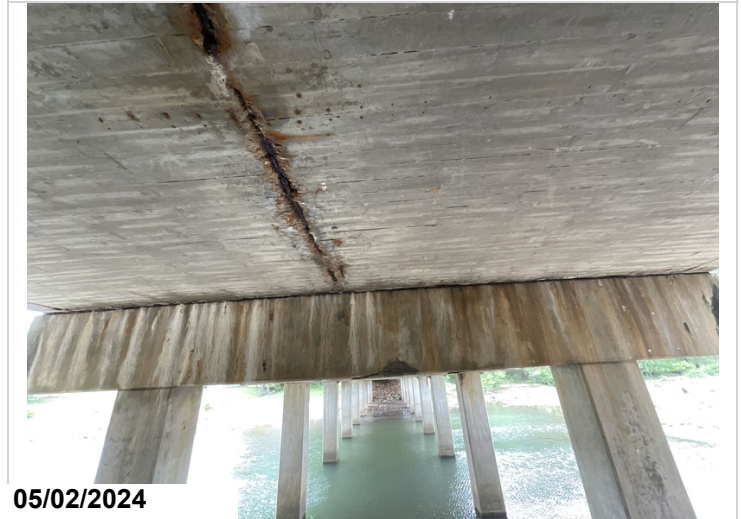
Superstructure is in Fair condition with cracking, delaminated & spalled areas. Most of the spalled areas have corroded reinforcing steel exposed.

Typical undersurface.

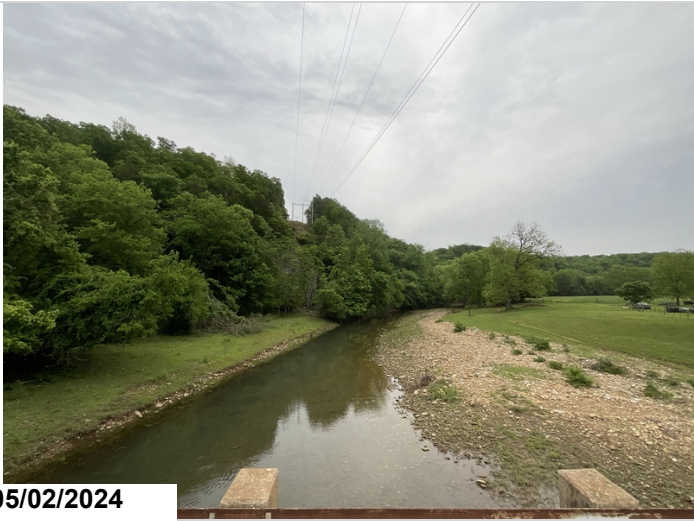
Channel is in Satisfactory condition with scour in channel and around columns where drift was previously located.

Right side of Bridge: Channel view.

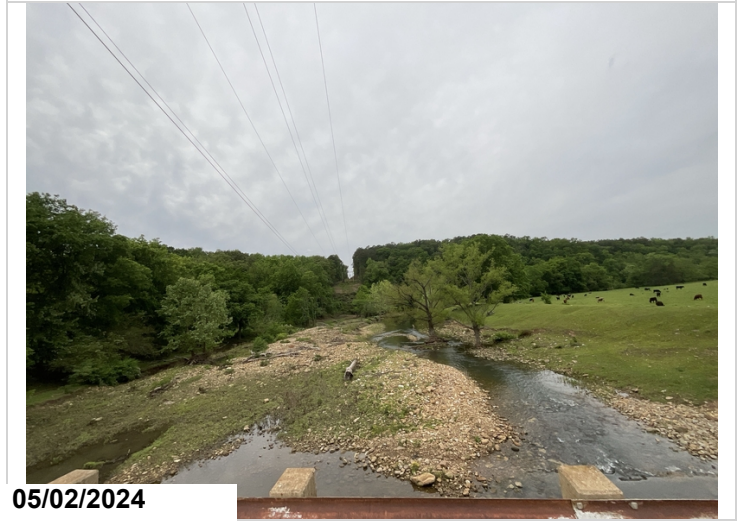
Left side of Bridge: Channel view.
