Bridge #01782(Routine)
SH 7-10 Log 16.70 over MIDDLE FORK SALINE RIVER

Team Lead: Shane Byrd Inspection Date: October 21, 2020

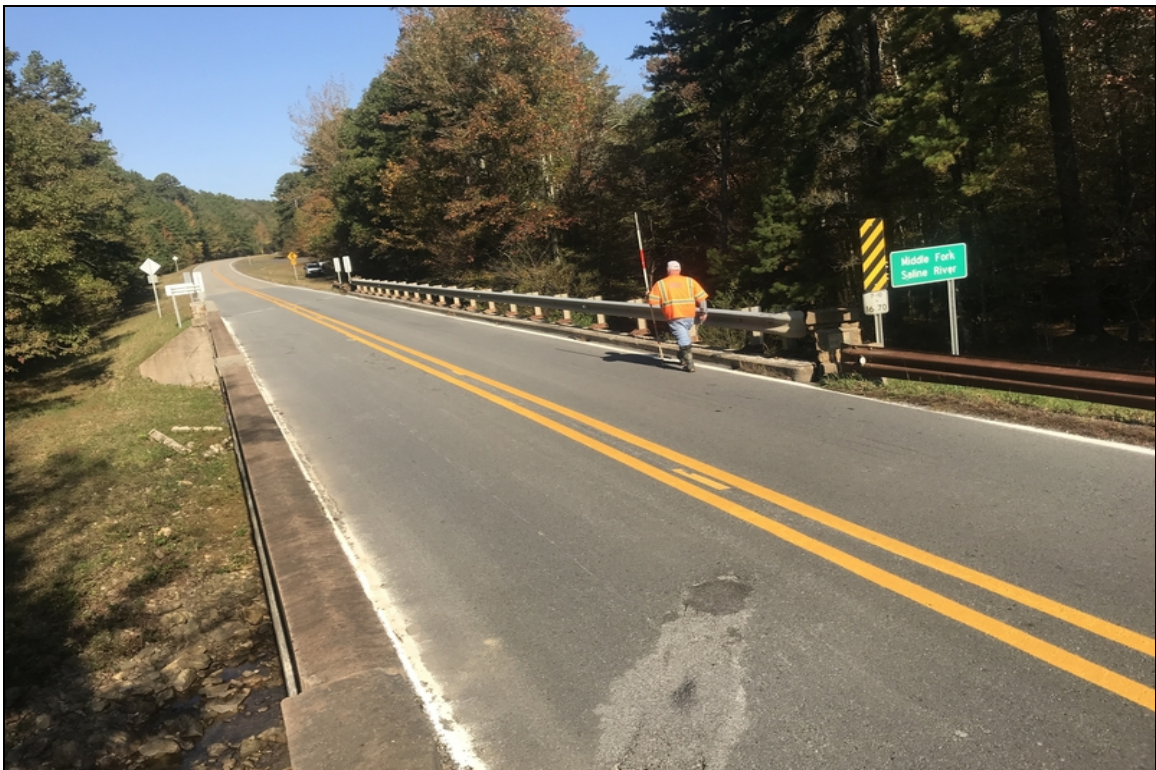
(16)							
All spans have spalls with exposed rebar, cracks and cracks with efflorescence. The left edge of the deck has spalls, cracks with efflorescence and is disintegrating. The wearing surface has a new overlay. Patches and a few potholes remain in the deck at bents 1 & 4.							
110	Reinforced Concrete Open Girder/Beam	LF	254	215	38	1	0
1080	Delamination/Spall/Patched Area	LF	3	0	2	1	0
1090	Exposed Rebar	LF	11	0	11	0	0
1120	Efflorescence/Rust Staining	LF	4	0	4	0	0
1130	Cracking (RC and Other)	LF	21	0	21	0	0

Deck overview.

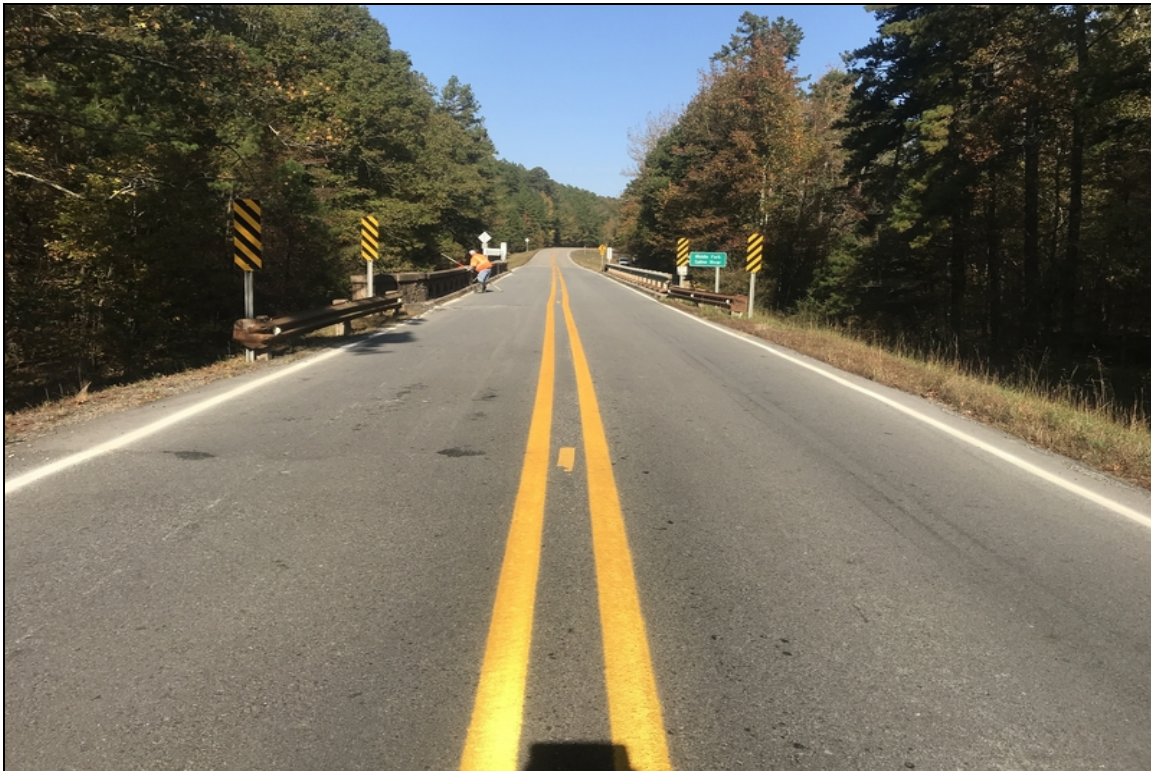
Approach Northbound.
