**Bridge #M2968(Routine)**  
**SH 365 Log 6.39 over WHITE OAK BAYOU**

**Location: 8.5 MI N OF I-40**

**Team Lead: Chris Doggett Inspection Date: February 03, 2020**

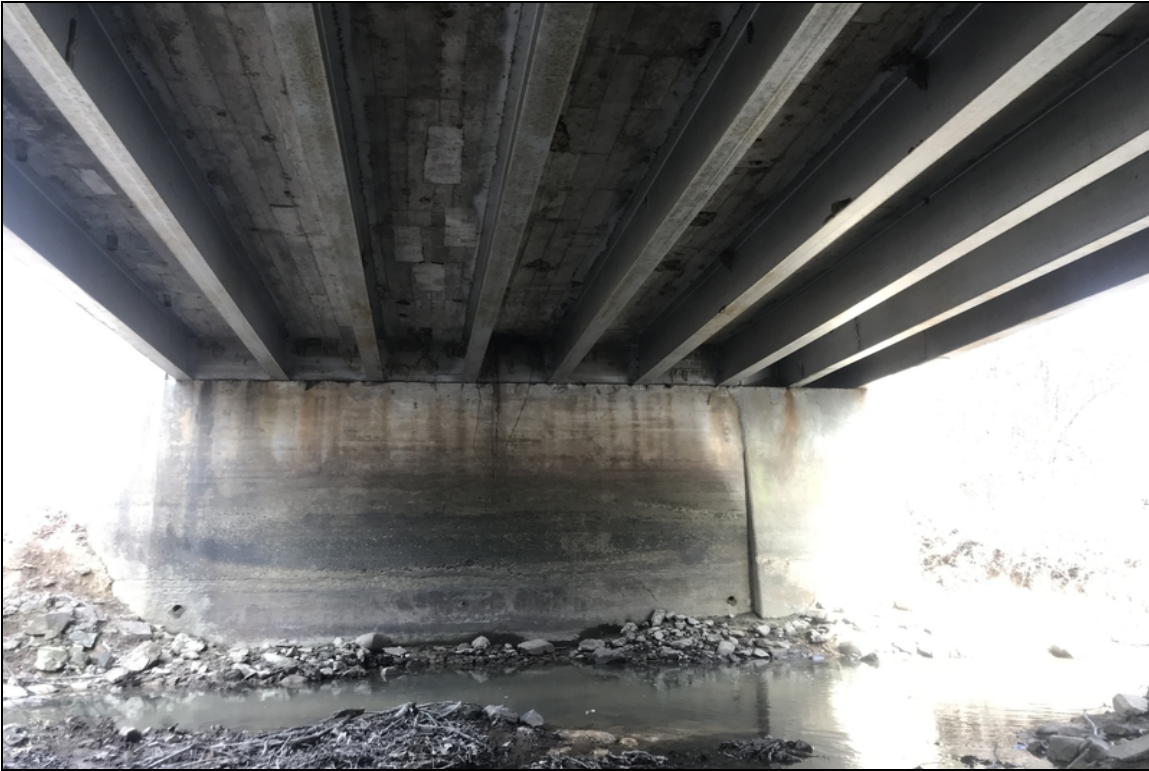
Soffit view

(12)	Soffit left side of beam 4 has spalls with exposed rebar. Random cracks in the wearing surface.						
107	Steel Open Girder/Beam	LF	387	292	82	13	0
1000	Corrosion	LF	95	0	82	13	0
515	Steel Protective Coating	SF	2197	1748	0	436	13
3440	Effectiveness (Steel Protective Coatings)	SF	449	0	0	436	13
