Asset #05868(Routine, Underwater type 2)

SH 381 Log 10.98 over BIG DITCH

Location: 11 SO JCT US 70 & SH 381

Team Lead: Bryan Saunders, Inspection Date: 09/20/2022

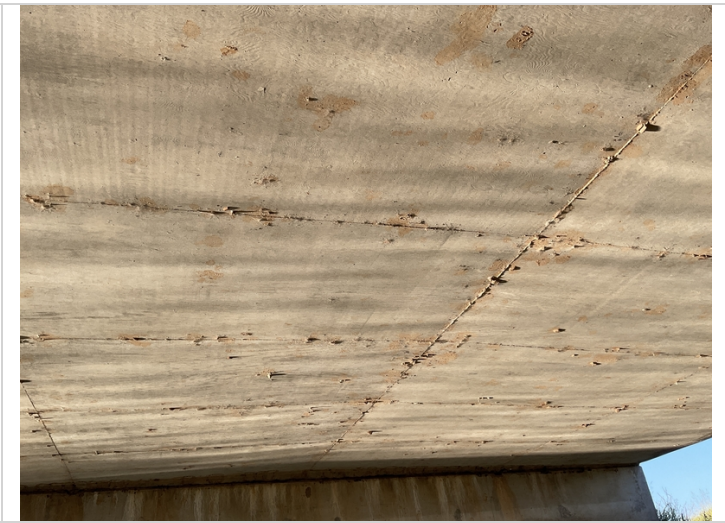
Soffit view

ELEMENTS	DESCRIPTION	UNITS	TOTAL	CS1	CS2	CS3	CS4
38	RC Slab	SF	2310	1935	375	0	0
1130	Cracking (RC and Other)	SF	125	0	125	0	0
1190	Abrasion/Wear (PSC/RC)	SF	250	0	250	0	0
(38) Deck all spans have small longitudinal crack at center line and scattered areas of minor wear deck has abrasion from farm machinery
