Asset #M3143(Routine, Underwater type 2)

SH 381 log 3.48 over SKINNERS BRANCH

Team Lead: Bryan Saunders, Inspection Date: 05/15/2023

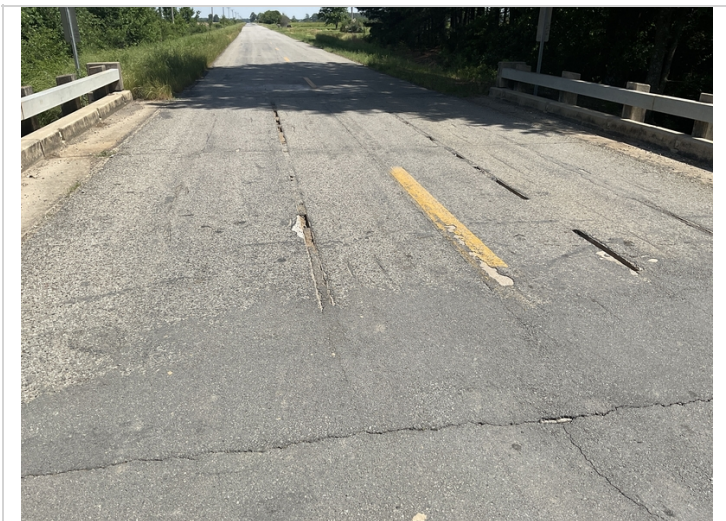
Deck view

(16) Approximately 8 feet of grout between the units is missing. Bent 2: spall on unit 1 in spans 1 & 2. Similar condition to unit 8							
110	Reinforced Concrete Open Girder/Beam	LF	608	604	4	0	0
1090	Exposed Rebar	LF	4	0	4	0	0

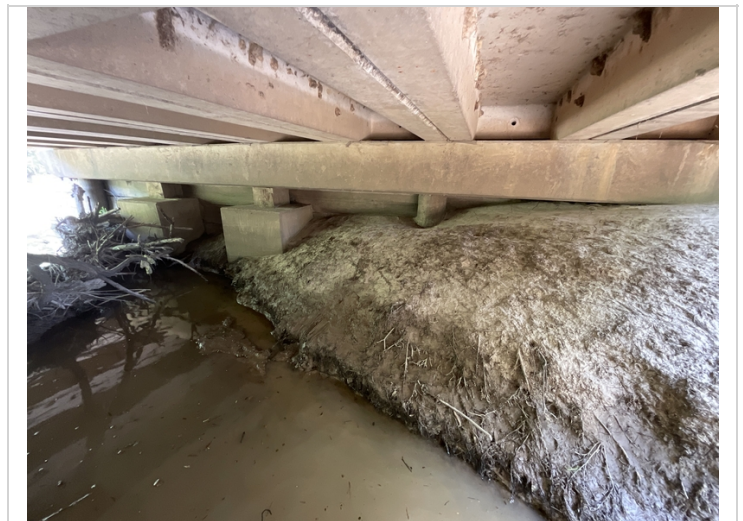
soffit view

(110) Span 1, unit 1 has a spall with exposed rebar at the base of the third rail post. Scattered very small cracks in the legs of the channel beams.							
216	Timber Abutment	LF	110	78	20	12	0
1140	Decay/Section Loss	LF	12	0	0	12	0
1160	Crack (Timber)	LF	20	0	20	0	0
