Route:183 Section:01 Log:4.88

IDENTIFICATION	
(1) State Names	5 - Arkansas
(8) Structure Number	07297
(5) Inventory Route	1
(2) Highway Agency District	06 - District 06
(3) County Code	125 - Saline County

Asset #07297 (Routine)
SH 183 over UPRR Spur
Location: 2.5 MI S Bryant

Team Lead: Chris Doggett Inspection Date: 08/06/2024

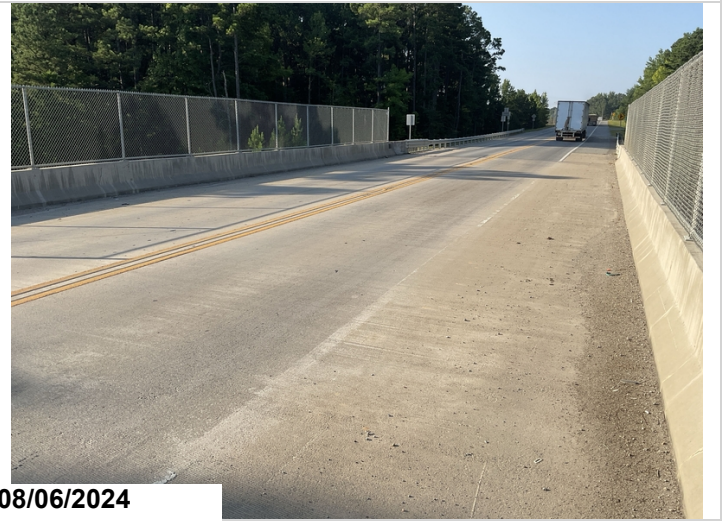
Deck view.

Multiple unsealed longitudinal cracks running the entire length of the bridge.

Multiple unsealed longitudinal cracks that span the entire length of the deck.

A-54 - Sealable Deck Cracks (Yes)

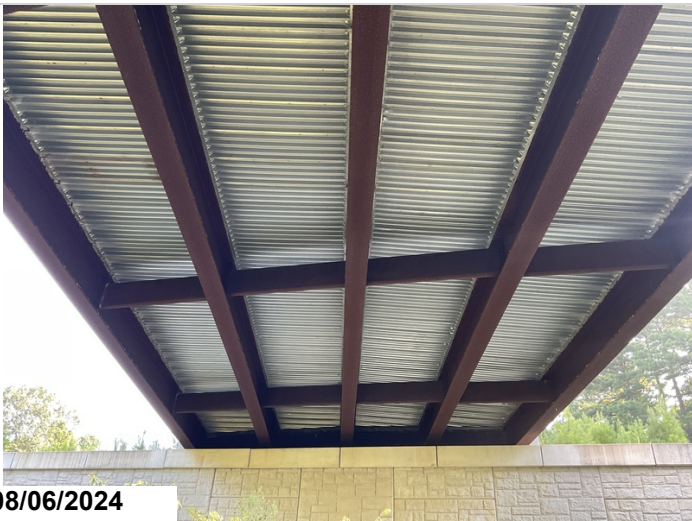
Under surface view

The superstructure is in good condition.
