Asset #M2246(Routine)

SH 183 Log 2.93 over ALCOA PLANT PVT. RD.

Location: 3 MI E JCT SH 35 & 183

Team Lead: Keith Harris Inspection Date: 01/04/2024

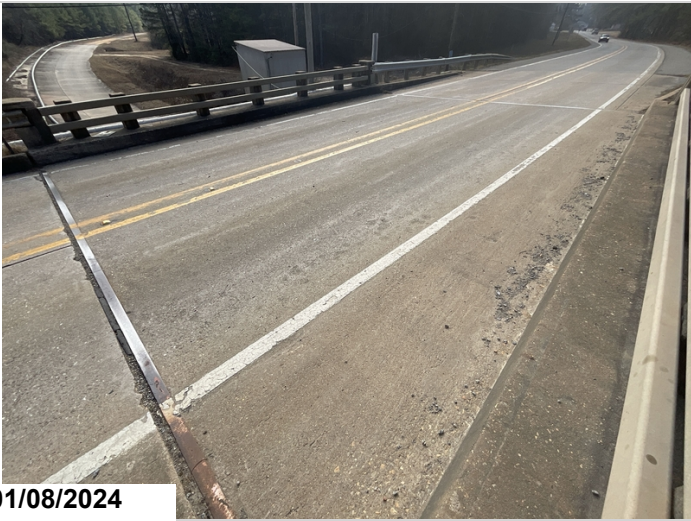
Deck has exposed reinforcing steel on right side at beginning of bridge and scattered cracks throughout structure.

Deck overview

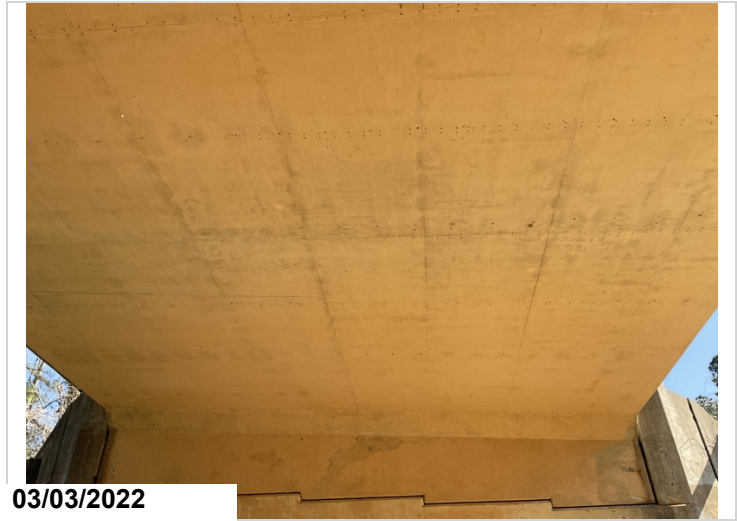
Under side of slab has 3 small spalls on left side.

Soffit view
