Asset #06813(Routine)

SH 11 Log 2.38 over Bayou Des Arc

Team Lead: Bryan Saunders, Inspection Date: 06/28/2023

General Observation

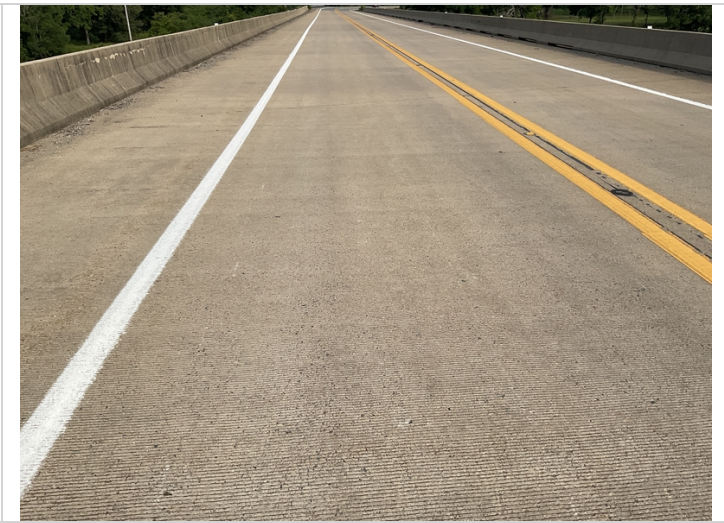
Deck view

ELEMENTS	DESCRIPTION	UNITS	TOTAL	CS1	CS2	CS3	CS4
12	Reinforced Concrete Deck	SF	21795	19780	2015	0	0
1120	Efflorescence/Rust Staining	SF	240	0	240	0	0
1130	Cracking (RC and Other)	SF	1775	0	1775	0	0
(12) Small longitudinal and transverse cracks in all spans Cracks with efflorescence in overhang .
