## Bridge 07284 Inspection Report

US 70/Roosevelt Rd over Rice St. & UPRR

Location: 1 MI E of Jct Asher Rd

Team Lead: Jonathan Gonzalez Inspection Date: 09/05/2025

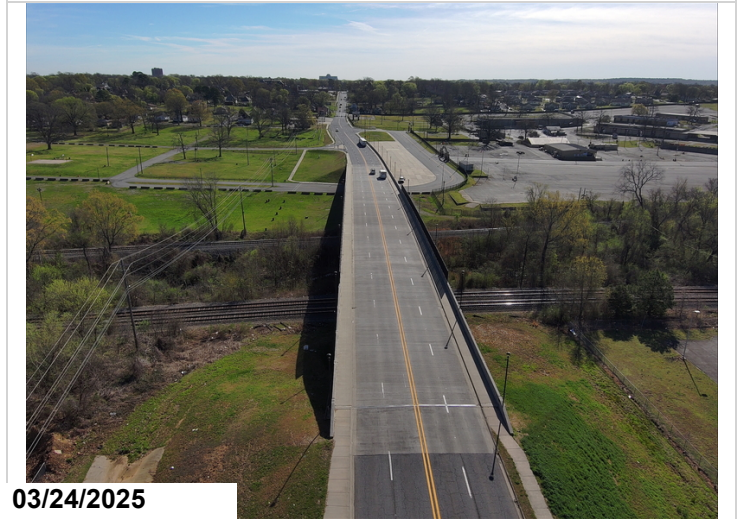
Deck view

Overall the deck is in good condition. Transverse and longitudinal cracks on the deck in all spans. 0.010 to 0.015 crack width.  
The sidewalk has numerous unsealed transverse cracks at an average spacing of 4 feet. This is common to the opposite sidewalk.

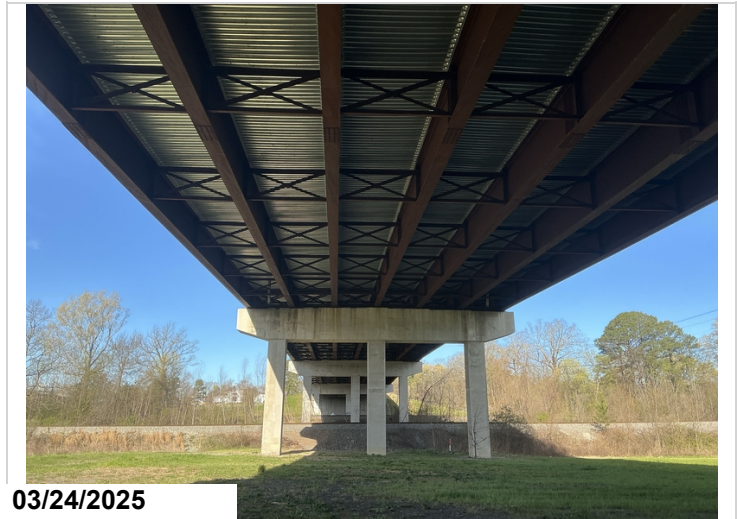
Under surface view

Overall the steel girders are in great condition. The weathering steel patina is fully developed and is tightly adhered.

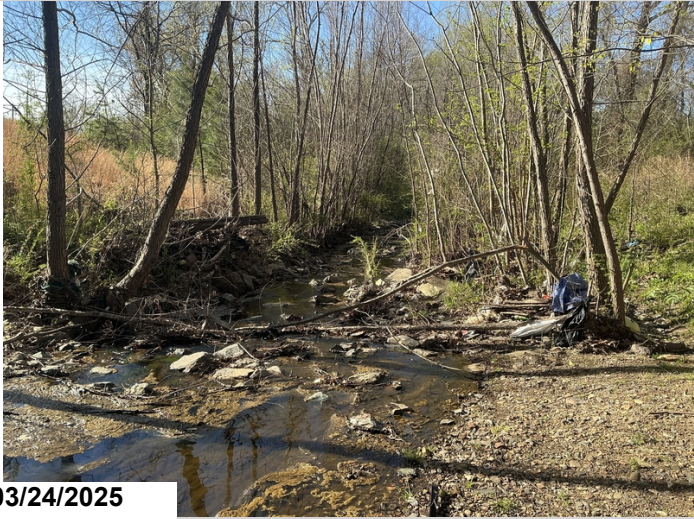
Channel looking downstream

Channel is in good condition.
