## Bridge 06981 Inspection Report

Route:270 Section:08 Log:4

Asset #06981 (Routine)  
US 270 Log 4.00 over UPRR  
Location: .3 MI NW US 67

Team Lead: Keith Harris Inspection Date: 09/10/2025

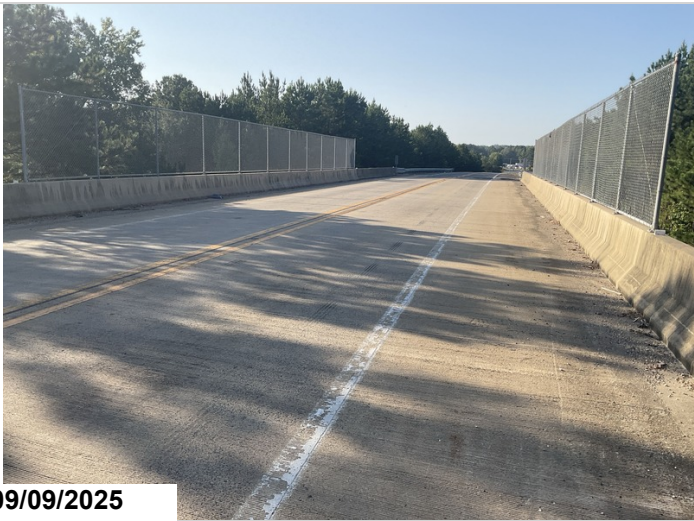
Deck overview

The deck is in good condition. The overhangs have cracks with efflorescence and the deck has unsealed cracks.

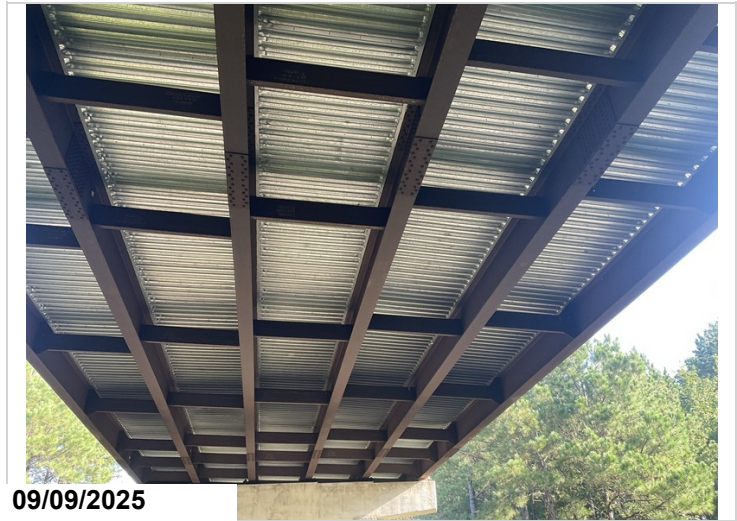
Undersurface span 2.

The superstructure is in good condition. All girders have a granular texture.
