Asset #06863(Routine, Underwater type 2)

SH 98 S:1 LM 0.52 over Beech Creek

Location: 0.9 mi E of US 82 & 98

Team Lead: Rickie Bratton, Inspection Date: 04/13/2021

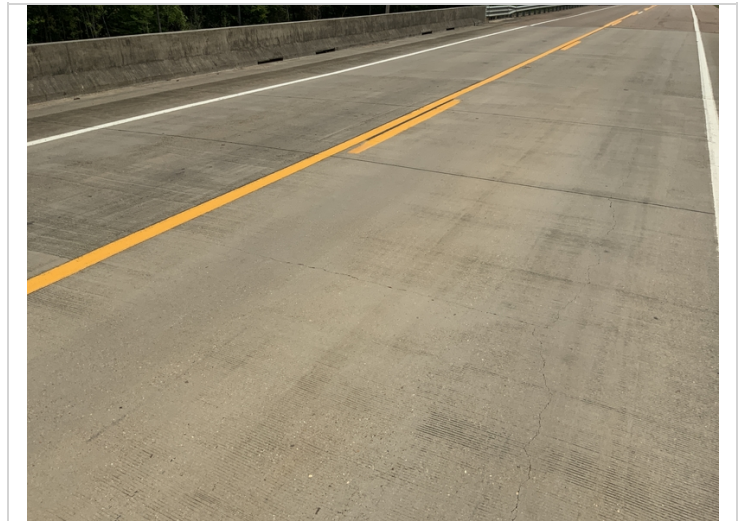
Deck overview

Deck has numerous longitudinal and transverse cracks all spans. Some areas of the deck adjacent to the joints have cracking.

Numerous sealable longitudinal and transverse cracks.
