Asset #M0177(Routine, Underwater type 2)

SH 7 S-6 LM 2.81 over MILL CR.

Location: 2.81 MI W DALLAS CO

Team Lead: Lee Swan, Inspection Date: 05/11/2022

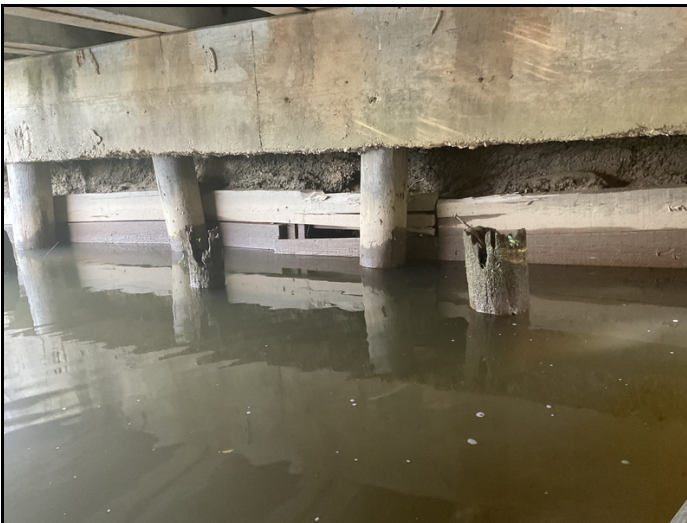
Bent 3

(234) Bent 1 has cracks and delamination. Bents 2 and 3 have exposed rebar.							
330	Metal Bridge Railing	LF	76	76	0	0	0
515	Steel Protective Coating	SF	243	243	0	0	0
