Asset #X1106(Routine)

SH 7 S-5 LM 9.82 over Cypress Creek

Location: 10.09 Mi. No. Oua. Co.

Team Lead: Rickie Bratton, Inspection Date: 01/03/2024

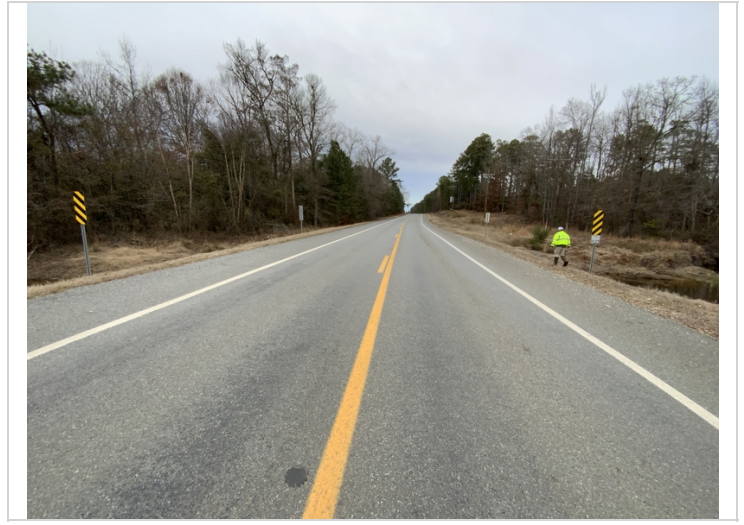
Approach roadway Northbound

ELEMENTS	DESCRIPTION	UNITS	TOTAL	CS1	CS2	CS3	CS4
241	Reinforced Concrete Culvert	LF	228	228	0	0	0
(241) ACHM surface is rough over this box culvert. See picture file.
