Asset #06148(Routine, Underwater type 2)

SH 273 S-1 LM 7.55 over FREEO CREEK

Location: 7.56 MI E JCT SH 9

Team Lead: John Parks, Inspection Date: 09/13/2022

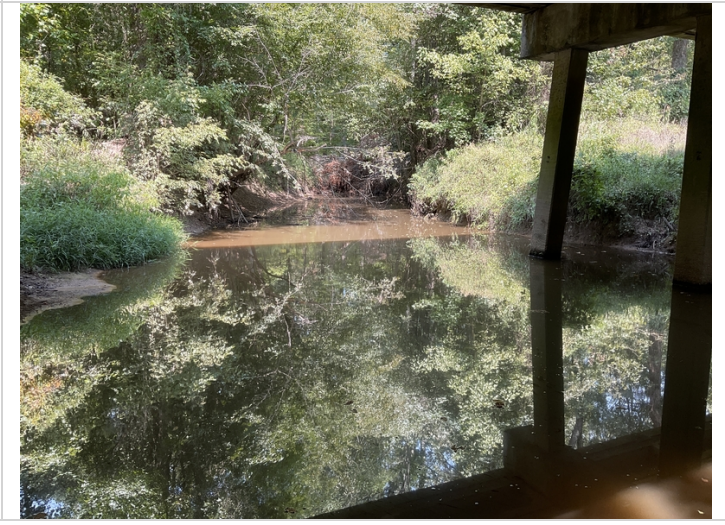
Downstream

Comment: Slope areas are heavily eroded below the rip rap zone. Bank lines are eroded also. Most rip rap is in place but will eventually erode. Scour hole under span 2 and along bent 2.

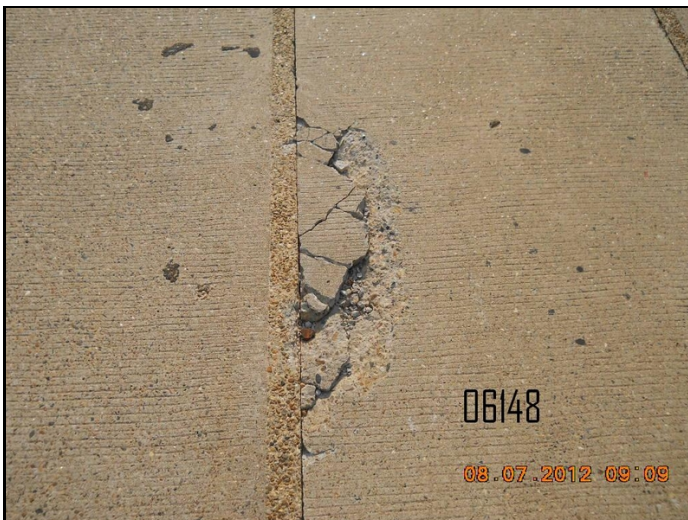
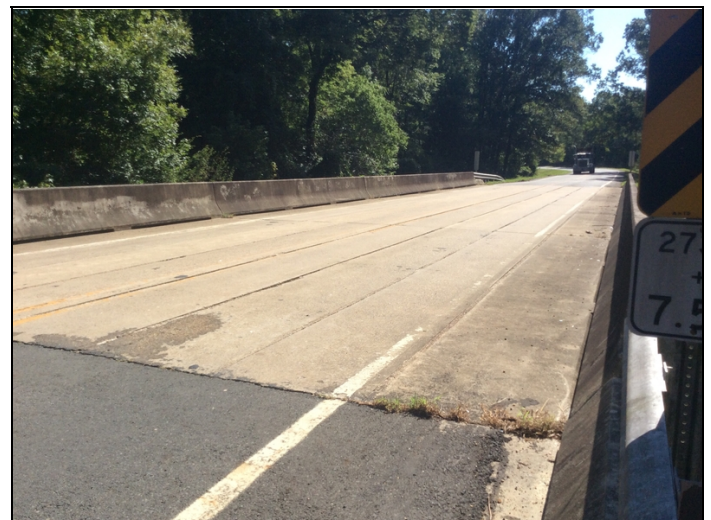
Deck

Comment: Small chips along keyways, unit 3 span 1 has large chips with loose concrete. Keyway grout is missing for a large portion of the structure.
