Asset #M0161(Routine, NSTM)

SH 7 S-4 LM 2.10 over PALMER BAYOU

Location: 2.13 MI N JCT US 79B

Team Lead: Rickie Bratton, Inspection Date: 06/28/2023

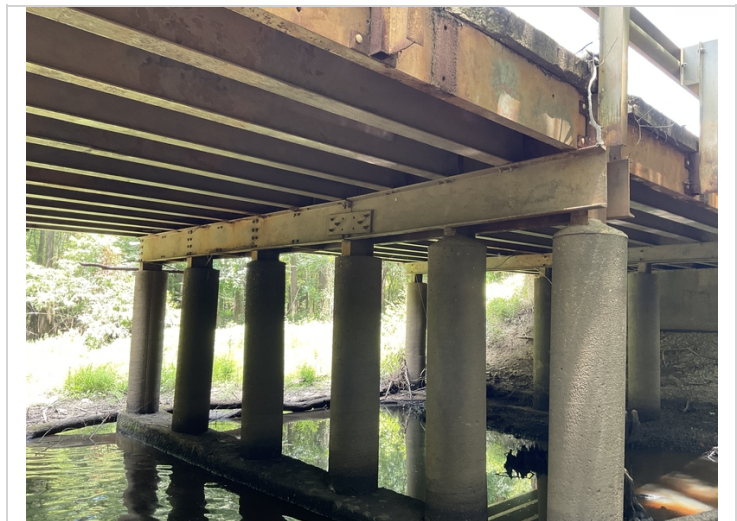
NSTM Steel Caps

Steel Cap 2: Both members have uniform surface rust. There are areas of minor pitting where the caps are connected to the columns and beams.

Steel Cap 3: Both members have areas surface corrosion with minor pitting. There is section loss in the webs of the C-Channel of the caps members up to 1/8" deep. The section loss has occurred at the edge of the connection points of the caps and columns, also the connection points of the diaphragms that are between the two C-Channel members that make up the steel cap.

Steel Cap 4: Both members have uniform surface rust. There are areas of minor pitting where the caps are connected to the columns and beams.

(231) All caps are steel and are "doubled" each has two segments parallel that are welded and bolted to the exposed section of the H piles. Some rust and coating loss. Bent 4 cap @ Rt. side has some paint loss with some rust and pitting with some section loss to the top flange and has started pitting into the web.							
330	Metal Bridge Railing	LF	156	156	0	0	0
515	Steel Protective Coating	SF	312	312	0	0	0
