Asset #01381(Underwater)
US67 Sec4 Lm 0.01 over LITTLE MISSOURI RIVER
Location: 2.2 MI S SH 51
Team Lead: Victoria Elliott **Inspection Date:** 03/14/2024

US67 Sec4 Lm 0.01 over LITTLE MISSOURI RIVER

ARDOT Structure # 01381

Underwater Inspection Procedures

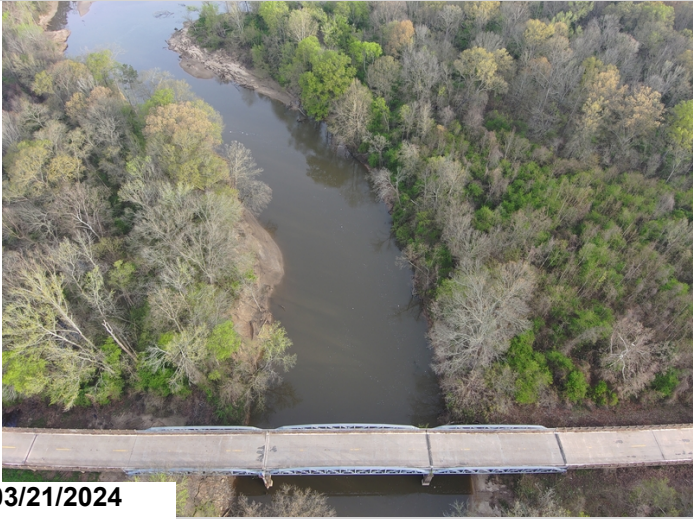
Left Channel

03/18/2024- VLE, NLB, DWG
Overall the channel is in fair condition with cut banks, minor channel migration, and pier scour.

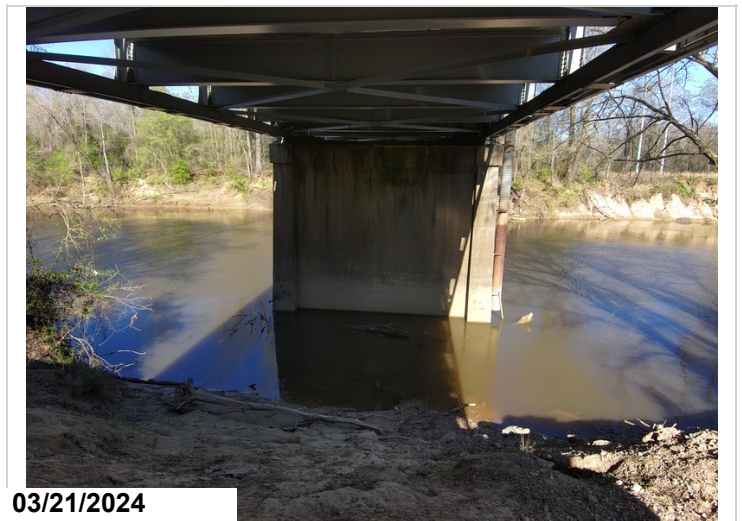
Pier 2 Back Overview

03/18/2024- VLE, NLB
According to plans, Piers 2 & 3 have a bottom of footing elevation of 171.30'. The approximate cover at time of construction was 9' at Pier 2 and Pier 3. The amount of cover left is approximately 6' at Pier 2 and 5' Pier 3. The footings are keyed into rock according to boring logs on plans. Pier scour due to channel migration has caused a widening of the channel directly under the bridge behind Piers 2 & 3. Pile Bents have local scour holes up to 2' deep at various locations.

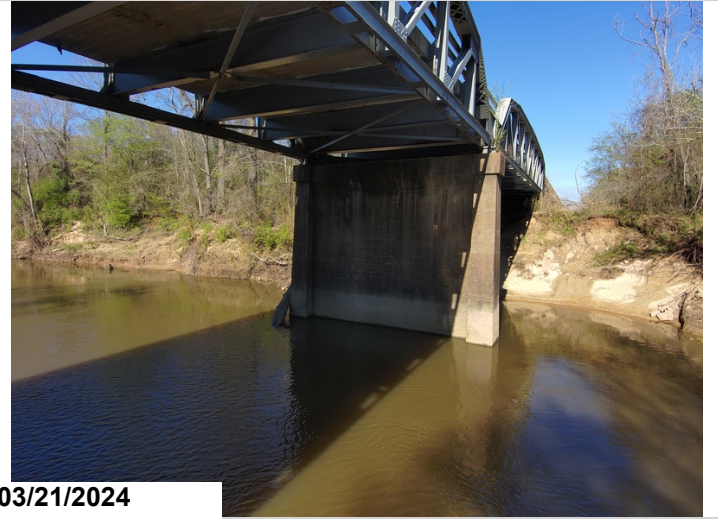
Pier 3 Back Overview

(210) 2024 Underwater Inspection Initials of Team members NOTES AND LOCATIONS ARE NOTED BY PLANS. There may be more than one defect for each location but a (X EA) or (X SF) will be listed with the location that quantifies. If top side defects overrule, none will be quantified. Inspection Limit is 5' above the waterline at an elevation of 185.2'.							
Pier 2, Ahead: Spall. Located 5' to the right of Column 1 there is a 2' diameter spall up to 5" deep starting 6" above the ground line. (CS3) (2 LF) Pier 2, Ahead: Spall. Located 5' to the left of Column 2 there is a 2' diameter spall up to 6" deep starting 6" above the ground line. (CS3) (2 LF) Spalls appear to be in locations of concrete form supports during construction. Pier 2: Abrasion. CS2 abrasion throughout.							
Pier 3, Back: Spall. Located 5' to the right of Column 1 there is a 2' diameter spall up to 5" deep starting 5' above the ground line. (CS3) (2 LF) Pier 3, Back: Spall. Located 5' to the left of Column 2 there is a 2' diameter spall up to 6" deep starting 5' above the ground line. (CS3) (2 LF) Spalls appear to be in locations of concrete form supports during construction. Pier 3, Back: Cracking. Located 8.5' to the right of Column 1 there is a CS2 vertical crack starting at the waterline extending to the inspection limit line. (CS2) (1 LF) Pier 3: Abrasion. CS2 abrasion throughout.
