Asset #01382(Routine)

US 67 S-4 LM 0.31 over MOON LAKE

Location: .31 MI NE OF NEVADA CO

Team Lead: John Parks Inspection Date: 01/09/2023

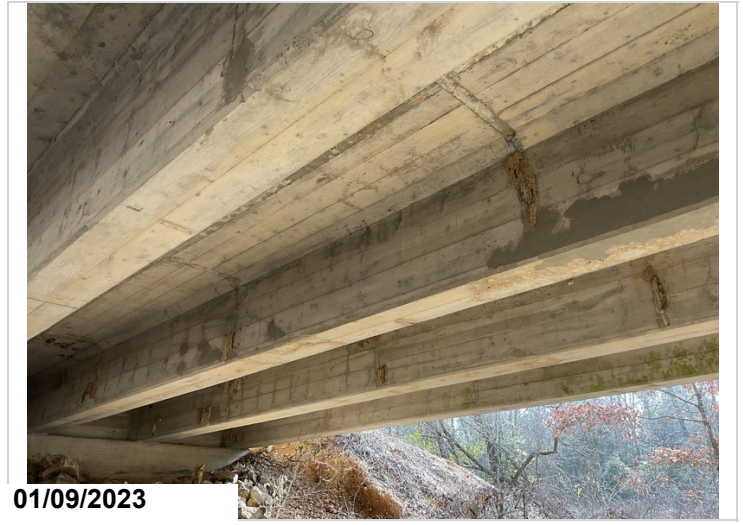
Numerous spalled areas with some exposed steel, G1 bent 2 spalled with exposed steel, also G1 Bt 5 Girder 1 bent 3 back has failed , this bent has helper piles supporting the girders(ahead and back).

Typical view of the superstructure

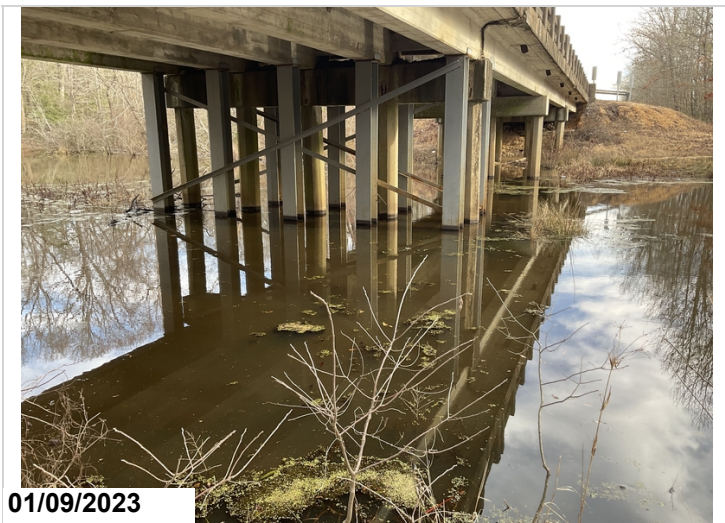
Able to observe channel bottom at all piles, no scour noted. Wade and probe type 2 UW. Caps have some spalls and cracks, bt 3 cap has spalls at the bearing areas , bt 5 cap has spalls @ bearing areas. 01/09/2019 JPR -- helper footing (12'w X 30'l X 2'd) reinforced concrete footing was placed around original Bt.3 and 5 (12" X 12") H-beam columns (65#/ft.)/ahead and back side of original Bt. 3 were placed under each girder both ahead and back of Bt. 3.

Typical view of the substructure
