Asset #05944(Routine)

US 79 S-5 LM4.61SB over CHAMPAGNOLLE CR

Location: 1 MI W JCT 79&US167B

Team Lead: John Parks Inspection Date: 05/08/2023

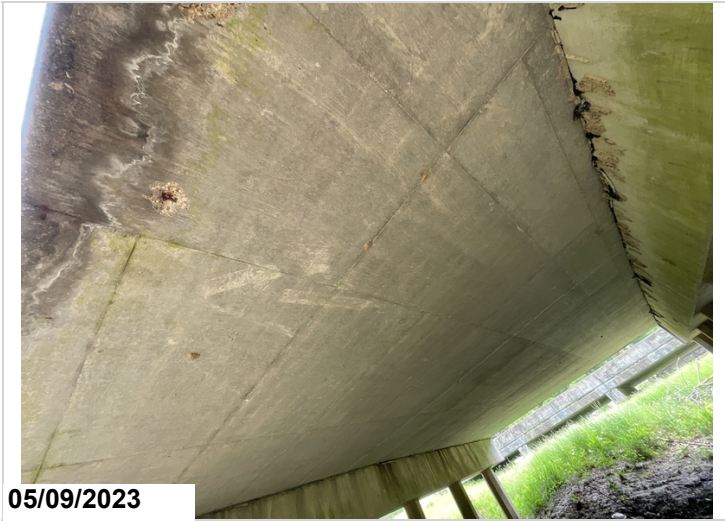
Light efflorescence reflecting through to the bottom of the slab, 2 minor exposed rebar & 1 minor spall.

Typical superstructure.

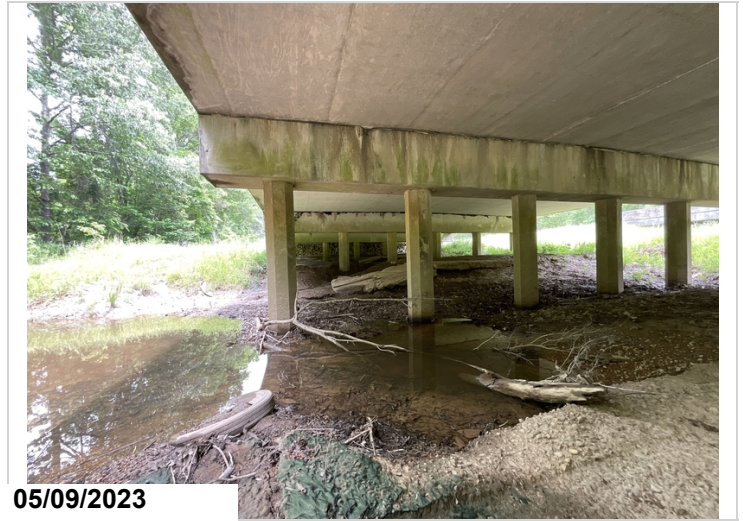
Local scour at piles & Caps have large spalls on the end.

Typical substructure.
