Bridge M2114 Inspection Report

Asset #M2114(Routine, Underwater type 2)

SH 160 / S-9 over GRASSY POND CREEK

Team Lead: John Parks Inspection Date: 09/30/2024

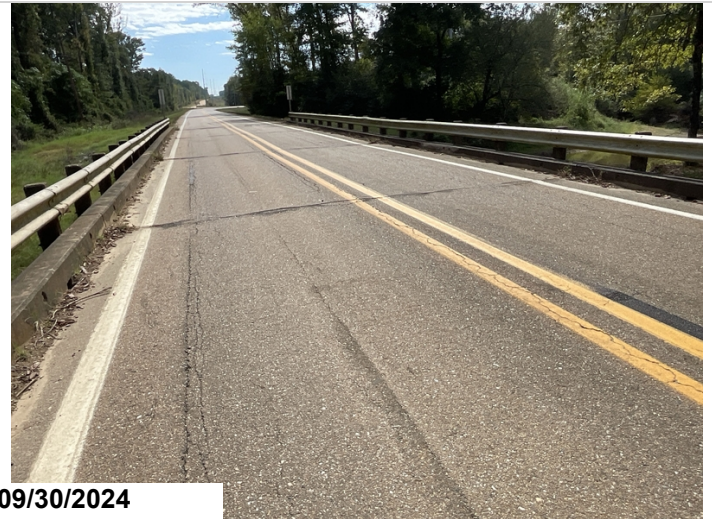
Deck is rated 7 due to the channel unit top flanges having no defects observed in the under surface of the top flange. There are no defects in the top surface of the top flange reflecting through the wearing surface. Asphalt wearing surface has minor cracks.

Deck overview

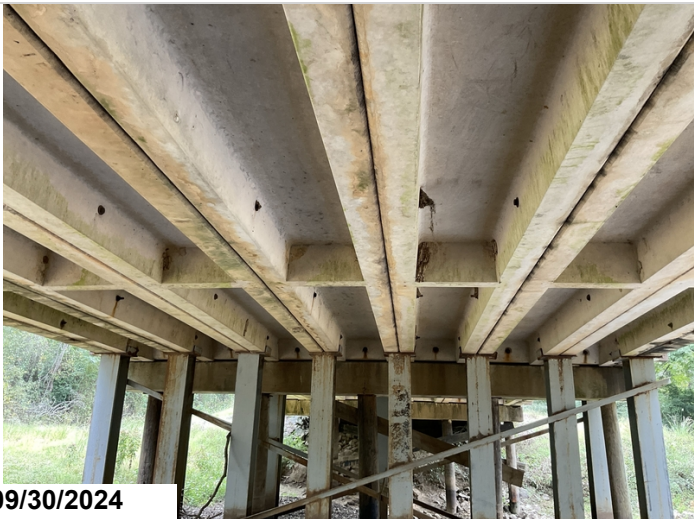
Under surface of top flange

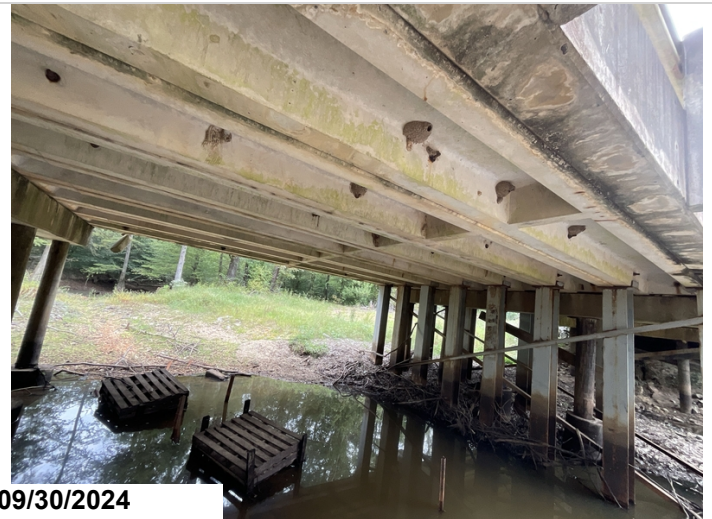
Superstructure is rated 7 do to the channel unit legs having minor spalls and cracks.

Typical superstructure

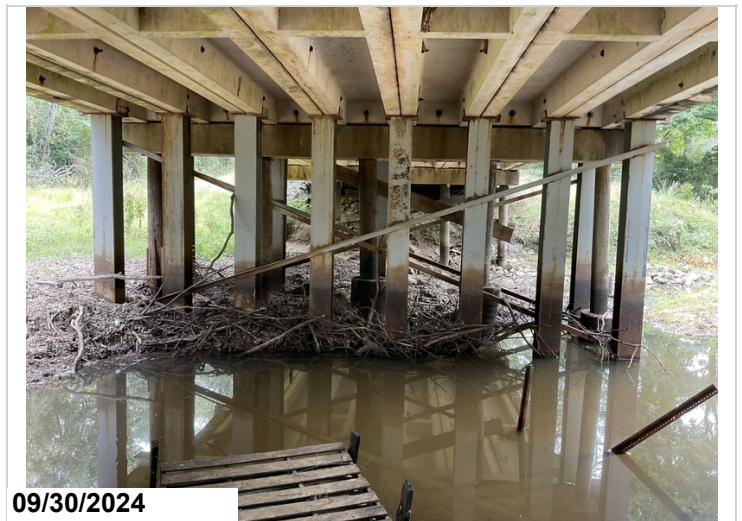
Substructure is rated 5 due to Bent 3 cap has dropped previously causing the cap to crack. Supplemental bents are in place to support Spans 2 and 3 at Bent 3. Other caps have minor cracks and spalls. Most of the timber piles have been repaired by concrete splice collars.

Typical substructure
