Bridge M2647 Inspection Report

Asset #M2647(Routine)

SH 274 S-3 LM10.53 over DITCH

Team Lead: John Parks Inspection Date: 08/27/2024

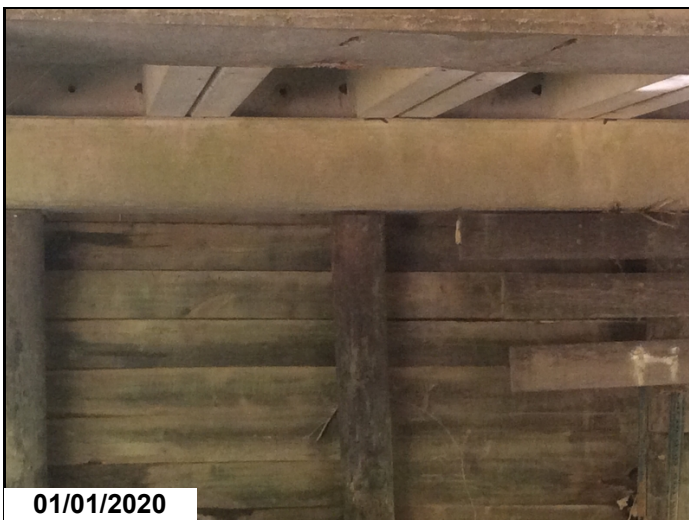
08/13/2020

Abutment 2 backwall has not been repaired, numerous backwall boards are rotten allowing dirt from behind the backwall to silt through the holes, there is some minor roadway settlement.
