Bridge 05679 Inspection Report

US 371 S-7 LM 3.79 over BIG CREEK

Location: 1.8 MI W JCT SH 19

Team Lead: John Parks Inspection Date: 05/13/2024

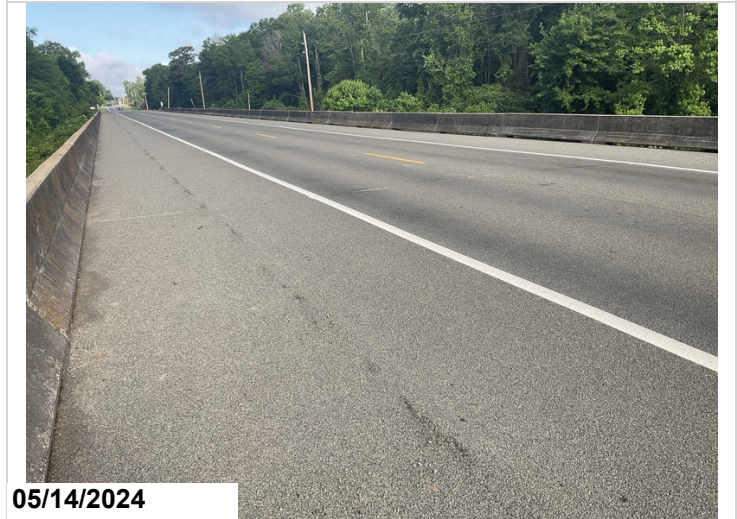
Deck overview

Deck is rated 7 due to polymer overlay applied to the topside of the slab that is sealing all cracks.

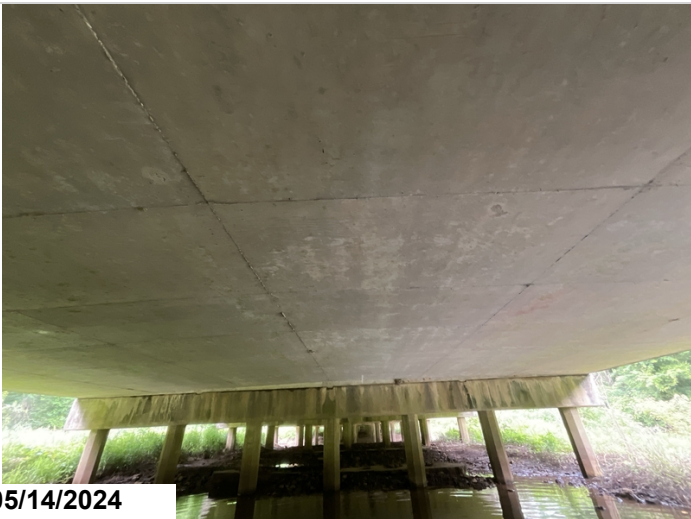
Undersurface of slab

The superstructure is rate 6 due to the edges of the slab having minor cracks with efflorescence, the underside having minor cracks with efflorescence, few moderate spall with exposed rebar scattered throughout, and the slabs have up to 1/2" creep at midspan.

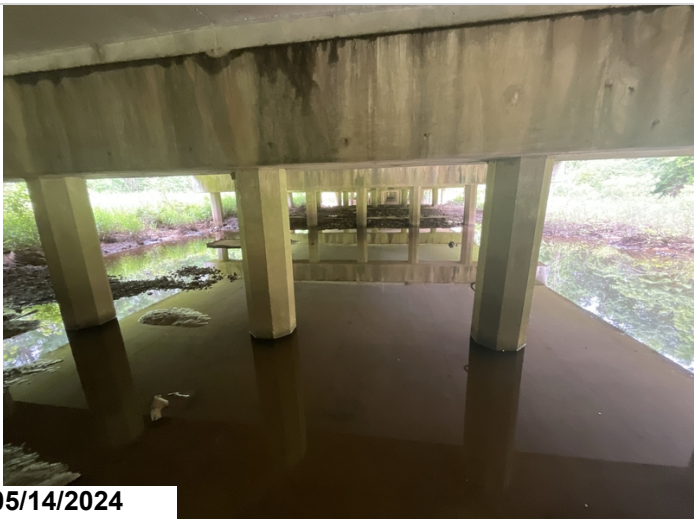
Typical substructure

The substructure is rated 6 due to piles having minor abrasion and local scour, and a moderate spall in the cap of Bent 9.

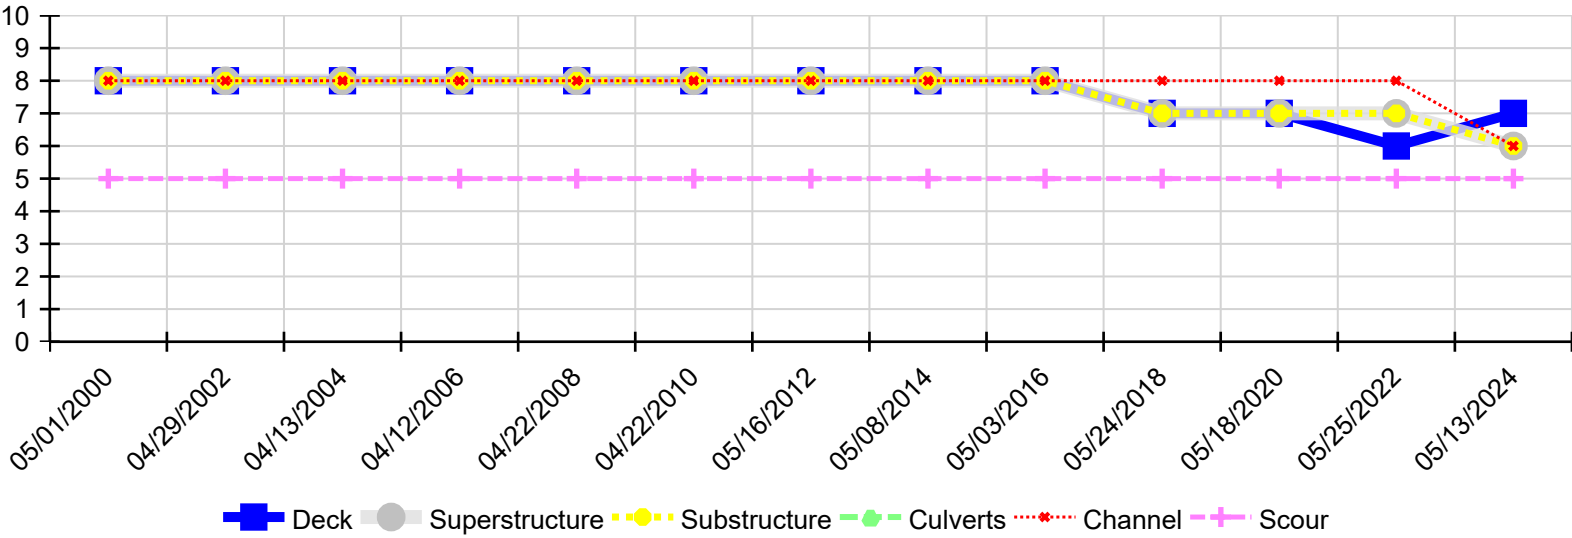
Condition History

Inspection Date	Deck	Superstructure	Substructure	Culverts	Channel	Scour
05/13/2024	7	6	6	N	6	5
05/25/2022	6	7	7	N	8	5
05/18/2020	7	7	7	N	8	5
05/24/2018	7	7	7	N	8	5
05/03/2016	8	8	8	N	8	5
05/08/2014	8	8	8	N	8	5
05/16/2012	8	8	8	N	8	5
04/22/2010	8	8	8	N	8	5
04/22/2008	8	8	8	N	8	5
04/12/2006	8	8	8	N	8	5
04/13/2004	8	8	8	N	8	5
04/29/2002	8	8	8	N	8	5
05/01/2000	8	8	8	N	8	5
