Bridge #06182(Routine)

US 270 over Williams Creek

Team Lead: William Wood Inspection Date: July 22, 2020

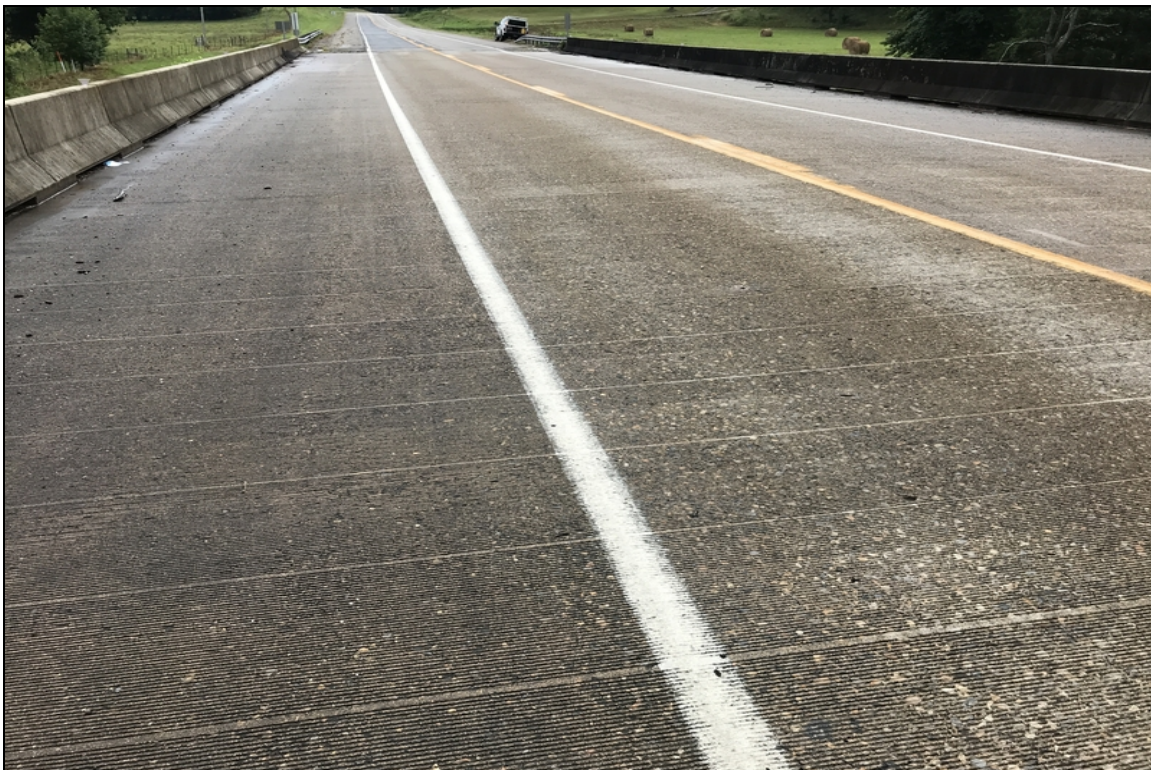
(12)	MODERATE TO MAJOR CRACKING THROUGHOUT DECK. MINOR SCALE THROUGHOUT DECK. MODERATE CRACKING W / EFFLOR IN SOFFIT.						
107	Steel Open Girder/Beam	LF	1044	1044	0	0	0
515	Steel Protective Coating	SF	7078	7078	0	0	0
205	Reinforced Concrete Column	EA	9	9	0	0	0
215	Reinforced Concrete Abutment	LF	133	128	5	0	0
1120	Efflorescence/Rust Staining	LF	5	0	5	0	0

Typical deck.

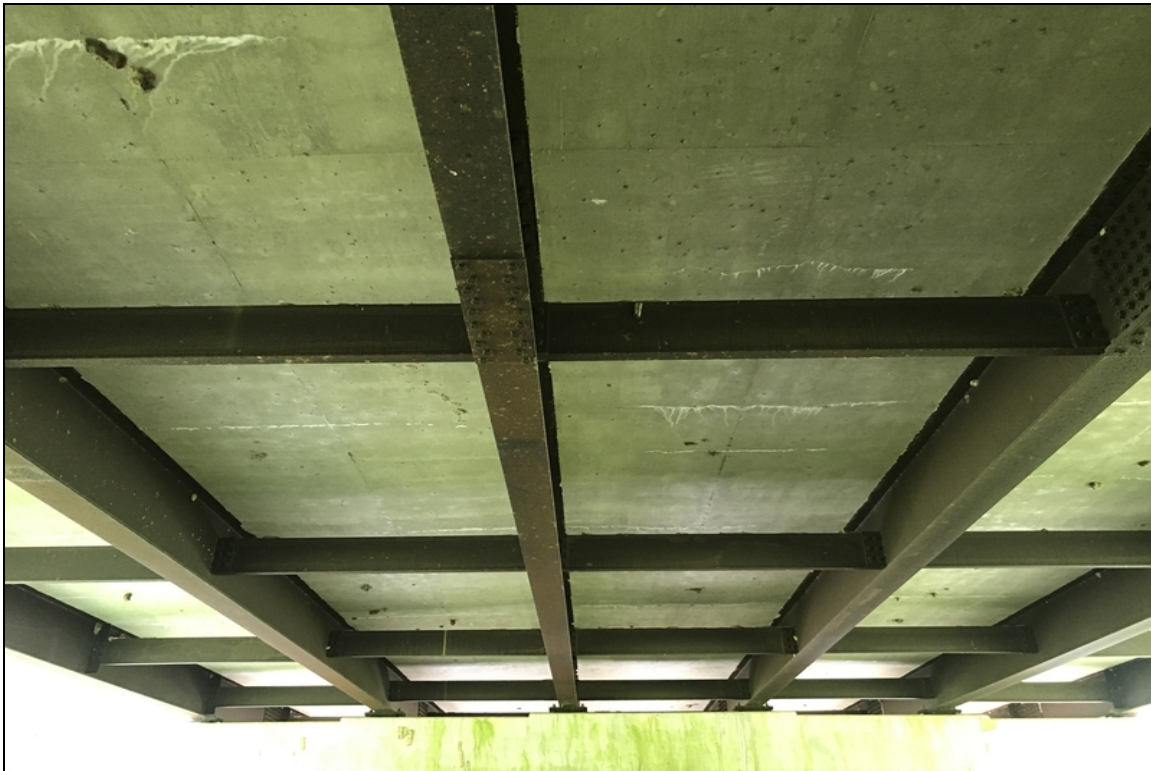
Typical undersurface.
