Asset #00355(Routine, Underwater type 2)

SH 22-Logan Co. over Six Mile Creek Relief

Location: 3.54 MI E OF FRANKLIN CO

Team Lead: Bob McEntyre, Inspection Date: 06/20/2023

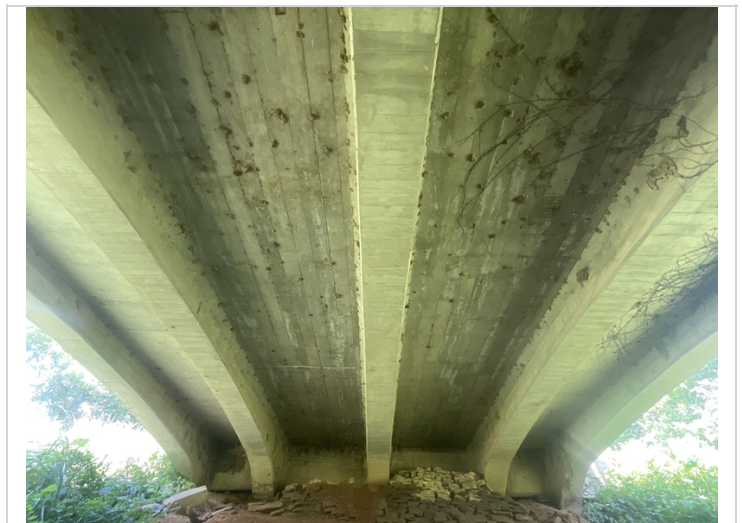
Span 1 undersurface

ELEMENTS	DESCRIPTION	UNITS	TOTAL	CS1	CS2	CS3	CS4
<p>(16) Span 1:</p> <ul style="list-style-type: none"> - Bays 2, 3 and 4 have a couple of transverse cracking with rust staining and efflorescence - Bay 3 has a couple shallow delaminated areas and an area of exposed reinforcing steel with corrosion adjacent to bent 2. <p>Span 2:</p> <ul style="list-style-type: none"> - Bays 2 & 3 have spalling with exposed reinforcing steel and transverse cracking with efflorescence - Bay 4 has longitudinal cracking (appears to be a construction joint) with heavy efflorescence accumulation full length of the span. <p>Span 3:</p> <ul style="list-style-type: none"> - Bays 2 & 3 have spalling with exposed reinforcing steel and transverse cracking with efflorescence - Bay 4 has longitudinal cracking (appears to be a construction joint) with a heavy accumulation of efflorescence full length of the span <p>Span 4:</p> <ul style="list-style-type: none"> - Bays 2 & 3 have transverse cracking with efflorescence <p>Span 5:</p> <ul style="list-style-type: none"> - Bays 2 & 3 have areas of exposed reinforcing steel with active corrosion and transverse cracking with efflorescence - Bay 4 has a heavy accumulation of efflorescence along the construction joint <p>Span 6:</p> <ul style="list-style-type: none"> - Bays 2 & 3 have multiple locations of exposed reinforcing steel with active corrosion - Bay 4 has a buildup of efflorescence along the construction joint <p>Span 7:</p> <ul style="list-style-type: none"> - Bays 2 & 3 transverse cracking with light efflorescence and 1 exposed reinforcing steel <p>Span 8:</p> <ul style="list-style-type: none"> - Bays 1 & 4 have efflorescence along the construction joint - Bays 2 & 3 have transverse cracking with efflorescence <p>Span 9:</p> <ul style="list-style-type: none"> - Bay 3 has spalling with exposed reinforcing steel adjacent to bent 9 - Bays 2 & 3 has transverse cracking with efflorescence - Bay 4 has efflorescence along the construction joint <p>Span 10:</p> <ul style="list-style-type: none"> - Bays 2 & 3 transverse cracking with efflorescence - Bay 4 efflorescence along the construction joint - Bay 2 has exposed reinforcing steel adjacent to abutment # 2. <p>(510-16) - The asphalt overlay has heavy deterioration with map cracking throughout with potholes forming along centerline and over expansion joint assemblies.</p>

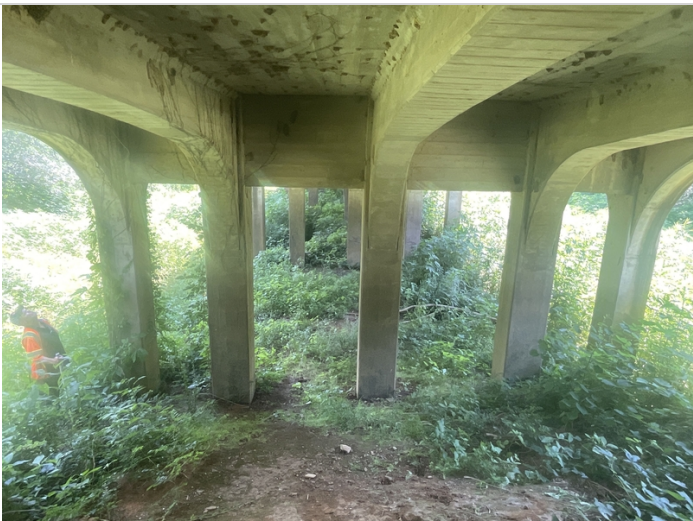
Bent 2

ELEMENTS	DESCRIPTION	UNITS	TOTAL	CS1	CS2	CS3	CS4
(205) Bent 2: -Column 5 spalling exterior side Bent 4: (span 4) - Columns 2 & 4 have spalling with exposed reinforcing steel Bent 5: (span 4) - Column 1 spalling along the base. Bent 6: Columns 2, 3 and 4 have light abrasion at base. Bent 7: -Columns 2, 3 and 4 have light abrasion at base of column. Column 2 has light abrasion with a 4" area of concrete deterioration approximately 1" deep at base of column. Bent 8: (span 7) -Columns 2 and 3 have light abrasion at base of columns. -Column 4 has shallow spalls with exposed reinforcing steel. Bent 8: (span 8) -Columns 3 & 4 have spalling with exposed reinforcing steel Bent 9: - Column 4 has spalling along the base - Column 2 has soft deteriorated concrete along the base							
220	Reinforced Concrete Pile Cap/Footing	LF	220	220	0	0	0

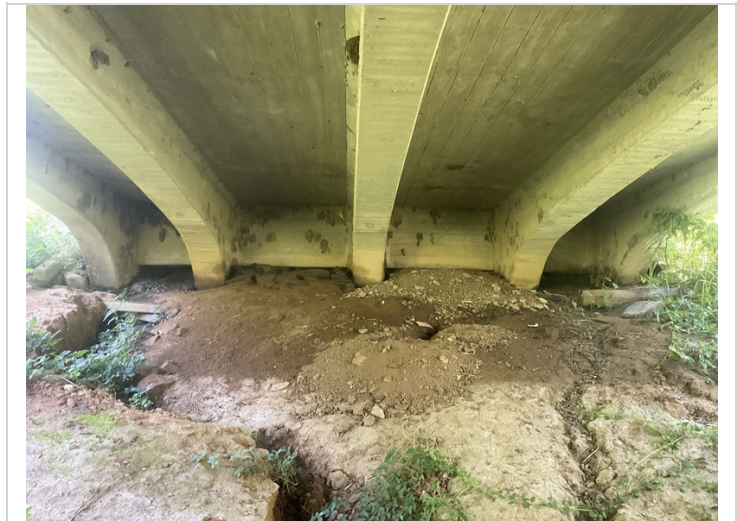
Abutment 2

06/20/2023 - RSM & SPC: Underwater Type II Inspection conducted this date. Visual observation in dry conditions revealed no apparent scour problems at this inspection. The east embankment at abutment # 2 has minor erosion that appears to be from approach roadway drainage.

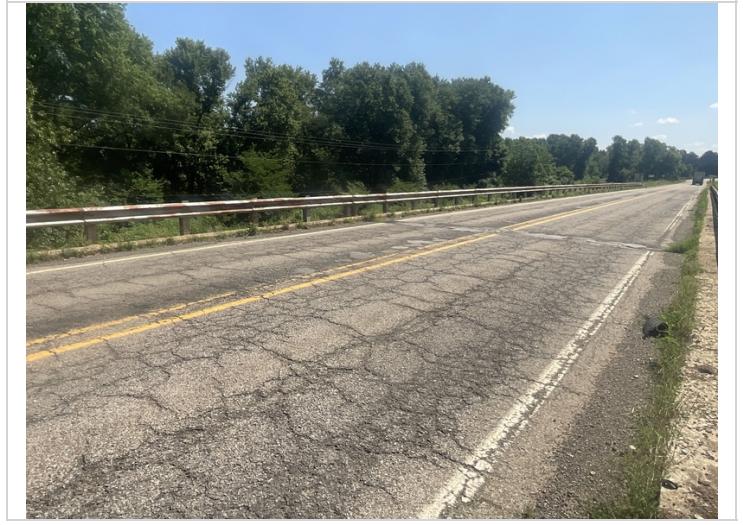
Bridge railing typical

(330) - Spans 2 & 3 have areas of collision damage on both sides of the structure - Bridge railing in span 10 on both sides of the structure has collision damage - Failed paint system throughout the structure with surface rust
