## Bridge 05653 Inspection Report

**State Highway 109 over Russ Creek-Logan Co.**

**Location: 3.26 MI S JOHNSON CO LINE**

**Team Lead: Bob McEntyre Inspection Date: 08/09/2022**

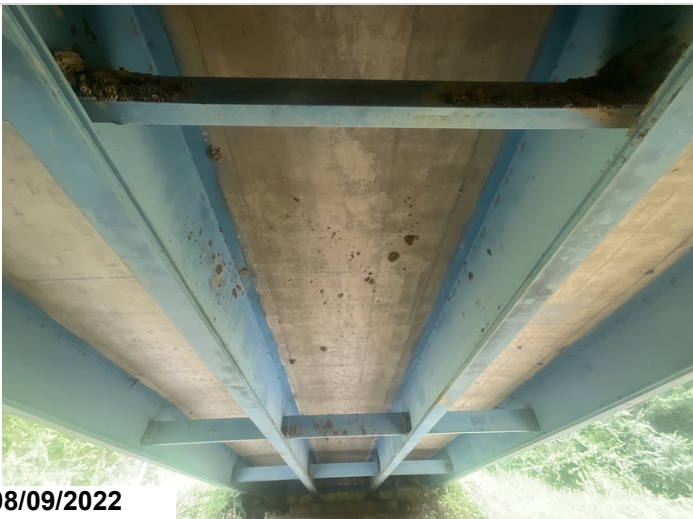
Undersurface

(12) Driving Surface: -The driving surface has an asphalt chip seal wearing surface. -Chip and seal wearing surface has areas of scrape marks and gouges in the left lane.  Deck Undersurface: -There are a few transverse cracks in the undersurface of the deck. -Isolated areas of hairline map cracking. -Undersurface of the deck overhangs have transverse cracks with light efflorescence. (510-12) -Chip and seal wearing surface has areas of scrape marks and gouges in the left lane.							
107	Steel Open Girder/Beam	LF	300	295	4	1	0
1000	Corrosion	LF	5	0	4	1	0
515	Steel Protective Coating	SF	2896	0	2896	0	0
3410	Chalking (Steel Protective Coatings)	SF	2896	0	2896	0	0

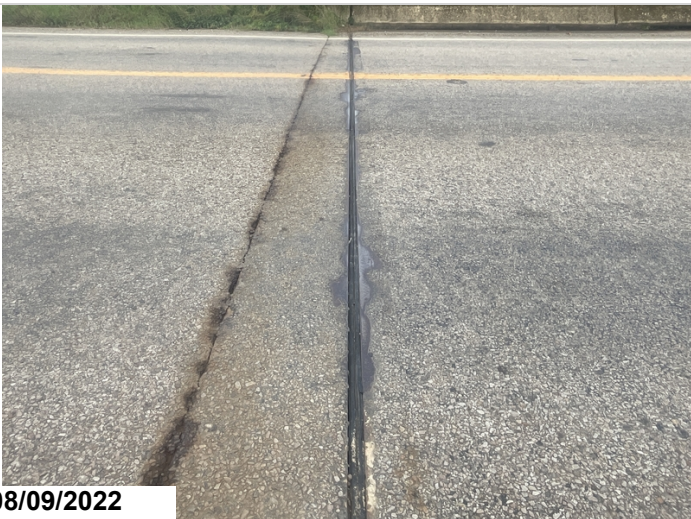
Abutment 1 expansion joint

(302) -The compression joint seals have rips and tears and appear to leak water. -The joint assembly anchorage appears to be sound during this inspection.							
311	Movable Bearing	EA	4	0	1	3	0
