Bridge #06408(Routine)

SH 23 Madison Co. over SEALS CREEK Madison Co

Team Lead: Nathan Rowland Inspection Date: August 16, 2021

Bridge #06408(Routine)
SH 23 Madison Co. over SEALS CREEK Madison Co

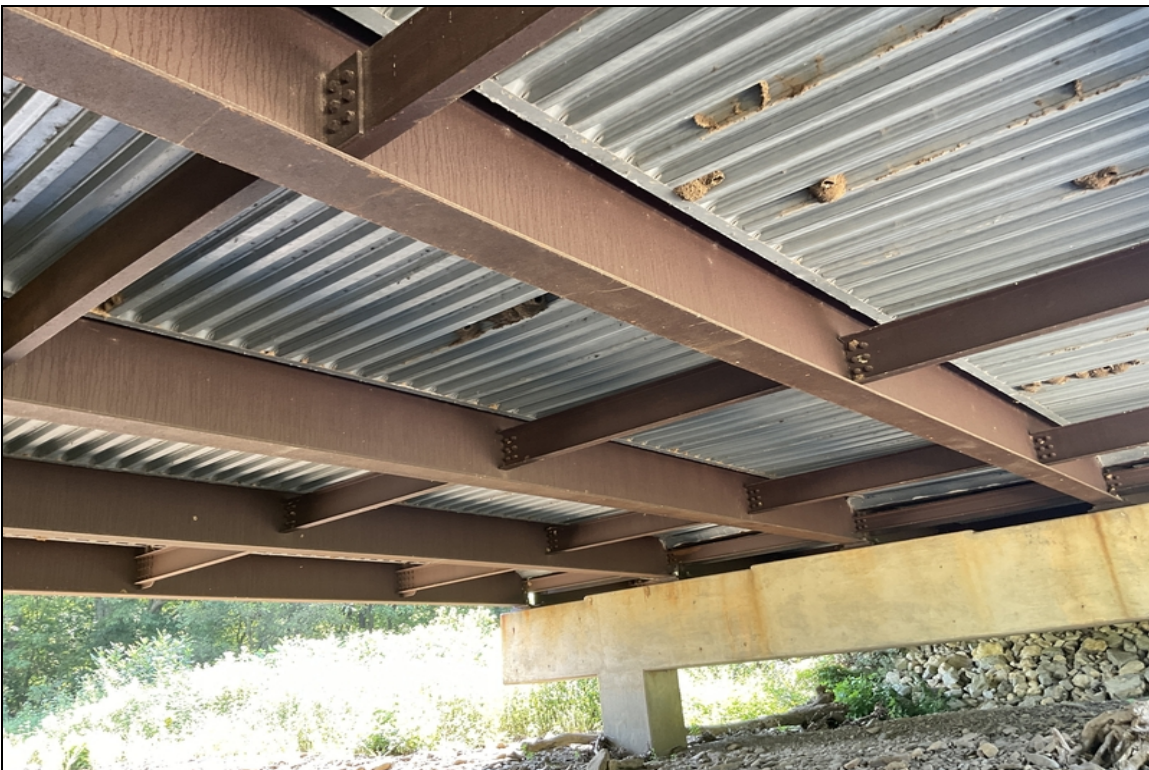
View of span #2 superstructure

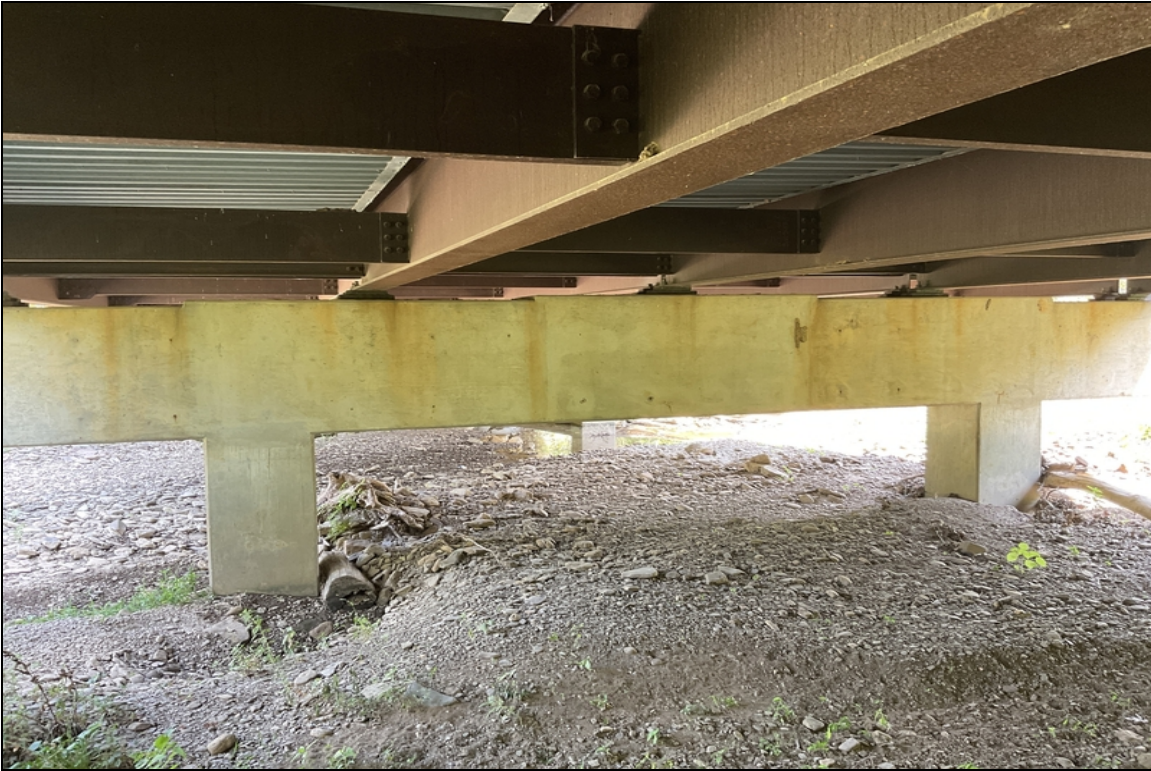
(234)							
08/16/2021 WNR & DBM:							
-The bent caps have staining from compression joint seals leaking.							
-Bent #1 cap has a hairline vertical crack with short duration horizontal cracks in bay #3 visible on both sides of cap.							
-Bent #1 cap right has a vertical crack with minor efflorescence accumulation. Vertical crack propagates into bearing #1 span #1.							
-The span #2 side of bent #1 cap has a short duration vertical crack under beam #5 and at the step down in bay #1.							
-The left side of bent #2 cap has a delaminated area on the back face that is approximately 3' long and propagates diagonally under bearing #1.

View of bent #1 behind side.

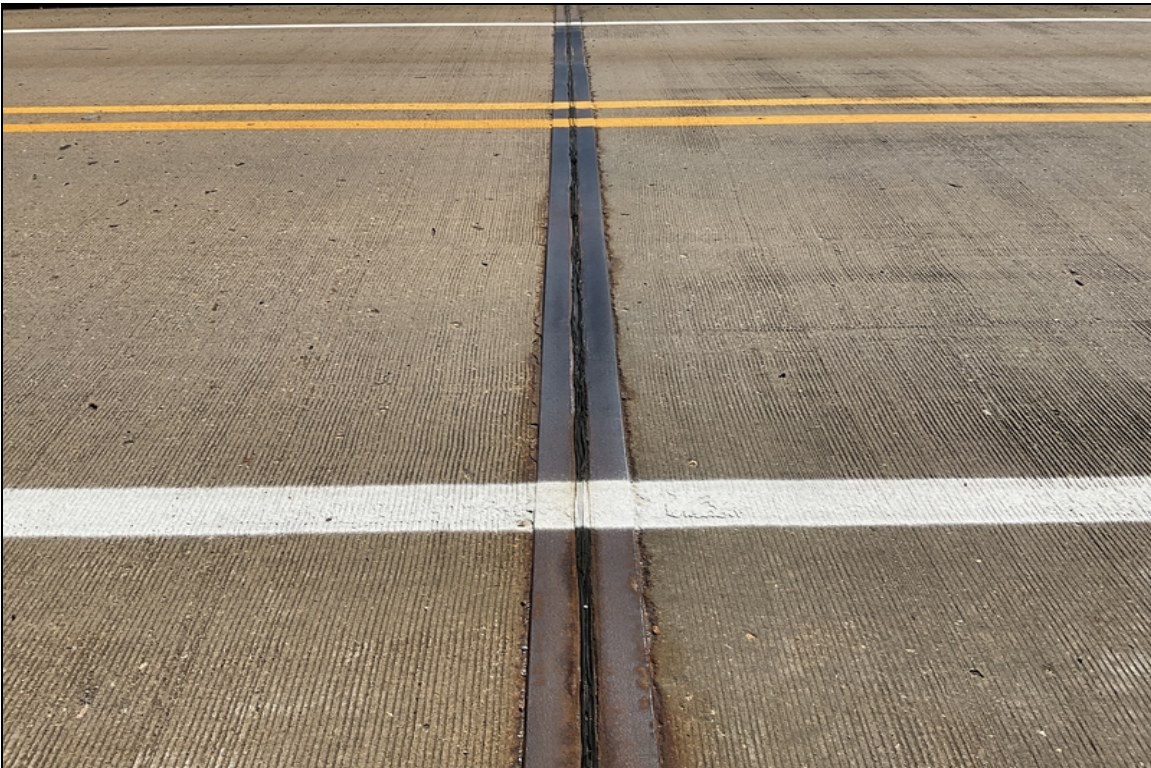
(302)							
08/16/2021 WNR & DBM:							
-The compression joint seals have areas of cracking and adhesion failure due to pack rust in the assemblies that appear to be causing adhesion failure and leakage.							
-The compression joint seal at bent #2 is sticking up above the assembly in the left lane and has damage due to traffic impact.							
311	Movable Bearing	EA	15	9	6	0	0
1000	Corrosion	EA	6	0	6	0	0
515	Steel Protective Coating	SF	15	9	0	6	0
3430	Oxide Film Degradation Color/Texture Adherence(Steel Protective Coatings)	SF	6	0	0	6	0

View of joint at bent #2.

Expansion joint seals - The compression joint seals are deteriorated with areas of cracking and adhesion failure. The assemblies have pack rust that appears to be contributing to the adhesion failure. The compression joint seal at bent #2 is sticking up above the assembly in the left lane and has damage due to traffic impact.

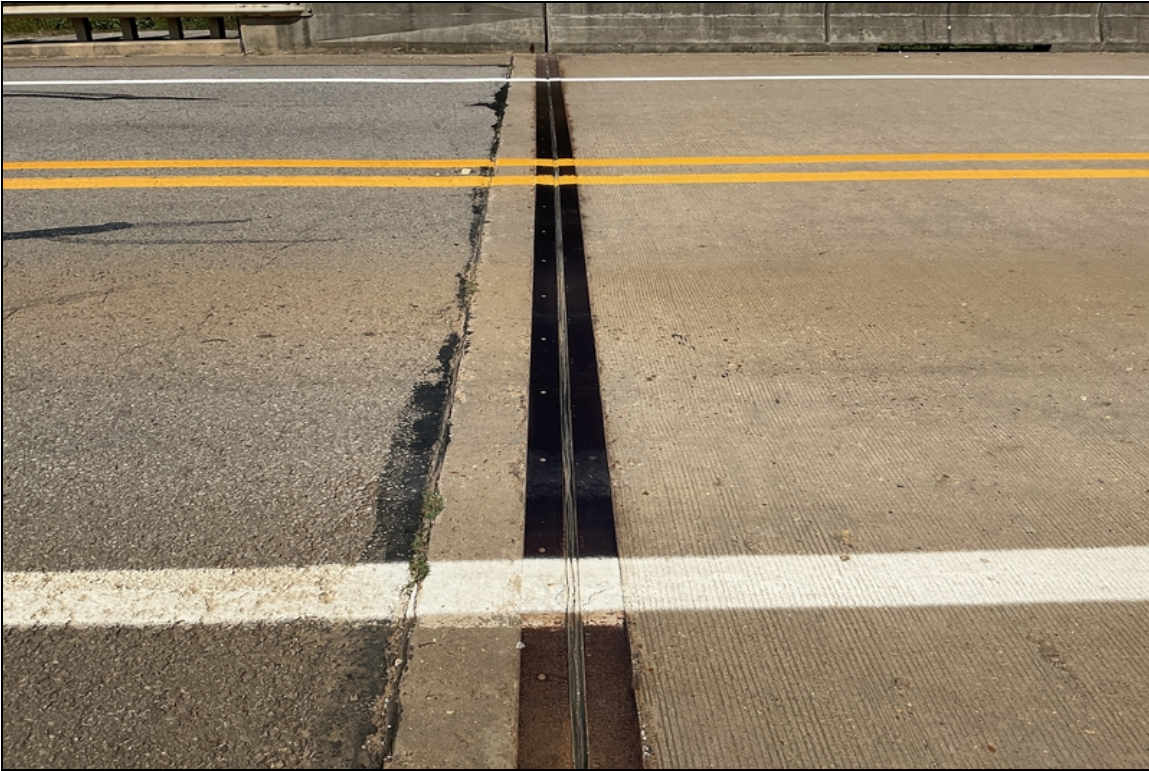
View joint at abutment #1.

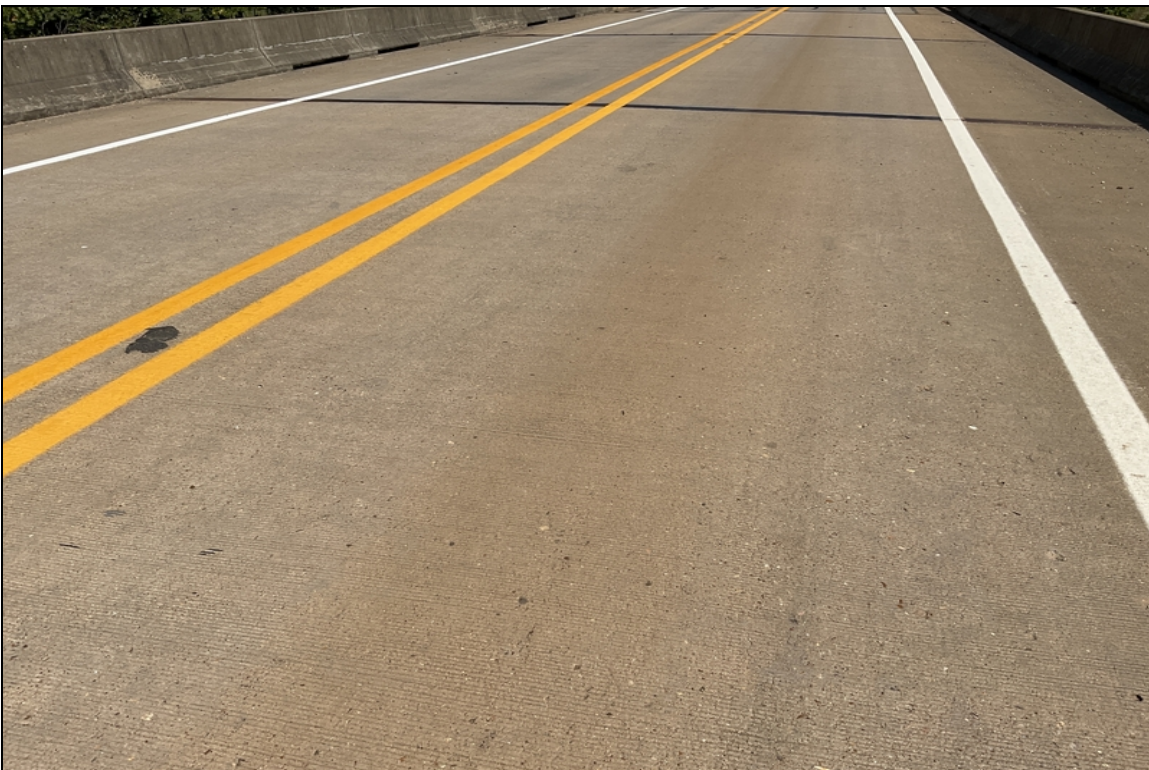
ELEM	DESCRIPTION	UNITS	TOTAL	CS1	CS2	CS3	CS4
12	Reinforced Concrete Deck	SF	4423	4275	148	0	0
1130	Cracking (RC and Other)	SF	148	0	148	0	0
(12)							
08/16/2021 WNR & DBM:							
-the deck driving surface has minor aggregate pop outs in the driving lanes.							
-The driving surface of the deck has short duration transverse cracks in the gutters that correspond with the sawn joints in the parapets.							
-The deck has areas of longitudinal cracking in random locations and diagonal cracking in the gutters adjacent to the expansion joint assemblies.							
107	Steel Open Girder/Beam	LF	570	570	0	0	0
515	Steel Protective Coating	SF	4650	4647	3	0	0
3430	Oxide Film Degradation Color/Texture Adherence(Steel Protective Coatings)	SF	3	0	3	0	0

General view of deck

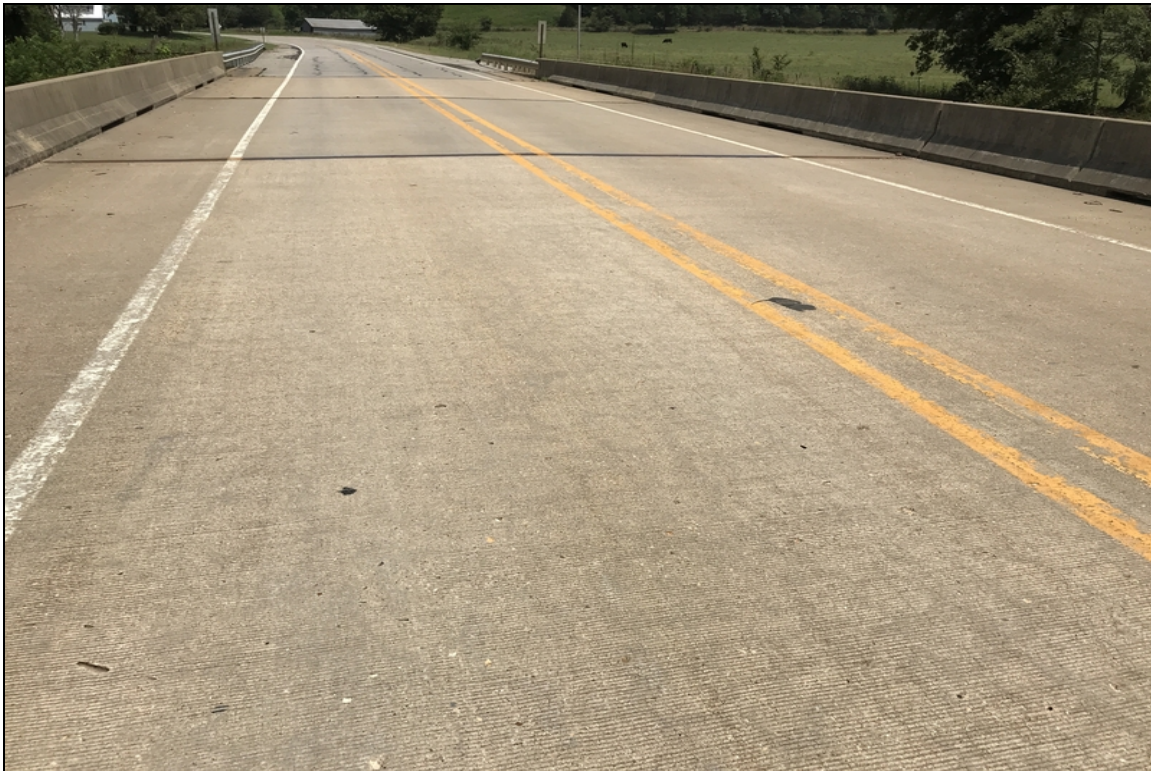
General view of deck

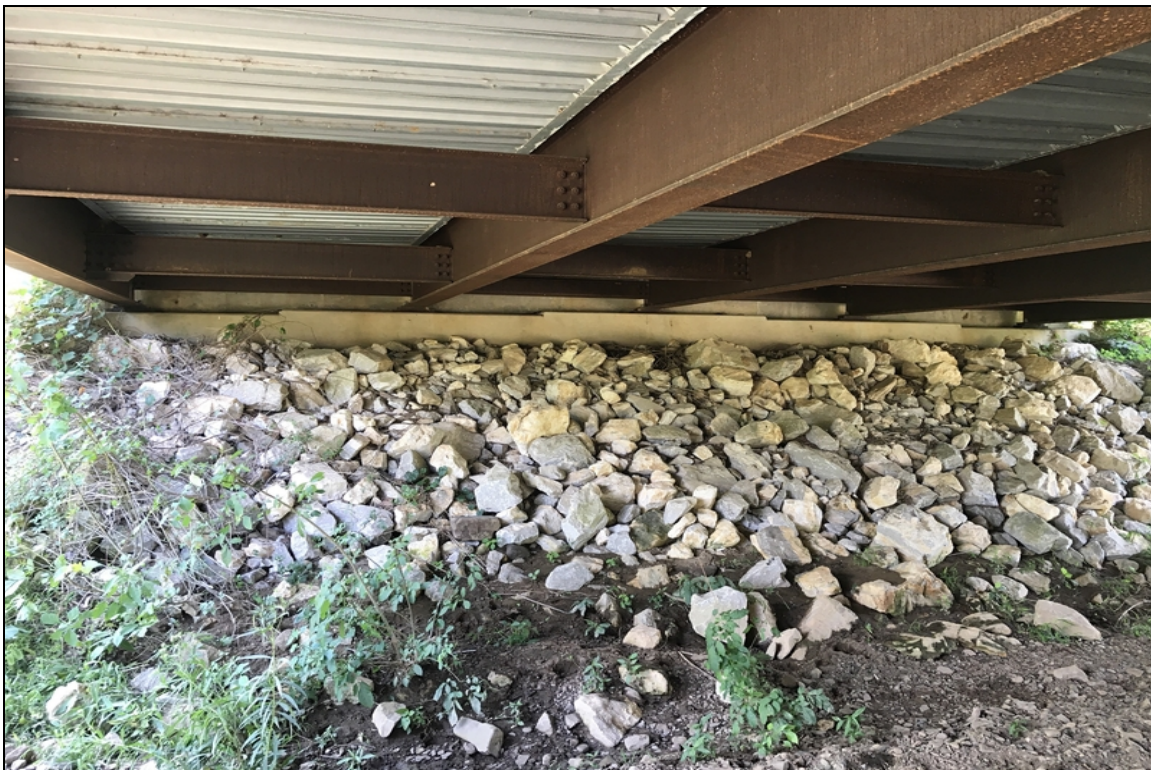
(215)							
08/16/2021 WNR & DBM:							
-The top of abutment back walls have transverse cracks at random spacing visible from the driving surface.							
-The abutment breastwalls have short duration vertical cracks at the step downs in locations.							
-The abutments have staining from compression joint seal leakage.							
-The North embankment has minor rip-rap displacement due to recent high water event.							
234	Reinforced Concrete Pier Cap	LF	72	65	7	0	0
1080	Delamination/Spall/Patched Area	LF	3	0	3	0	0
1130	Cracking (RC and Other)	LF	4	0	4	0	0

General view of abutment #1.
