Asset #M0673(Record Change)

SH 27 Searcy over Forest Creek

Location: 4MI NE JCT SH 333

Team Lead: Benjamin Smith, Inspection Date: 03/02/2023

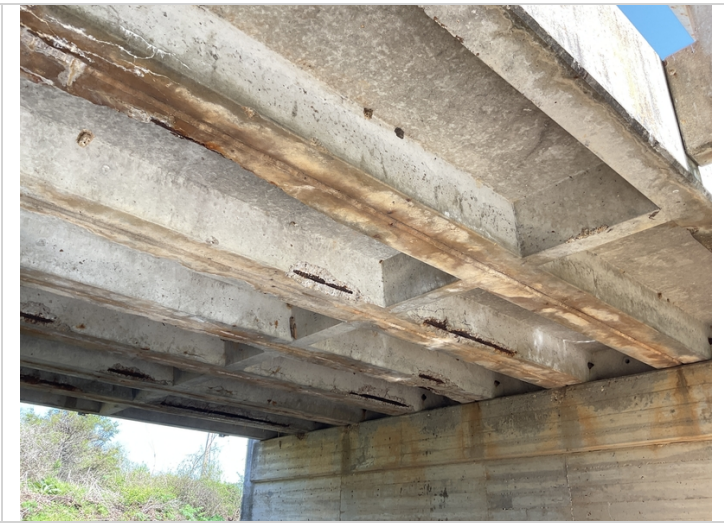
View of superstructure span #2

Span #2- RCCB #1 has map cracking with efflorescence on the diaphragm over pier wall #2 and the outside face of the channel beam, and in the deck undersurface near the end of the span. The right stem has 2' of delamination. RCCB #2 has 10' of spalling with exposed rebar on the left stem. RCCB #3 has 2' of spalling with exposed rebar and 4' of delamination on the left stem, the right stem has 2' of spalling with exposed rebar. RCCB #4 has 14' of spalling with exposed rebar on the right stem with 1' of delamination. The left stem has 4' of spalling with exposed rebar and 3' of delimitation. RCCB #5 has 1' of spalling with exposed rebar on the left stem and 1' of delamination on the right stem. RCCB #6 has 6' of spalling with exposed rebar on the left stem and 3' of spalling with exposed rebar on the right stem. RCCB #7 has minor insignificant spalling on the right stem.

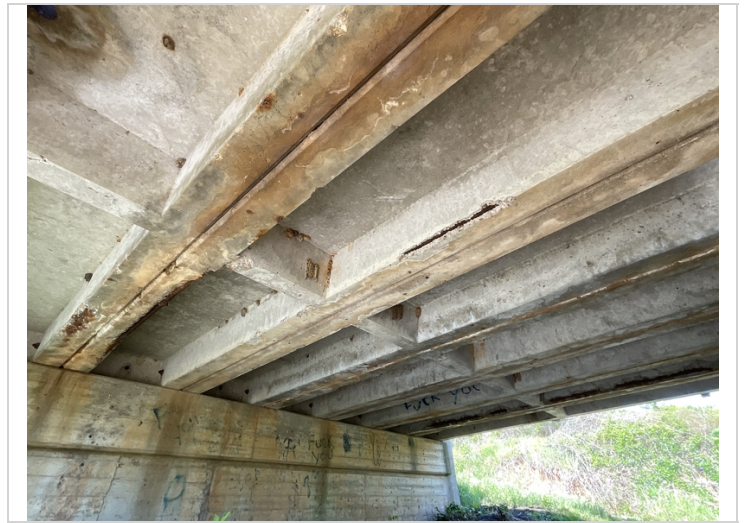
Span #1 superstructure

Span #1 has 34' total of spalls with exposed rebar. RCCB #1 has 4' of spalling with exposed rebar on the right stem with 6' of delamination on the right stem.

RCCB #2 has 12' of spalling with exposed rebar on the left stem. RCCB #3 has 2' of delamination on the left stem. RCCB #4 has 7' of exposed rebar on the right stem. RCCB #5 has minor vertical hairline flexure cracking. RCCB #6 has 2' of spalling with exposed rebar on the left stem and 6' of spalling with exposed rebar on the right stem. RCCB #7 has 2' of spalling with exposed rebar on the left stem with minor insignificant spalling on the left and right stems.

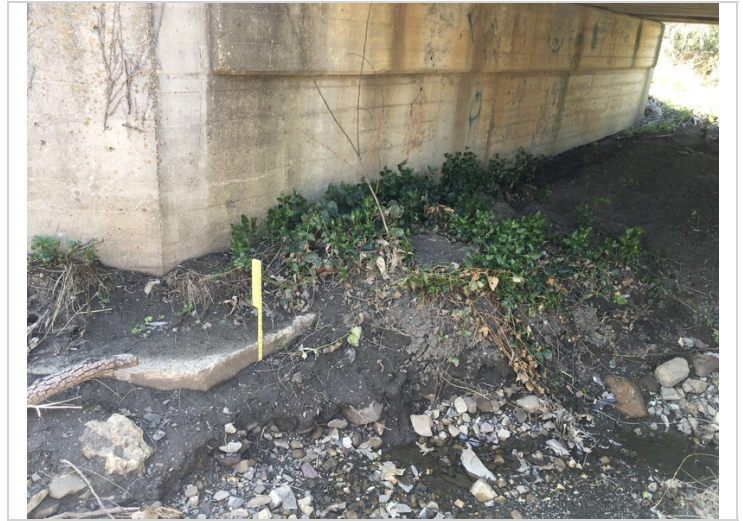
General view of the pier wall #1 footing cover.
