Asset #05911(Routine)

SH 112 Benton 2 over OSAGE CREEK

Location: 5.06 MI N WASHINGTON CO L

Team Lead: Anthony Wood Inspection Date: 07/17/2024

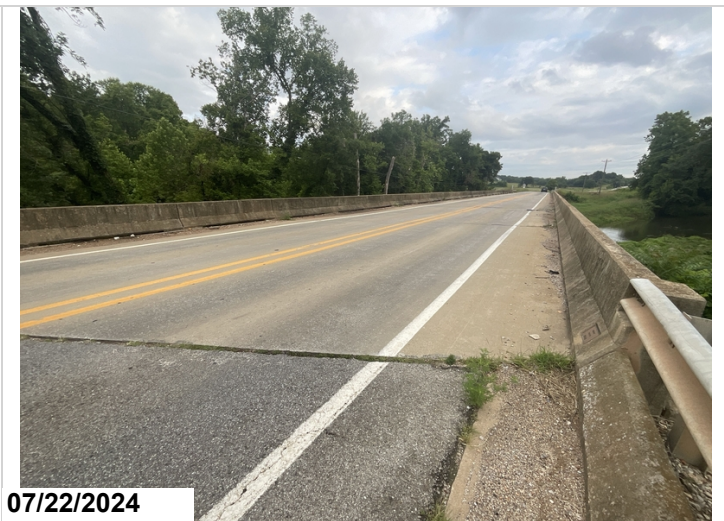
Overall, the deck is in satisfactory condition with areas of spalling with exposed reinforcing steel with section loss, spalling with sound and unsound patches, map cracking and abrasion in the driving surface.

Typical deck.

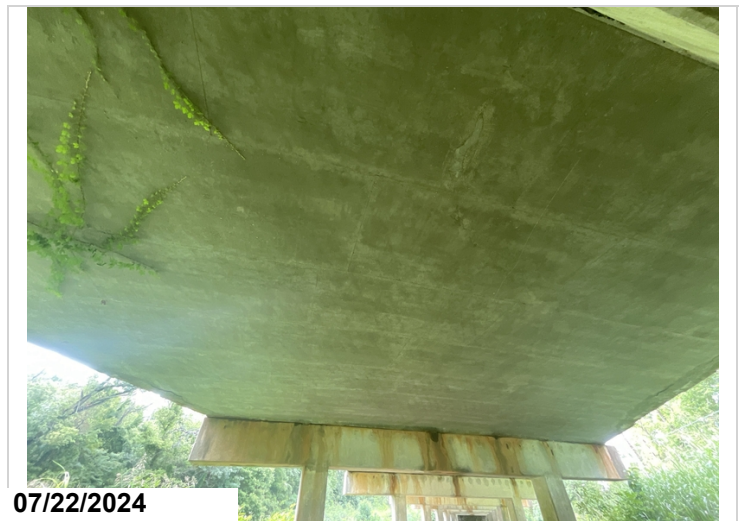
Overall, the superstructure is in satisfactory condition with areas of spalling with exposed reinforcing steel and cracking with efflorescence in the edges of the slabs.

Typical undersurface.

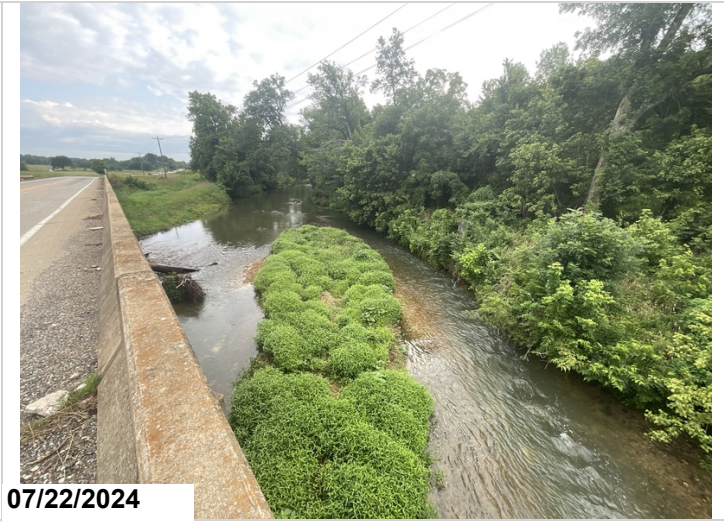
Channel, Right.

Overall, the channel is in good condition with minor trees and brush growing in channel.

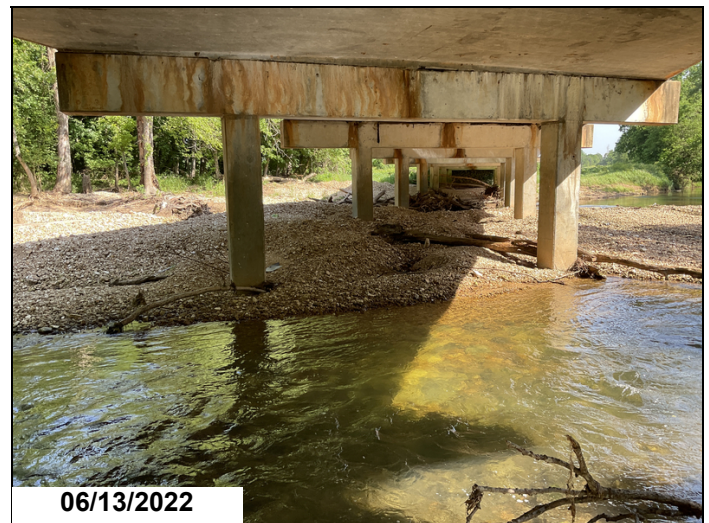
Overall, the scour condition is good with moderate drift causing localized scour at bent 4.

Bents 3 - 5: Large drift blocking channel. Localized scour at bent 4.

View of channel under structure
