Bridge 03345 Inspection Report

National Bridge Inventory Data Sheet

Team Lead: Benjamin Smith, Inspection Date: 05/29/2024

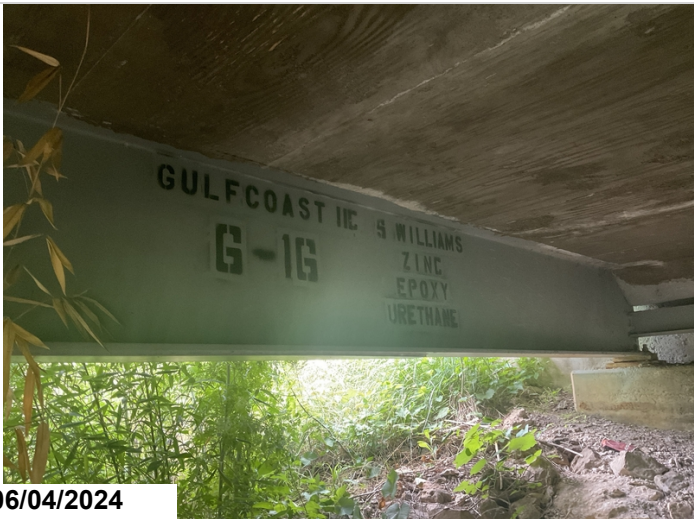
The beams and bearings have had a repainting contract in 2016. The beam paint condition is good with a few small areas of cs2 corrosion. the bearings have cs3 corrosion and pack rust at the abutments.

Paint stencil from 2016.

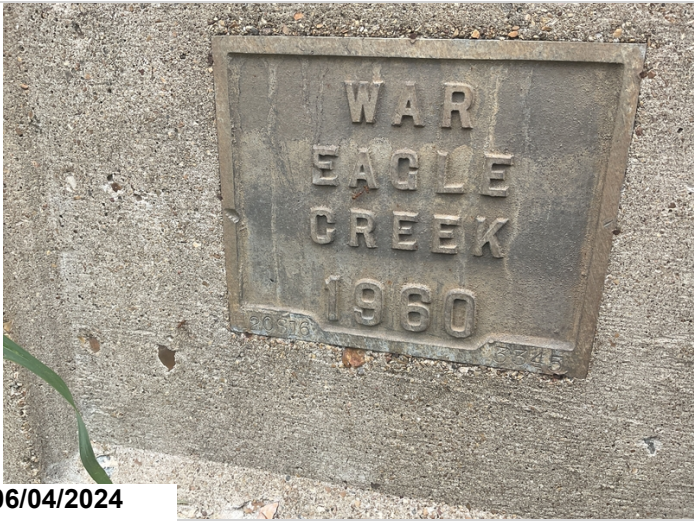
Bridge plate.

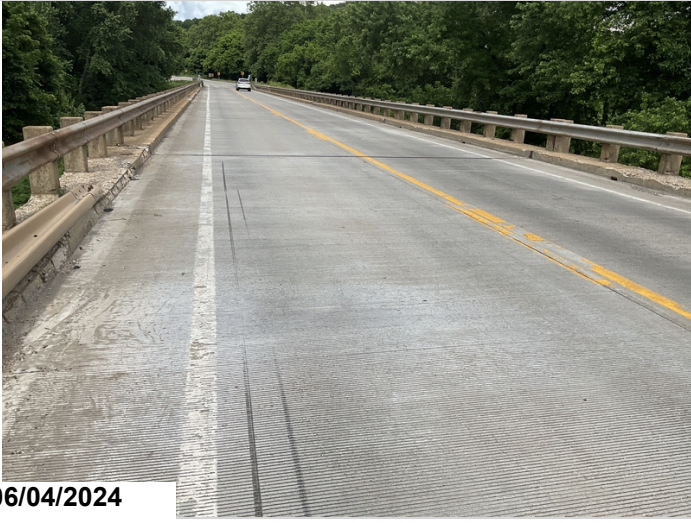
The driving surface of the deck has a hydro demolition with some short duration cracking in span #1. The curb sections have large areas of spalling with exposed rebar. The undersurface has full depth repairs with efflorescence cracking. The overhangs have large areas of spalling with exposed rebar.

Driving surface view.

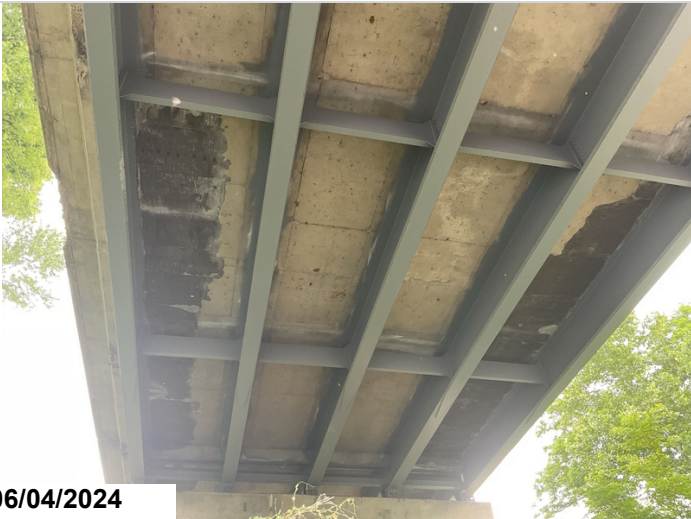
Undersurface view.

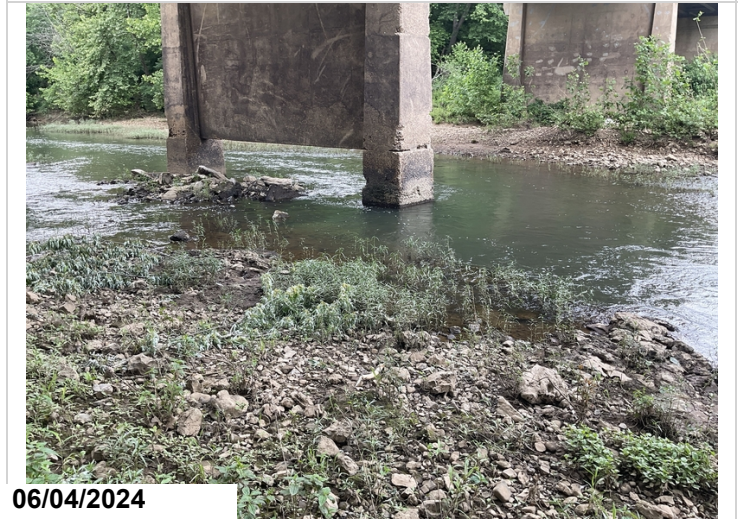
The channel beneath the structure is solid rock. A local scour was noted around the bent #1 columns. no footings are exposed. The abutment #1 slope has a large area of erosion at the toe of the slope.

Channel beneath the structure.
