Asset #00461 (Routine)

SH 35 S-5 LM 15.92 over BLAKEY CREEK

Team Lead: Lee Swan, Inspection Date: 05/19/2022

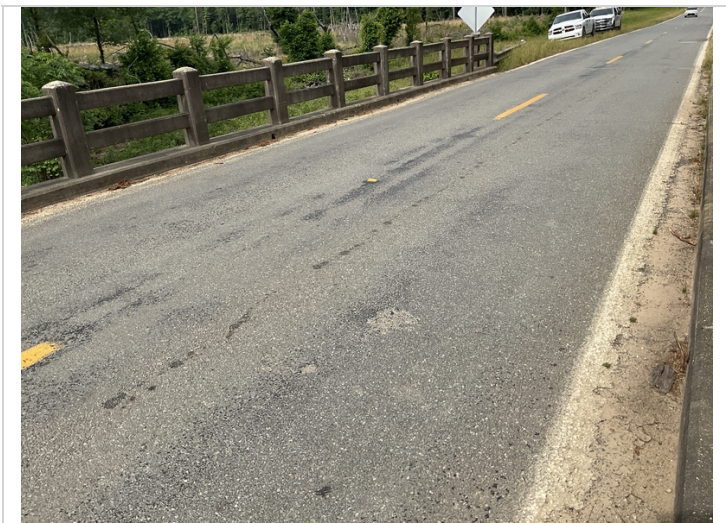
Typical deck

ELEMENTS	DESCRIPTION	UNITS	TOTAL	CS1	CS2	CS3	CS4
16	Reinforced Concrete Top Flange	SF	1449	1430	4	15	0
1080	Delamination/Spall/Patched Area	SF	4	0	4	0	0
1090	Exposed Rebar	SF	15	0	0	15	0
510	Wearing Surfaces	SF	1260	1200	0	60	0
3220	Crack (Wearing Surface)	SF	60	0	0	60	0
(16) Spalls with exposed rebar with section loss and delamination in both spans.							
(510-16) Transverse cracks at the joints.

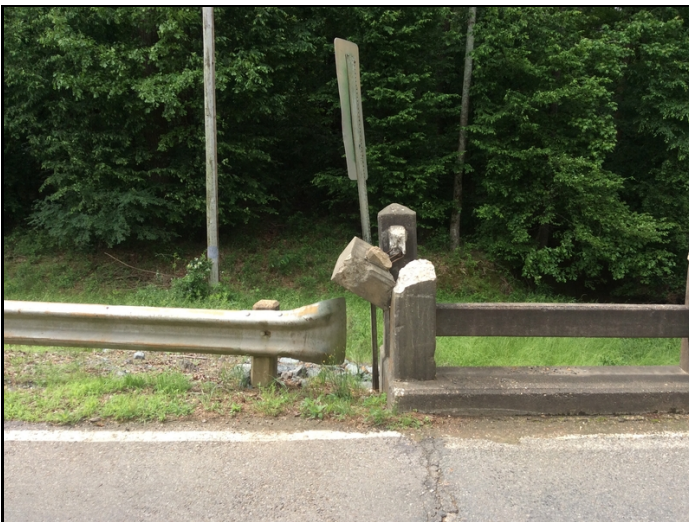
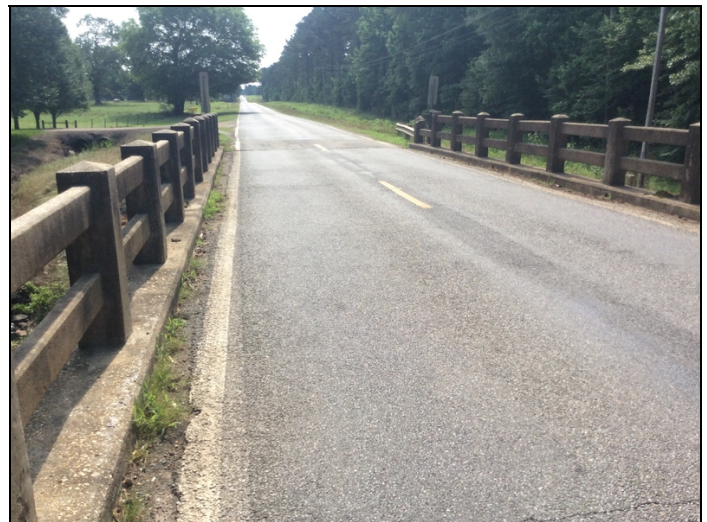
Bridge End Post and top concrete rail @ BR End Rt. collision damage, top of end post broke and top rail is missing.

Abutment 2 Rt. BR end post & top rail in last section before the BR end post, has collision damage.

5/19/2022-RLS-Bridge post and rail have been repaired.

Repaired bridge railing.

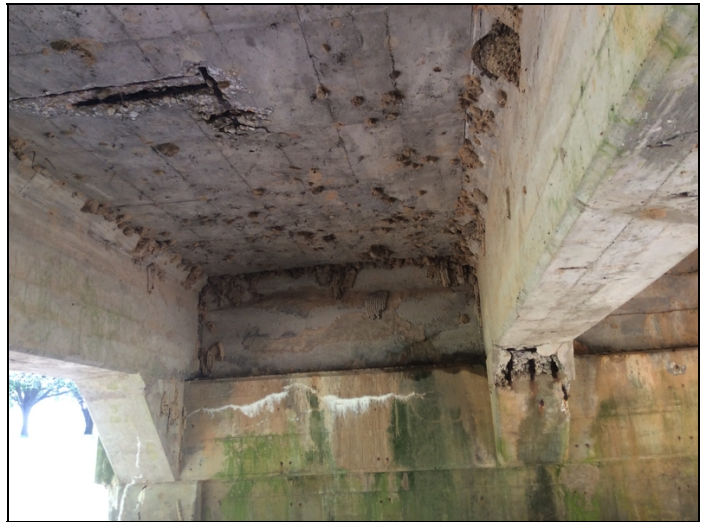
Span 1 Girder 2 @ bent 2 back, spall @ haunch with exposed steel with pack rust and section loss. 05/30/2018 JPR -- Little or no change since last inspection.

Bent 2 haunch below & back of bent 2 girder 2 has a spall with exposed steel with some section loss. Also bent 2 cap has some cracking with efflorescence on back face of the cap.
