Asset #03416(Routine)

SH 35 S-5 LM 12.28 over BIG CREEK RELIEF

Team Lead: John Parks, Inspection Date: 07/06/2022

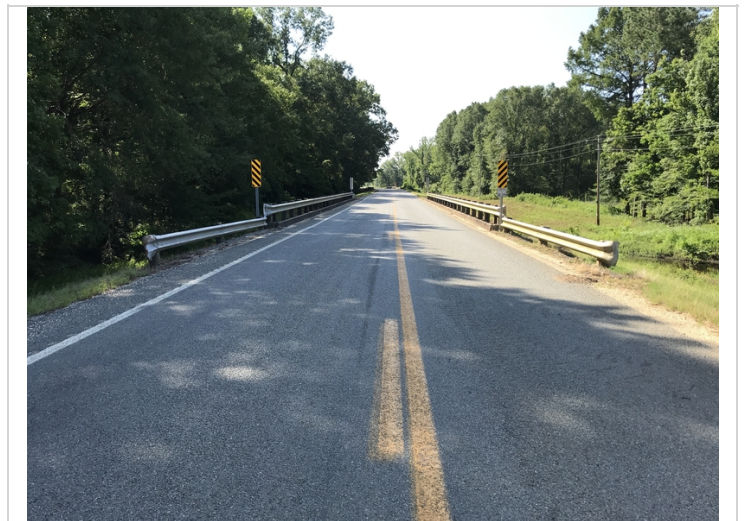
(215) Approach roadway settlement abutment 1							
227	Reinforced Concrete Pile	EA	18	3	6	9	0
1190	Abrasion/Wear (PSC/RC)	EA	15	0	6	9	0
(227) All columns bents 3-6 are "pebbled" from the high water line down with aggregates showing but still imbedded in the concrete.							
234	Reinforced Concrete Pier Cap	LF	153	143	1	9	0
1080	Delamination/Spall/Patched Area	LF	10	0	1	9	0
330	Metal Bridge Railing	LF	266	266	0	0	0
515	Steel Protective Coating	SF	532	532	0	0	0

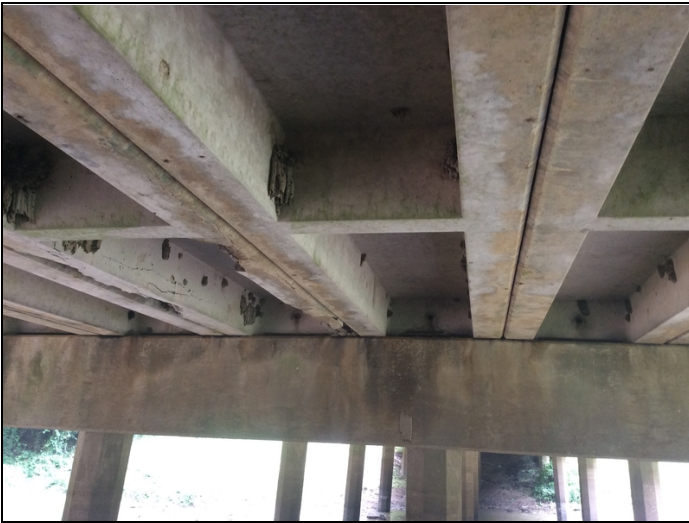
Span 2 deck Soffit.

(110) Numerous PC units have spalls with exposed steel moderate to severe section loss, cracks and spalls with little exposed steel. Some areas have both bottom strands exposed. Span 1 units 2,3,4,5,& 7 Span 2 units 3,6, & 7 Span 3 unit 5 Span 4 unit 1,2, & 5 Span 5 units 3,4, & 6 Span 6 units 3,5, & 6 Span 7 units 2 & 3							
215	Reinforced Concrete Abutment	LF	73	43	30	0	0
1080	Delamination/Spall/Patched Area	LF	4	0	4	0	0
4000	Settlement	LF	26	0	26	0	0
