Asset #05508(Routine)

SH 31Log 1.33 over BAYOU TWO PRAIRIE

Location: 0.3 MI SO OF I-40

Team Lead: Bryan Saunders **Inspection Date:** 10/25/2023

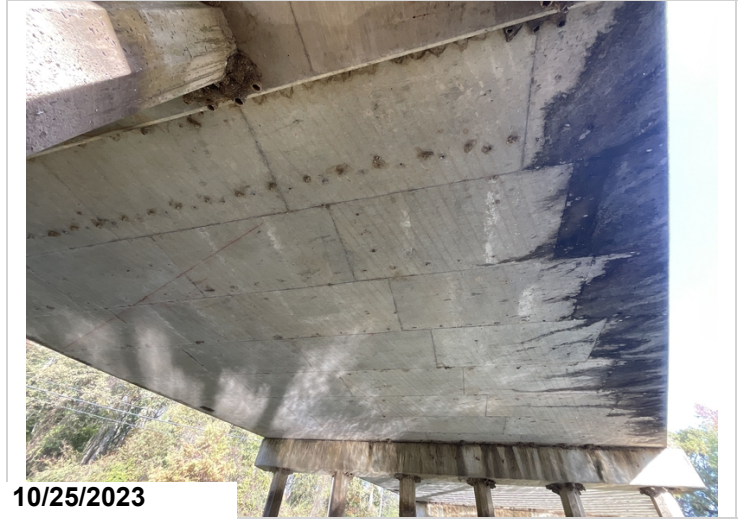
| ELEMENTS | DESCRIPTION | UNITS | TOTAL | CS1 | CS2 | CS3 | CS4 |
|--|---|---|---|---|---|---|---|
| (38) Longitudinal hairline cracks are visible on the soffit of all the spans near the sono voids. Span 4 soffit has small cracks with rust stains. Diagonal cracks are present in the deck surface near the joint and longitudinal and areas of map cracks are present in all spans. 0.030 inch avg. width. Both travel lanes have light abrasion | | | | | | | |

Soffit view span 2

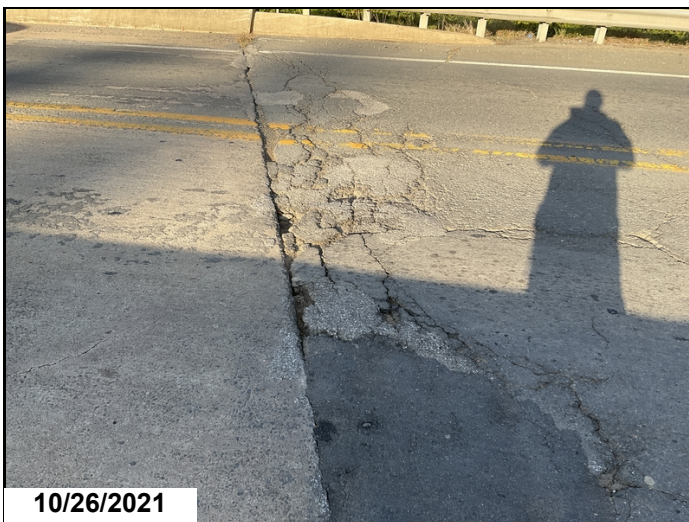
Approach roadway on south end of bridge has settled and has pot holes.
