Bridge 01205 Inspection Report

Asset #01205(Record Change)

SH 10-7 Log 2.97 over HOLLIDAY CREEK

Team Lead: Riley House Inspection Date: 02/18/2026

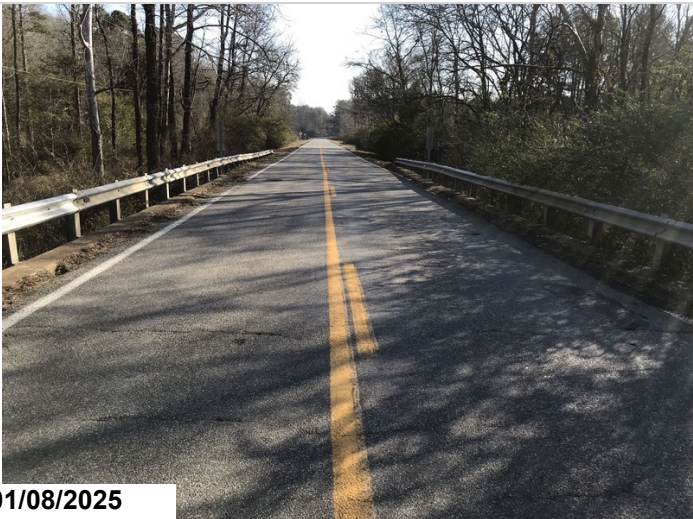
Deck view

(16) Span 1 undersurface between girders 2 & 3 small spalls with exposed rebar and scattered small cracks with light efflorescence. Span 2 soffit has scattered small spalls with rebar and cracks. (510-16) Some cracking in the wearing surface.							
110	Reinforced Concrete Open Girder/Beam	LF	180	174	0	6	0
1080	Delamination/Spall/Patched Area	LF	2	0	0	2	0
1090	Exposed Rebar	LF	4	0	0	4	0
