WRONG-WAY CRASH STUDY

INTERSTATES AND FREEWAYS | CALENDAR YEAR 2019

Published August 2021

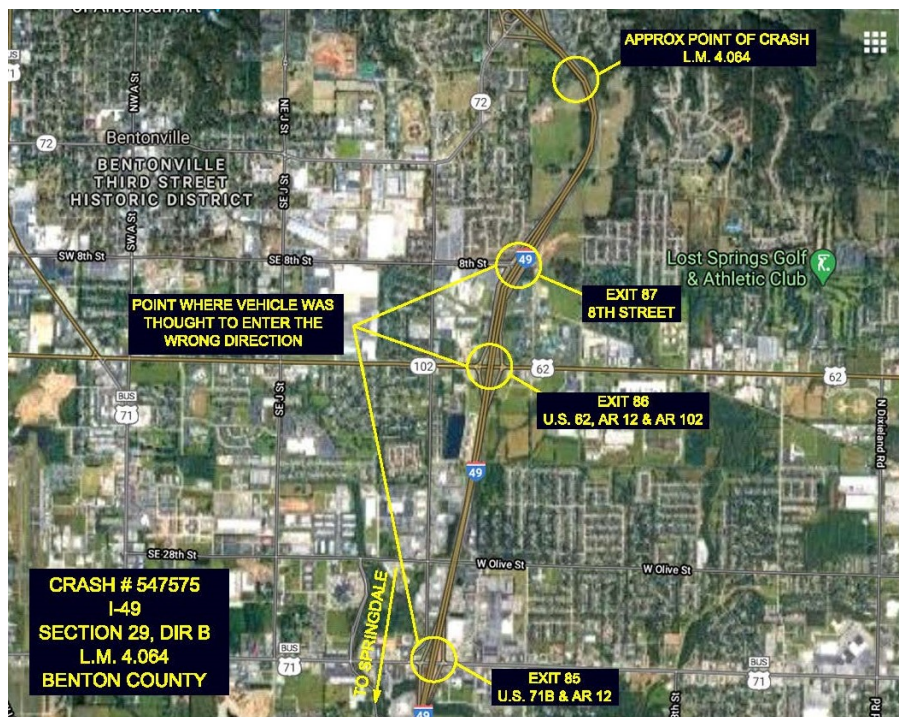
Crash # 2019547575 I-49, Section 29, Direction B, Log Mile 4.064

The driver accessed I-49 possibly at Exit 85 (US 71B & AR 12), Exit 86 (US 62, AR 12 & AR 102) or Exit 87 (8th St.) and travelled northbound in the southbound traffic lane on I-49. The operator of the southbound vehicle took evasive action and veered to the right. Consequently, the front-end of the wrong way vehicle sideswiped the entire left side of the southbound vehicle. The southbound vehicle began rotating counterclockwise as it entered the right shoulder, and then came to rest in the grassy ditch facing north in-between two highway department signs. The wrong way vehicle did not stop and continued traveling northbound in the southbound lane. Gouge marks illustrated that the vehicle entered the right lane after leaving the scene of the crash. The wrong-way vehicle was found in a disabled condition in the right lane and facing north. The wrong-way driver was found in the driver's seat and was passed out. The driver was driving under the influence of alcohol.

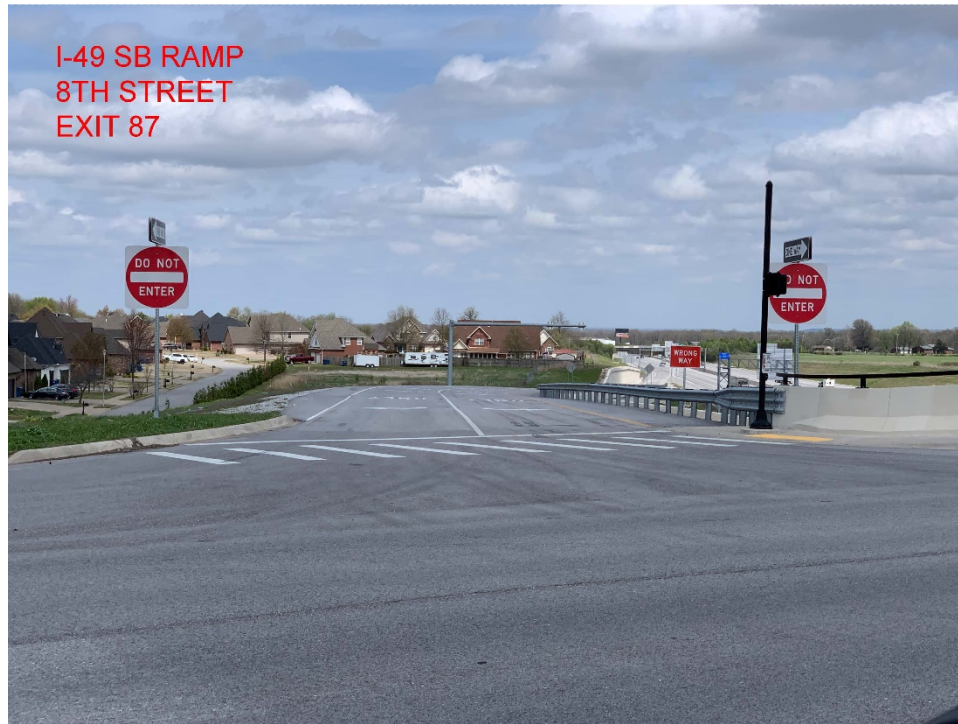
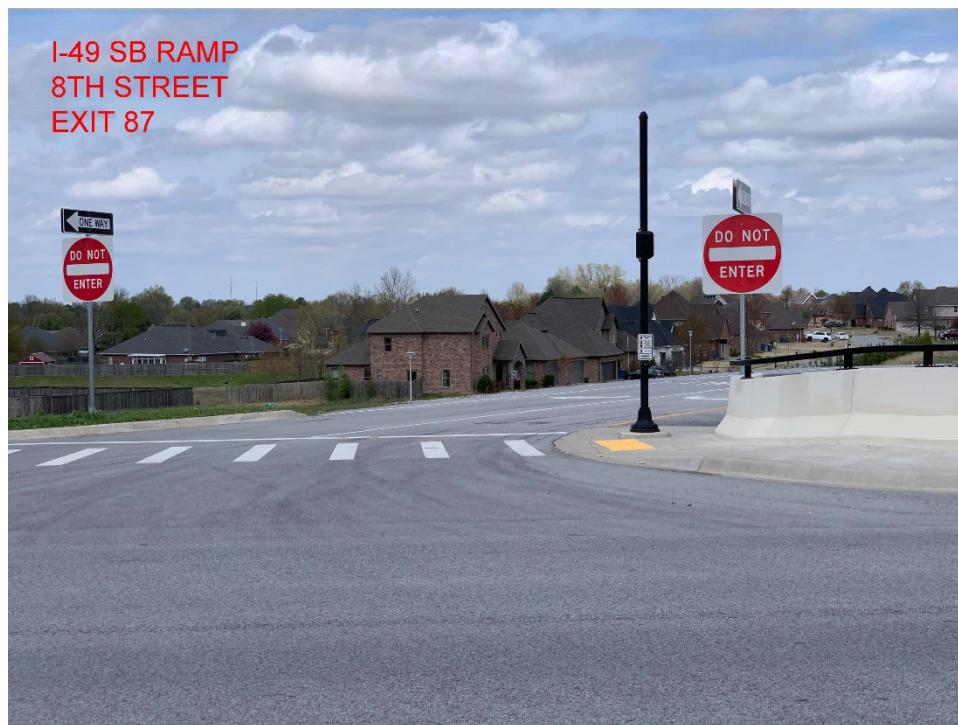
The interchange at Exit 87 was reviewed. Signs were in place and in conformance with MUTCD. However, the 42"x30" Wrong Way sign was missing and will be installed to be consistent with current ARDOT requirements. These modifications will be implemented by statewide forces as soon as their schedule permits.

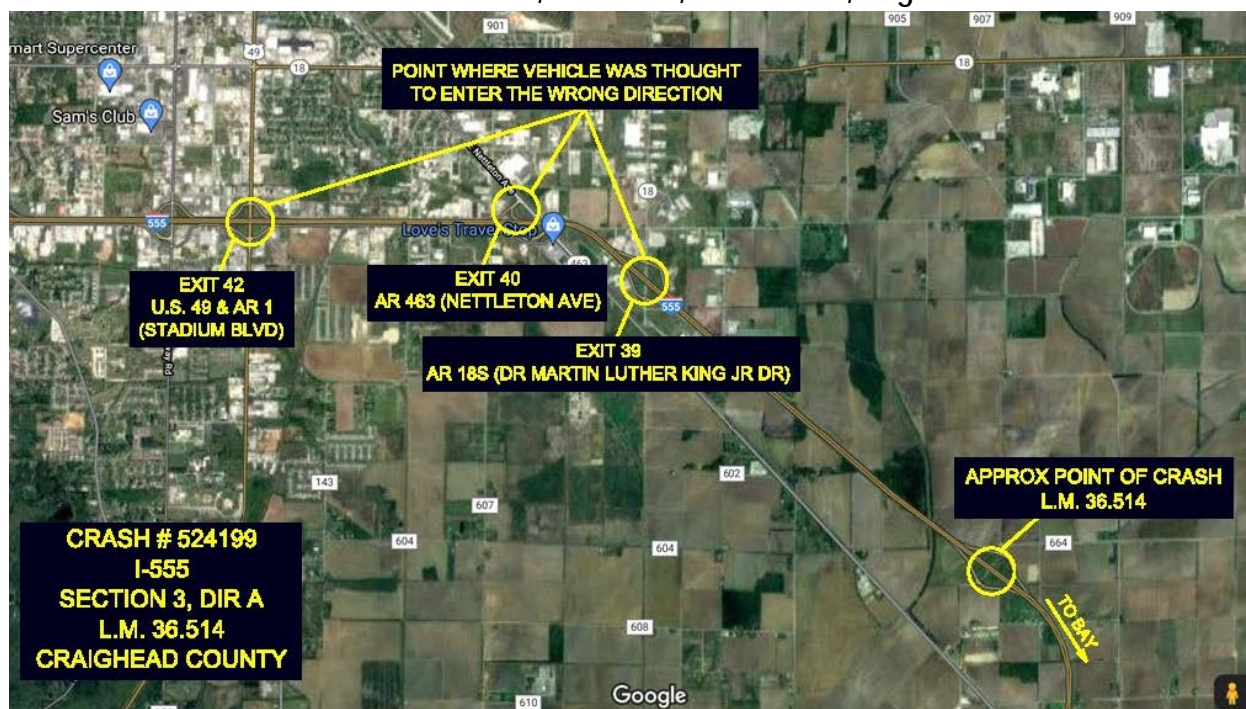
Crash # 2019524199 I-555, Section 3, Direction A, Log Mile 36.514

The driver accessed I-555 possibly at Exit 39 (AR 18S, Dr. Martin Luther King Jr. Drive), Exit 40 (AR 463, Nettleton Ave.) or Exit 42 (US 49 & AR 1, Stadium Blvd.) and travelled southbound in the northbound traffic lane on I-555. The 90-year-old driver was involved in a head on collision at log mile 36.514 which resulted in a fatality.

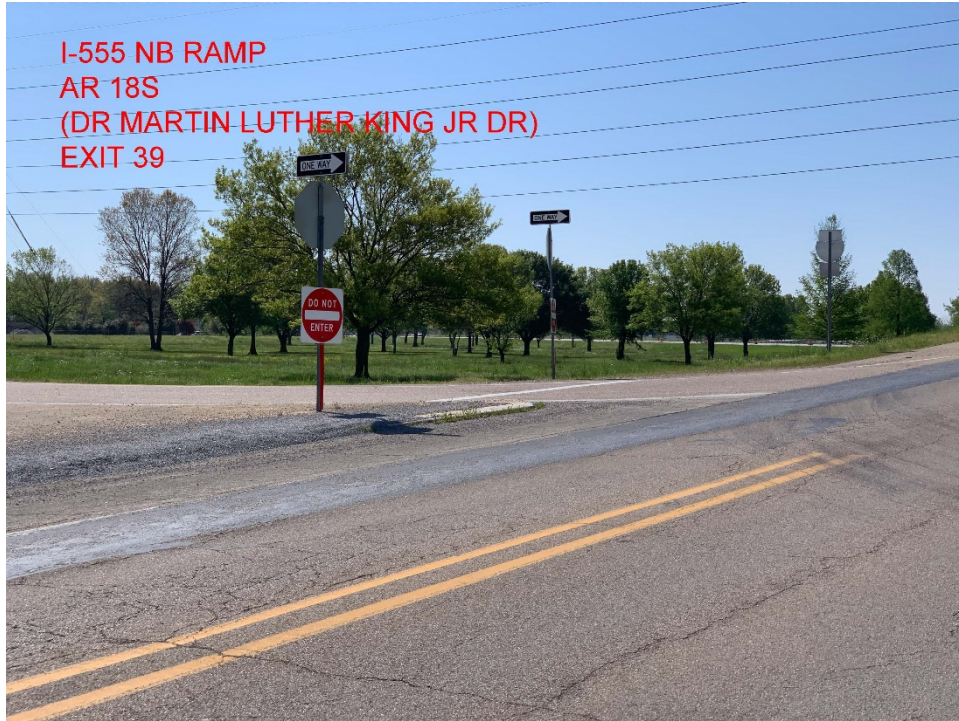
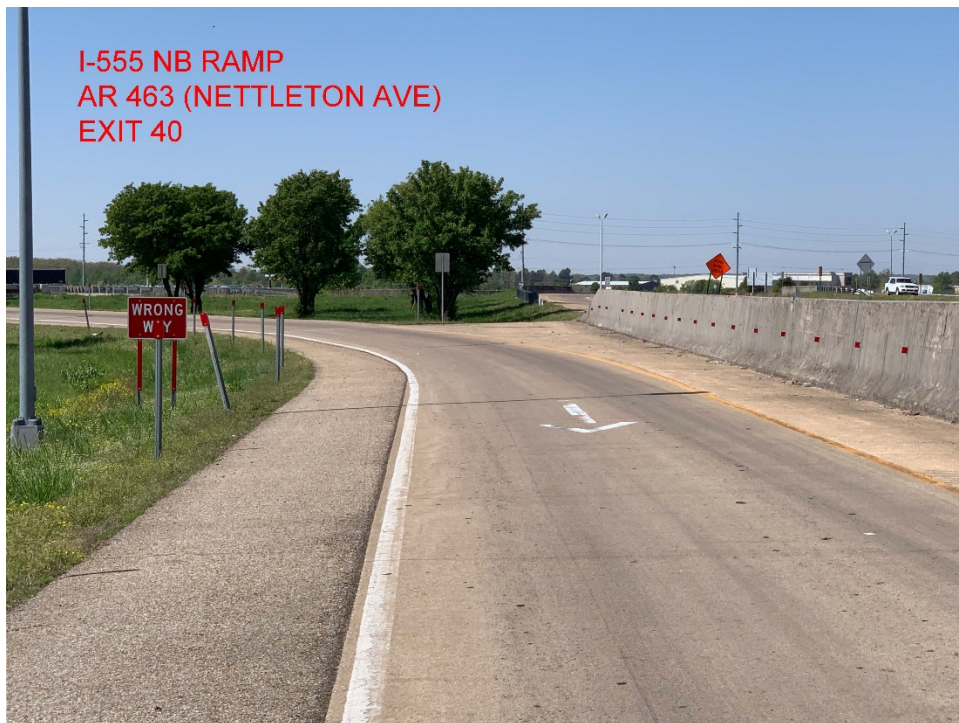
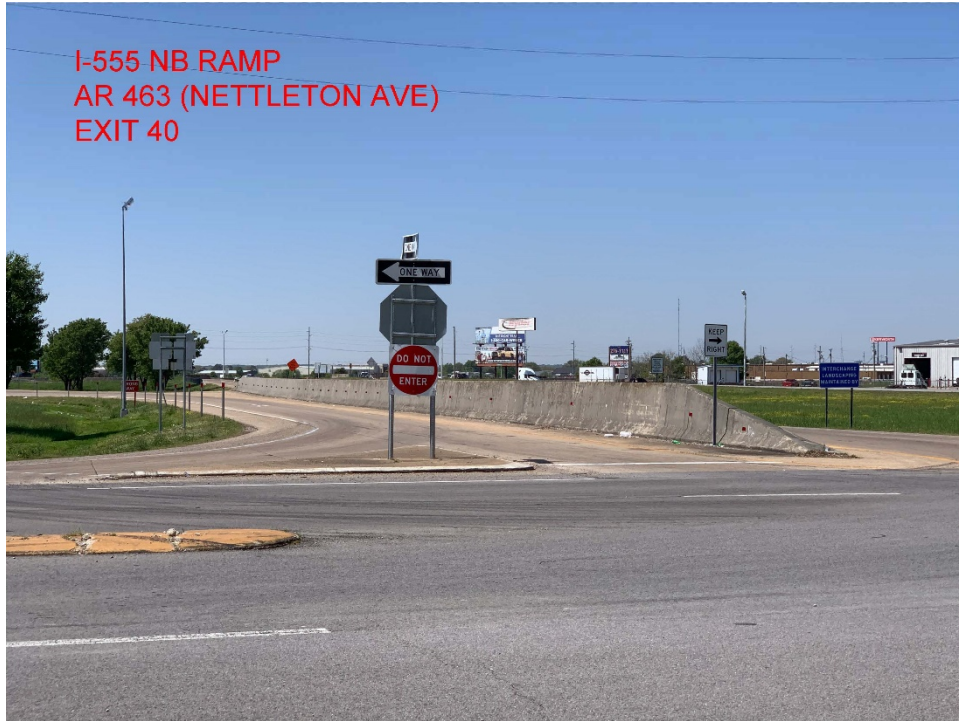
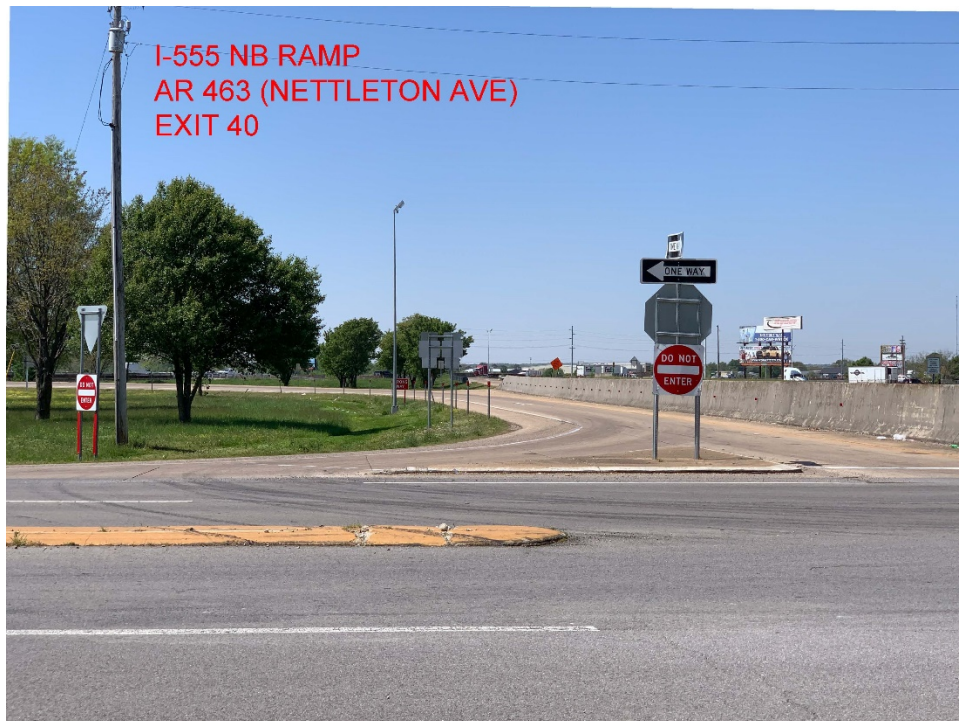
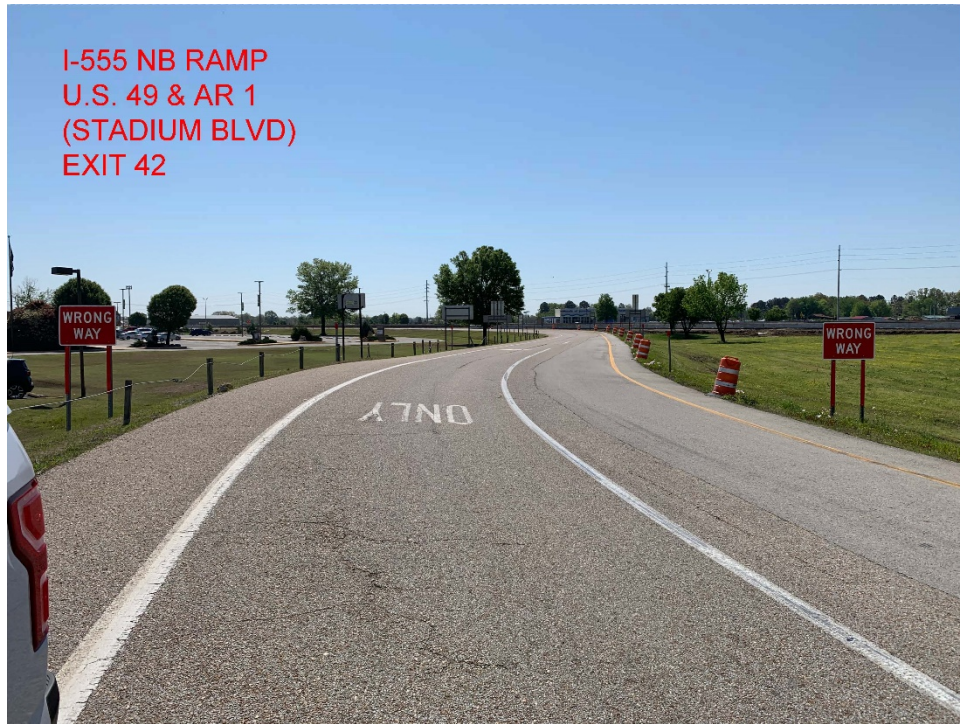
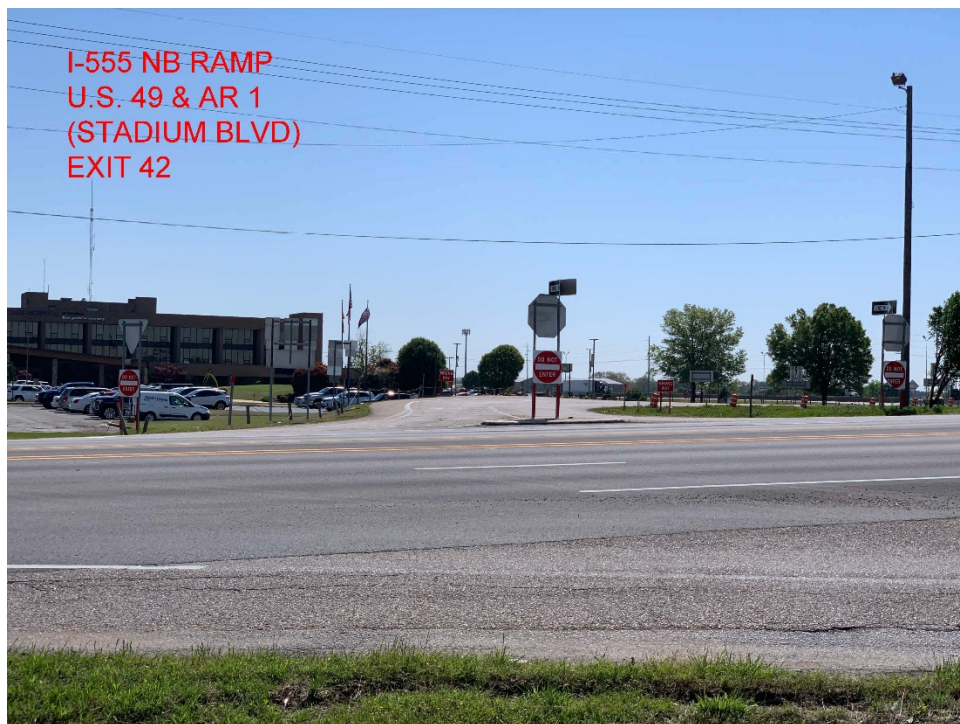
The interchange at Exit 40 was reviewed. Signs were in place and in conformance with MUTCD requirements. However, the 42"x30" Wrong Way sign was missing and should be installed to be consistent with current ARDOT requirements. This modification will be implemented by statewide forces as soon as their schedule permits. Also, the pavement markings should be installed to be consistent with current ARDOT requirements. This modification will be implemented by district forces as soon as their schedule permits.

The interchange at Exit 42 was reviewed. Pavement markings and signs were in place and in conformance with MUTCD and ARDOT requirements.

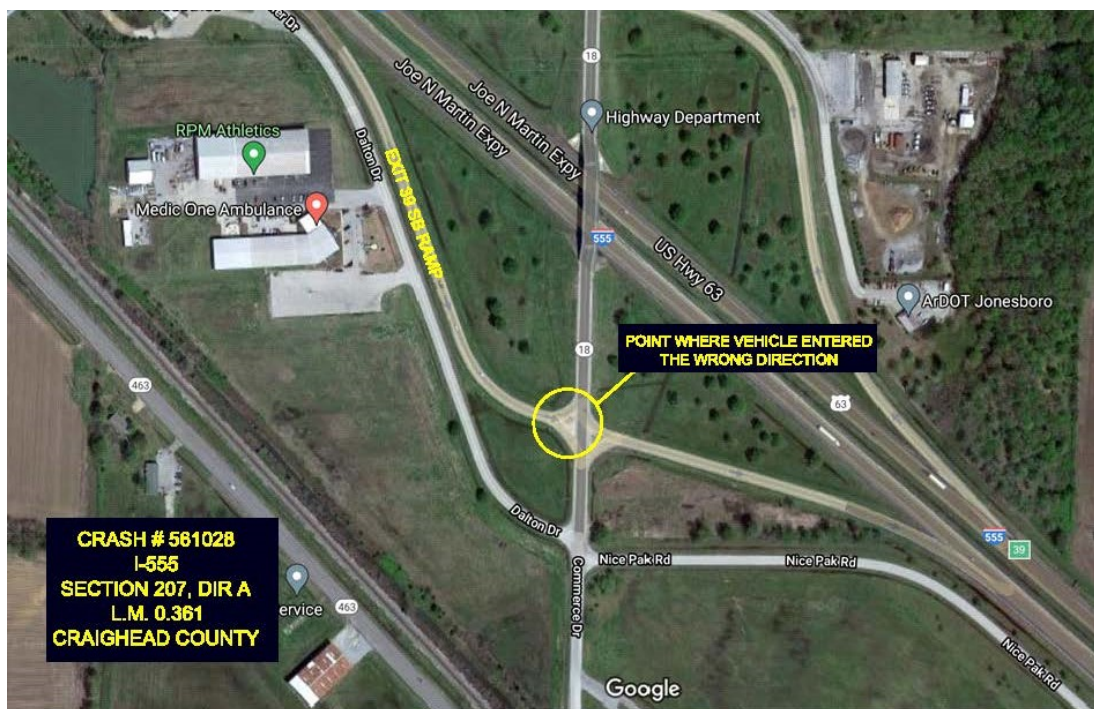
Crash # 2019561028 I-555, Section 207, Direction A, Log Mile 0.361

The driver attempted to access I-555 at Exit 39 (AR 18S, Dr. Martin Luther King Jr. Drive) and was traveling north on the southbound ramp of I-555. He immediately observed his mistake and maneuvered his vehicle to the north side shoulder of the exit ramp. He did not see the culvert, which was a straight drop off from the roadway. The vehicle front tire struck the culvert and his vehicle started to slide down the hill and rolled over before landing on it wheels in the ditch.

The southbound entrance ramp for the interchange at Exit 39 was reviewed. Signs were in place and in conformance with MUTCD requirements. However, the 30"x30" Do Not Enter and 36"x12" One Way signs were missing and installed to be consistent with current ARDOT requirements on May 10, 2021.

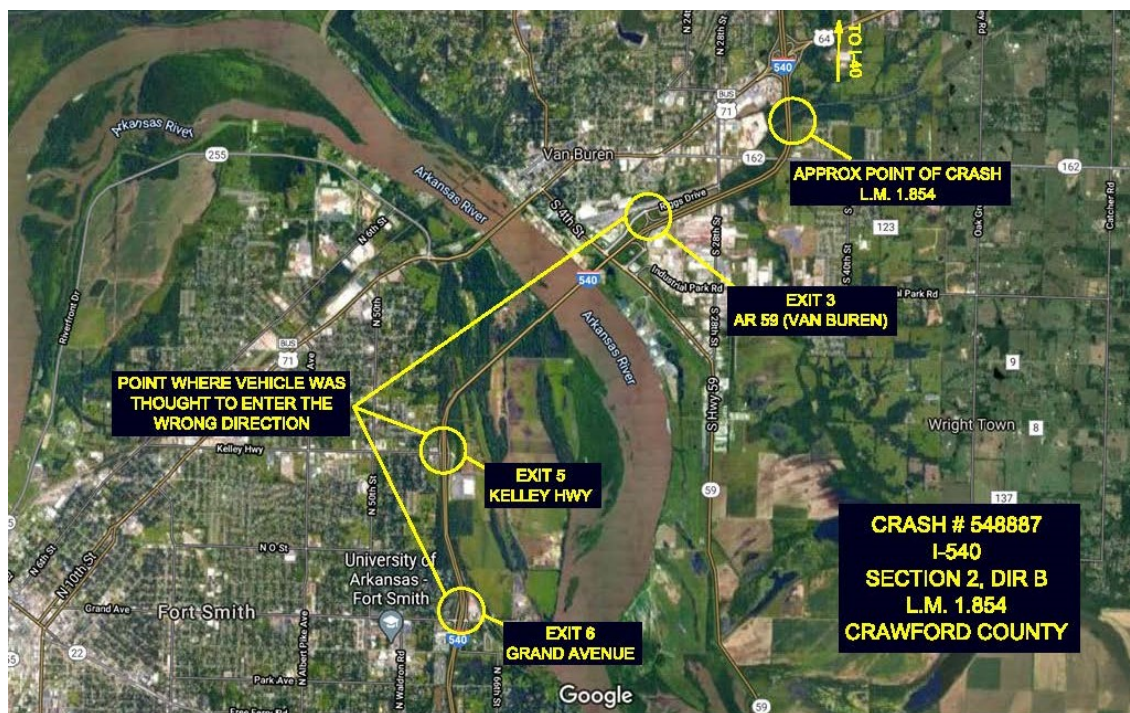
Crash # 2019548887 I-540, Section 2, Direction B, Log Mile 1.854

The driver accessed I-540 possibly at Exit 3 (AR 59, Van Buren), Exit 5 (Kelley Hwy.) or Exit 6 (Grand Ave.) and travelled northbound in the southbound traffic lane on I-540. The driver veered to the right shoulder, as an attempt to avoid a collision. The two vehicles then sideswiped in opposite directions. The wrong way vehicle's angle of approach impacted the southbound vehicle's left rear axle with his left front axle. The wrong way vehicle then spun counterclockwise along the right shoulder and guardrail, coming to final rest with its rear bumper against the concrete bridge wall. The southbound vehicle traveled out of control, impacting the guardrail with its left front bumper and side before coming to rest against the guardrail. The wrong-way driver was suspected of being under the influence of alcohol.

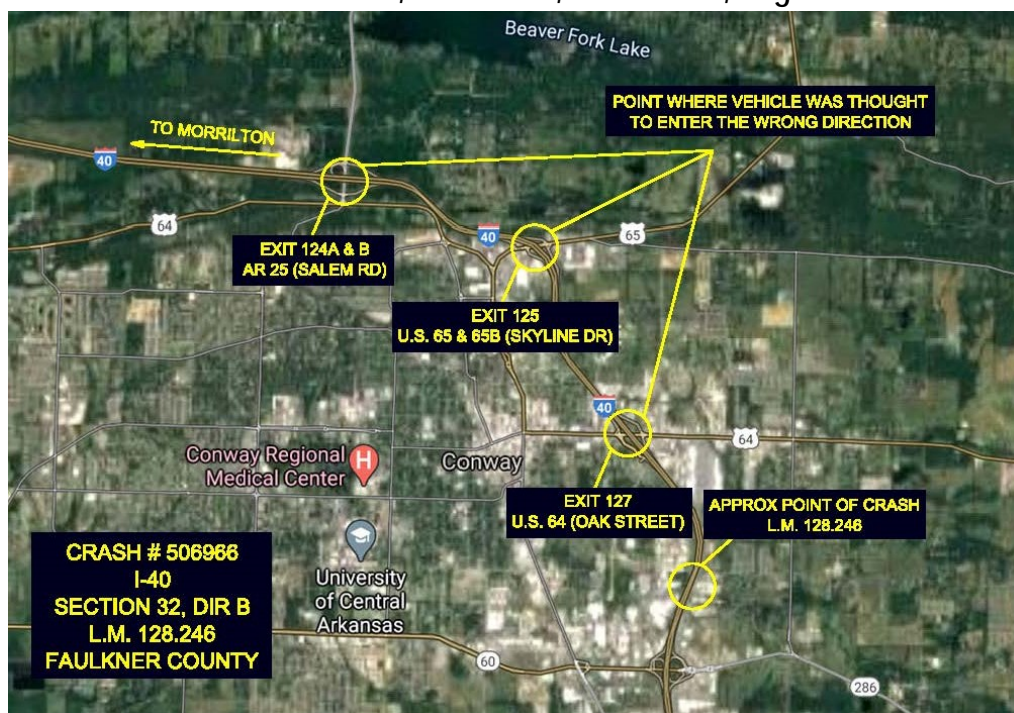
Crash # 2019506966 I-40, Section 32, Direction B, Log Mile 128.246

The driver accessed I-40 possibly at Exit 124A (Salem-North), Exit 124B (Salem-South), Exit 125 (US 65, Skyline Dr.) or Exit 127 (US 64, Oak St.), and travelled east in the westbound lanes of traffic. The driver crossed into the westbound lane, causing the front left of the vehicle to collide with the left front of the westbound vehicle. The wrong way driver continued eastbound and never stopped.

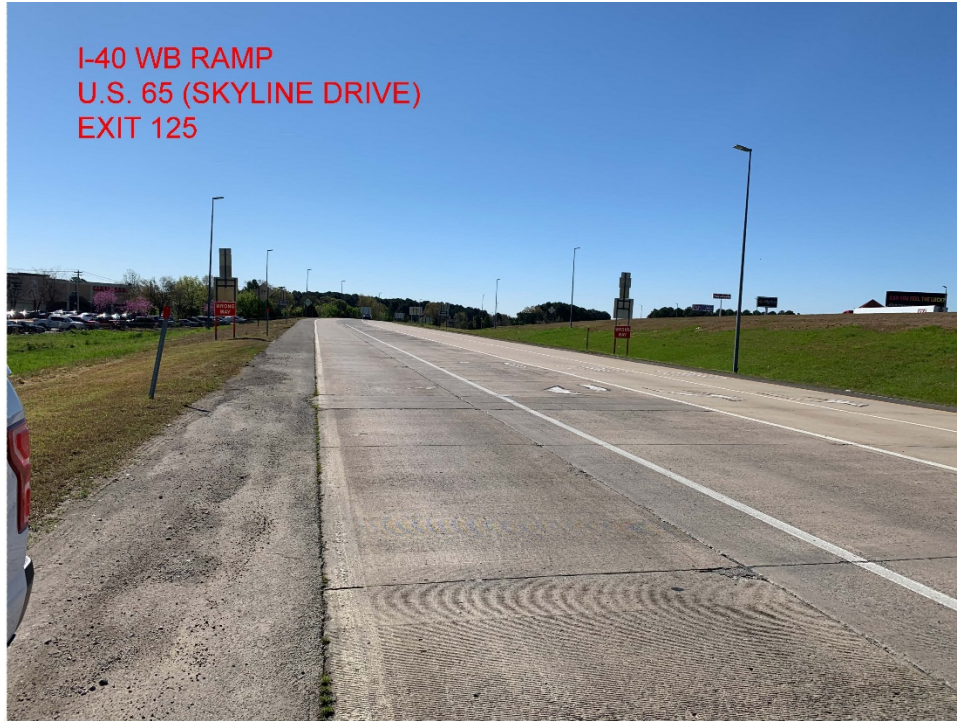
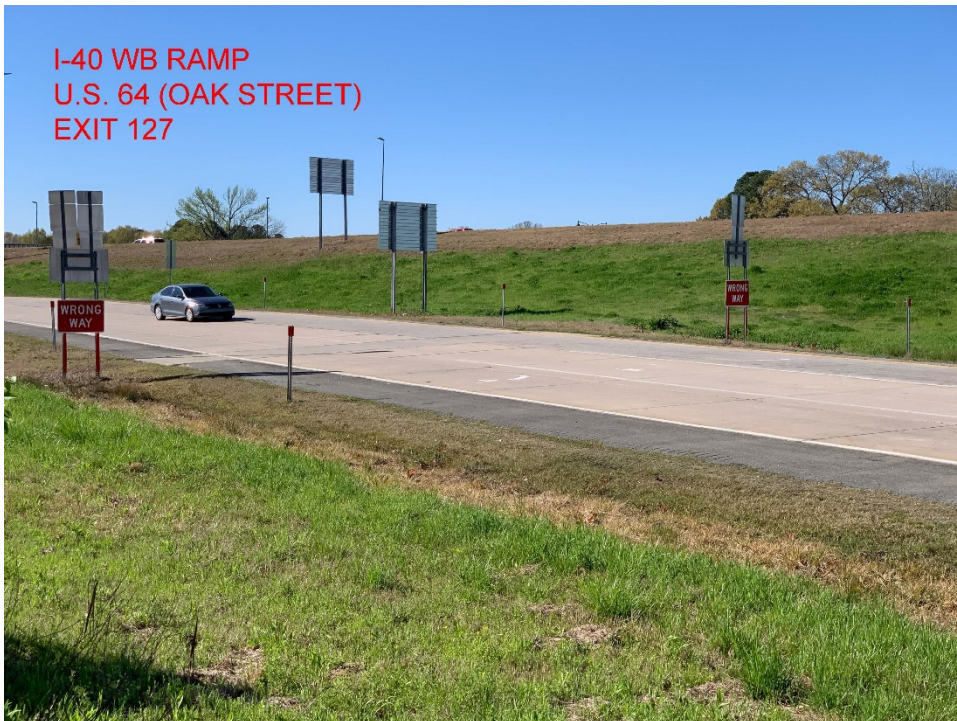
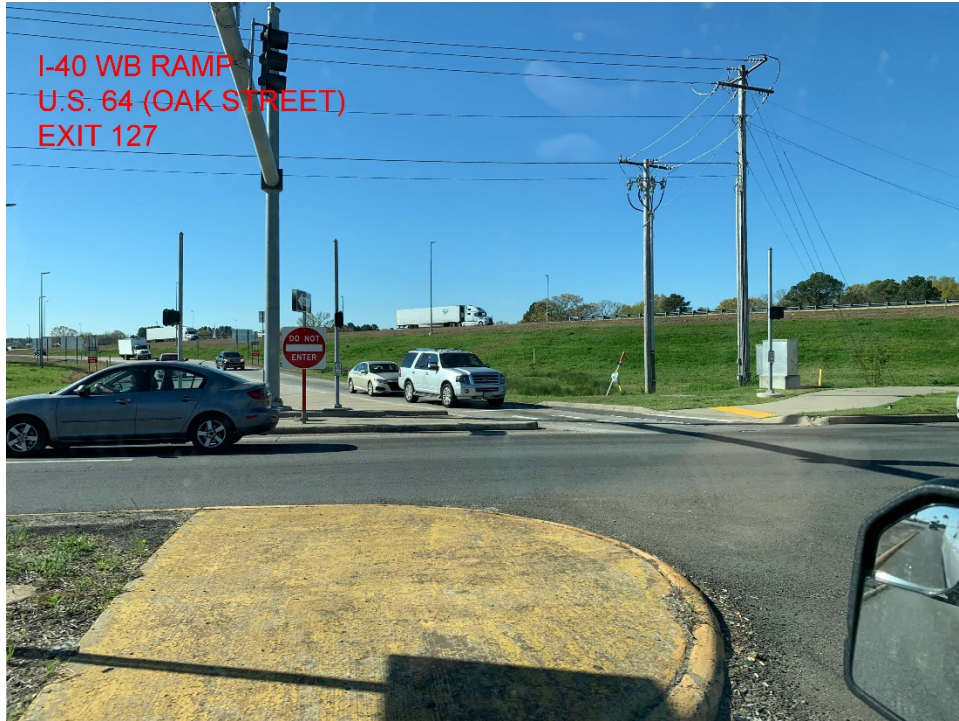
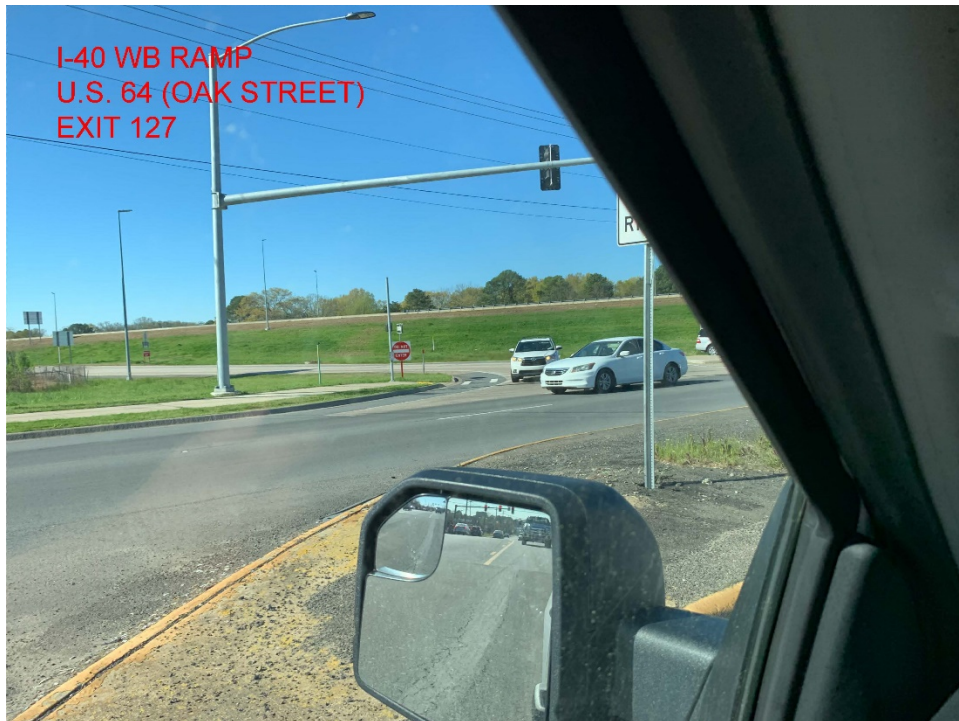
The interchange at Exit 127 was reviewed. Signs were in place and in conformance with MUTCD requirements. However, the 36"x36" Do Not Enter and 54"x18" One Way signs were missing and installed to be consistent with current ARDOT requirements on May 11, 2021.

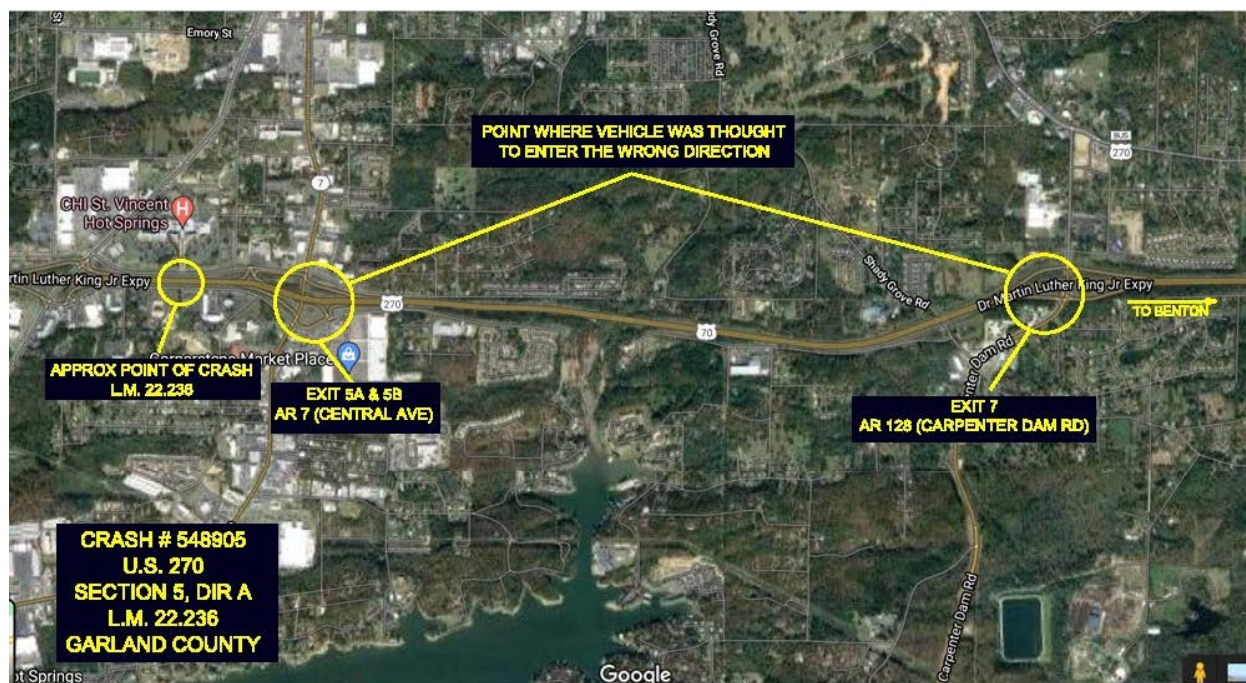
Crash # 2019548905 US 270, Section 5, Direction A, Log Mile 22.236

The driver accessed US 270 possibly at Exit 5A (AR 7 South, Central Ave.), Exit 5B (AR 7 North, Central Ave.) or Exit 7 (AR 128, Carpenter Dam Rd.) and travelled west in the eastbound traffic lane on US 270. The eastbound driver attempted to swerve to avoid colliding into the wrong way vehicle but was involved in a head on collision at log mile 22.236. The wrong way driver was pronounced deceased on scene.

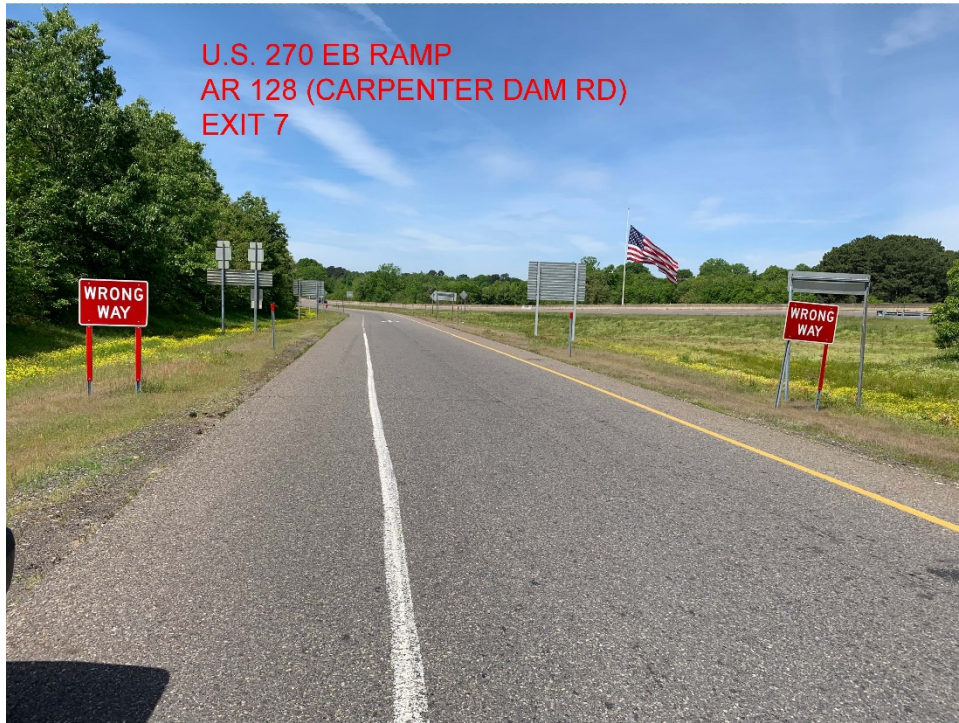
The interchange at Exit 7 was reviewed. Pavement markings and signs were in place and in conformance with MUTCD requirements. However, the 54"x18" One Way and 36"x36" Do Not Enter signs were missing and were installed to be consistent with current ARDOT requirements on May 12, 2021.

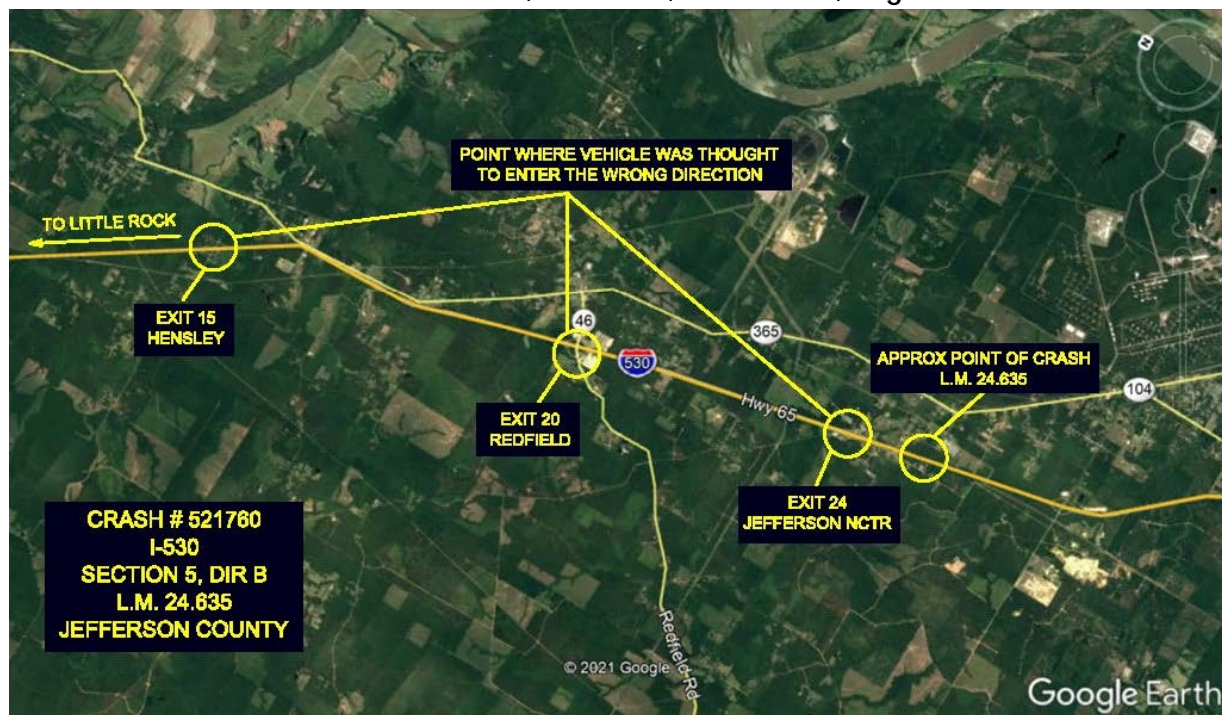
Crash # 2019521760 I-530, Section 5, Direction B, Log Mile 24.635

The driver accessed I-530 possibly at Exit 15 (Hensley), Exit 20 (Redfield) or Exit 24 (Jefferson N.C.T.R.) and travelled southbound in the northbound traffic lane on I-530. The driver angled the vehicle towards the outside lane shoulder and stopped in the outside traffic lane with their headlights away from traffic. The front bumper of the northbound driver collided with the front passenger side of the wrong way vehicle. Upon impact, the wrong way vehicle rotated counterclockwise and went off the roadway in a northeastern direction and came to final rest facing northeast in the tree line. The wrong-way driver was suspected of being under the influence of alcohol.

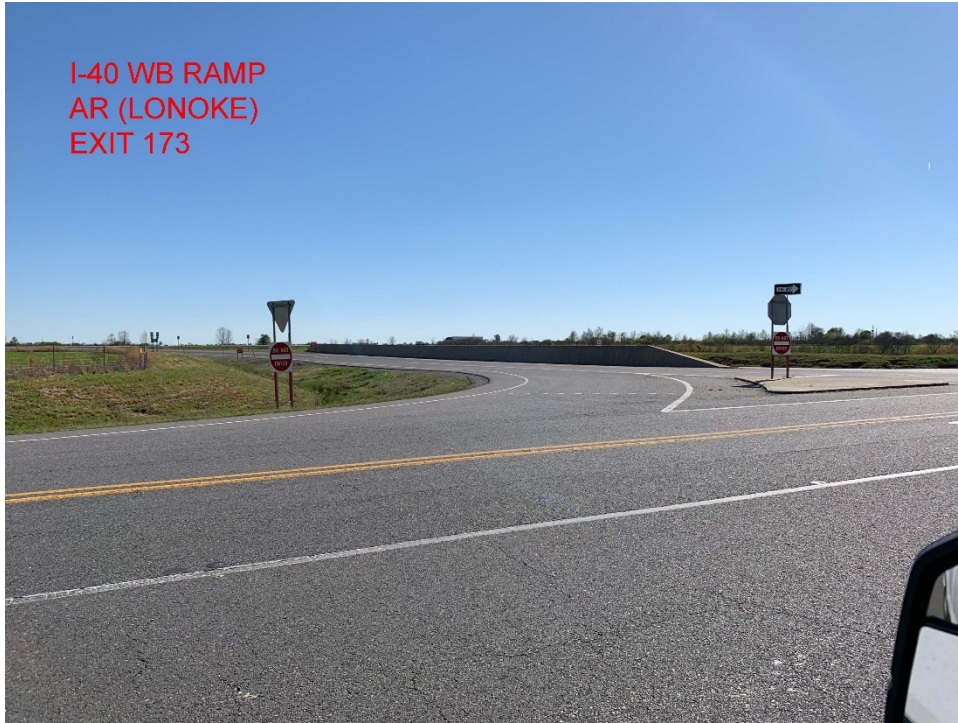
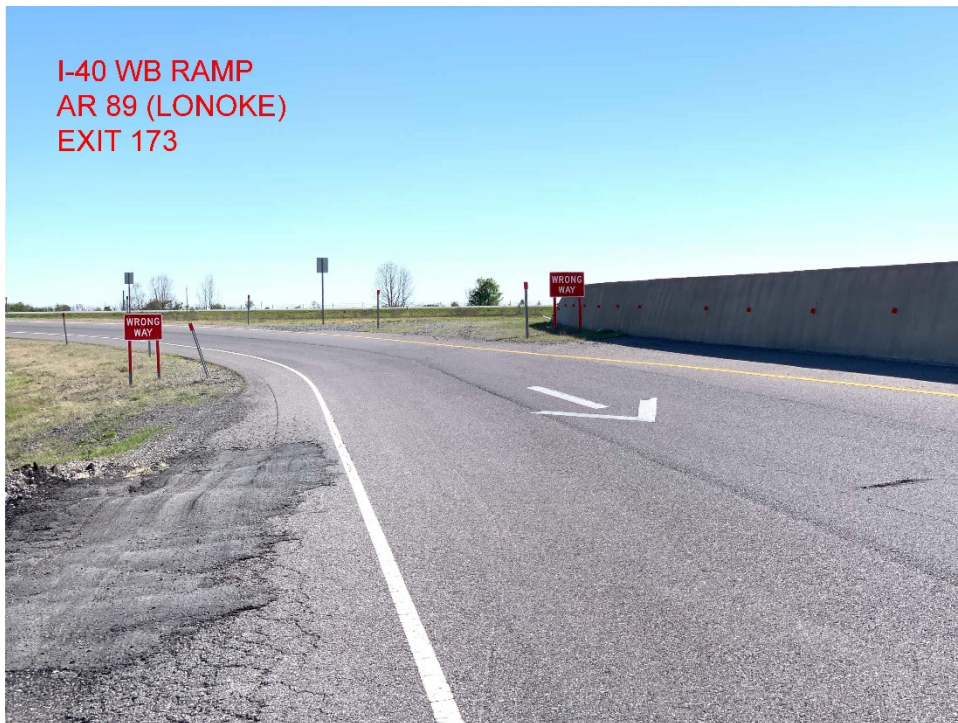
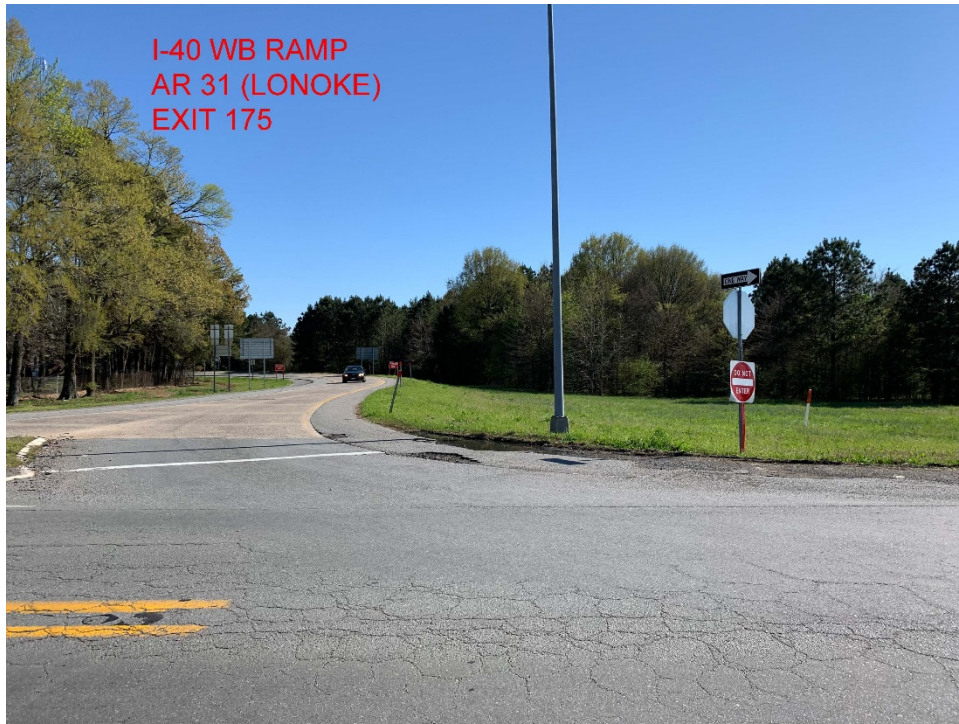
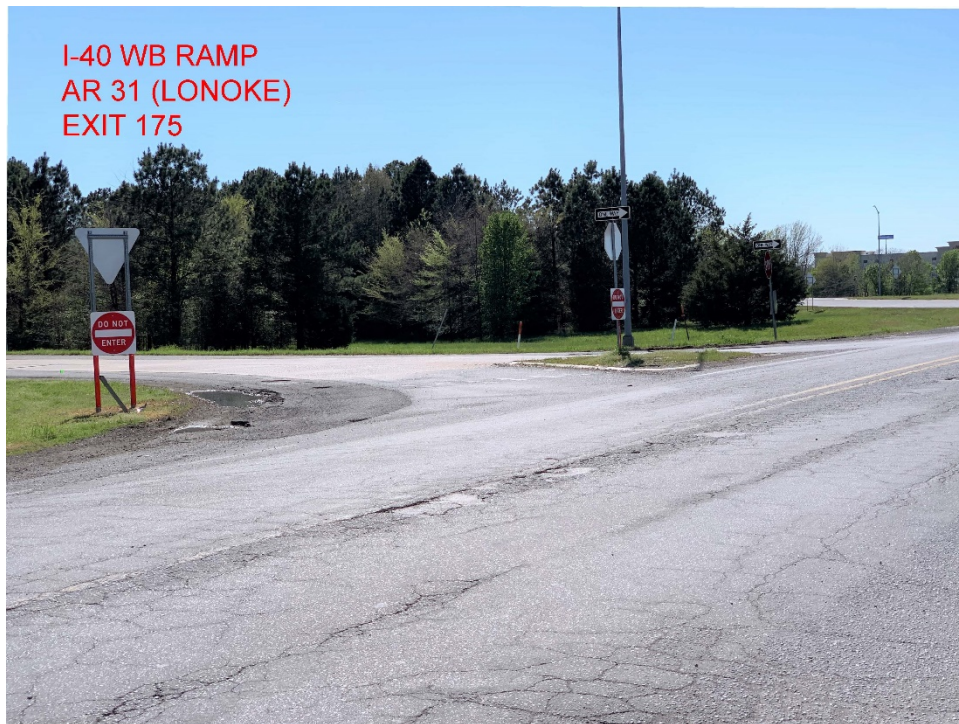
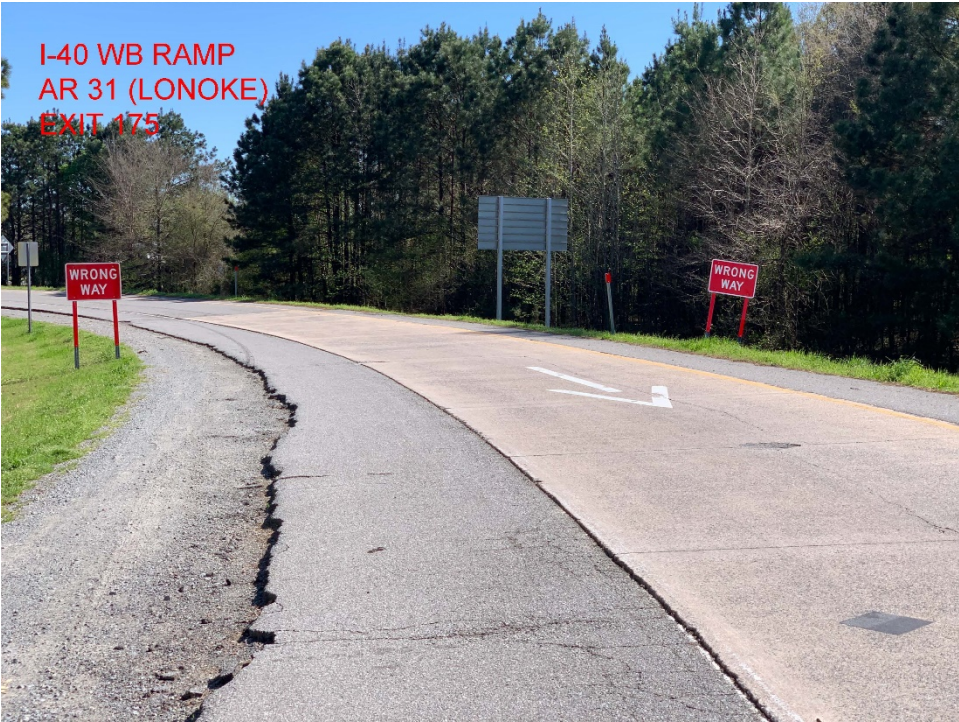
The interchange at Exit 169 was reviewed. Pavement markings and signs were in place and in conformance with MUTCD requirements. However, the 42"x 30" Wrong Way, 30"x30" Do Not Enter and 36"x12" One Way signs were missing and installed to be consistent with current ARDOT requirements on May 10, 2021.

The interchange at Exit 173 was reviewed. Pavement markings and signs were in place and in conformance with MUTCD requirements. However, the 24"x 30" Keep Right sign was missing and will be installed to be consistent with current ARDOT requirements. These modifications will be implemented by statewide forces as soon as their schedule permits.

The interchange at Exit 175 was reviewed. Pavement markings and signs were in place and in conformance with MUTCD and ARDOT requirements.
