WRONG-WAY CRASH STUDY

INTERSTATES AND FREEWAYS | CALENDAR YEAR 2019

Published August 2021

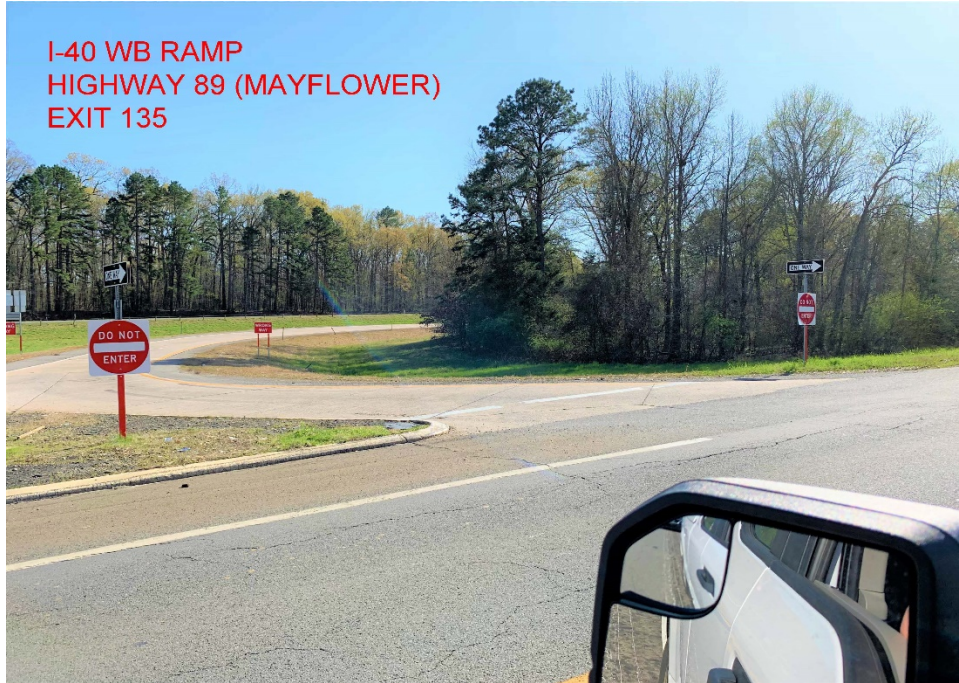
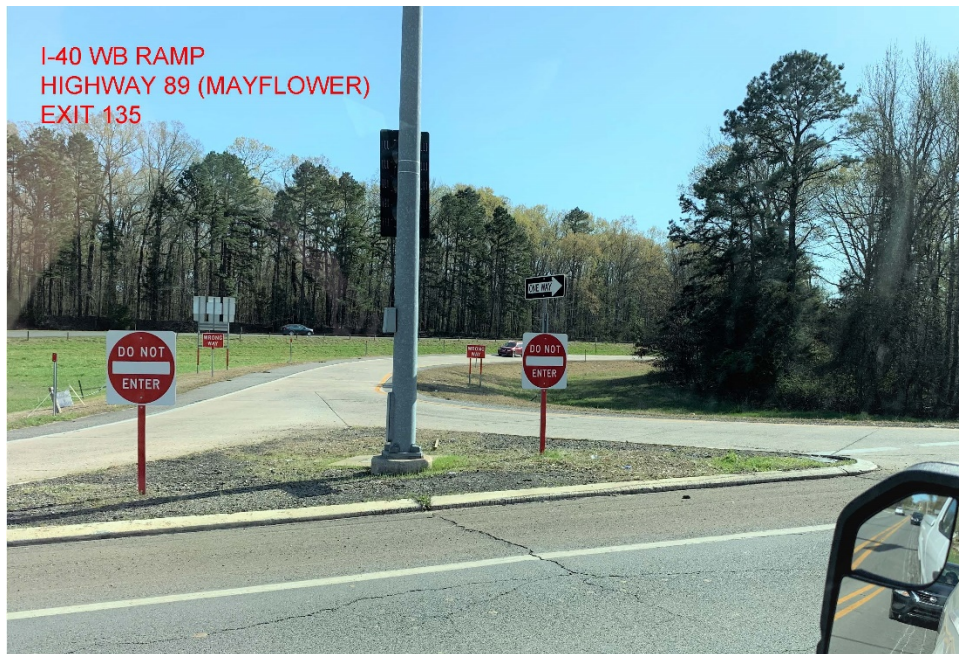
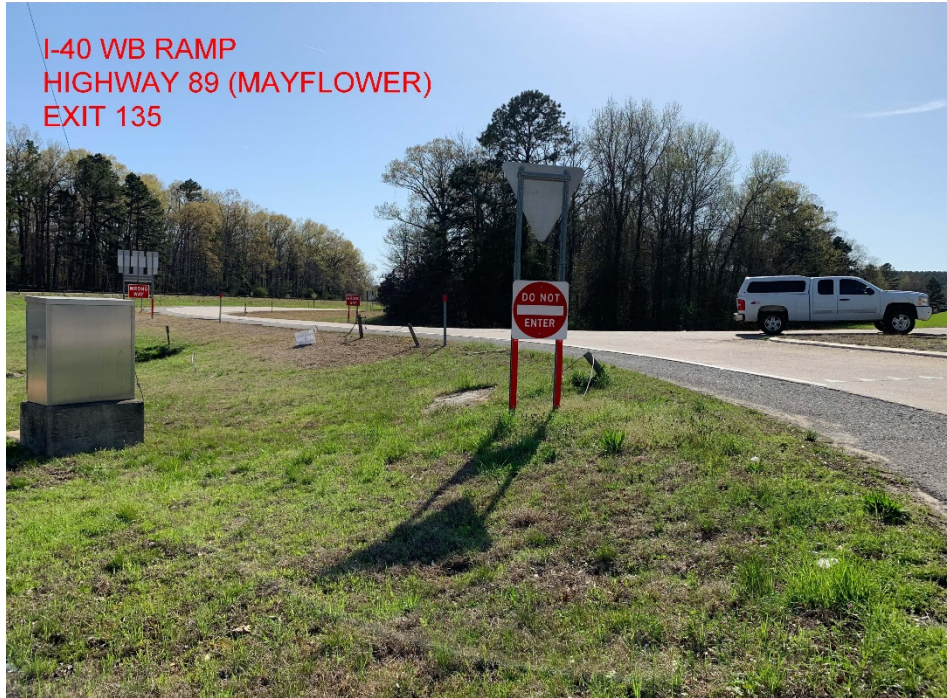
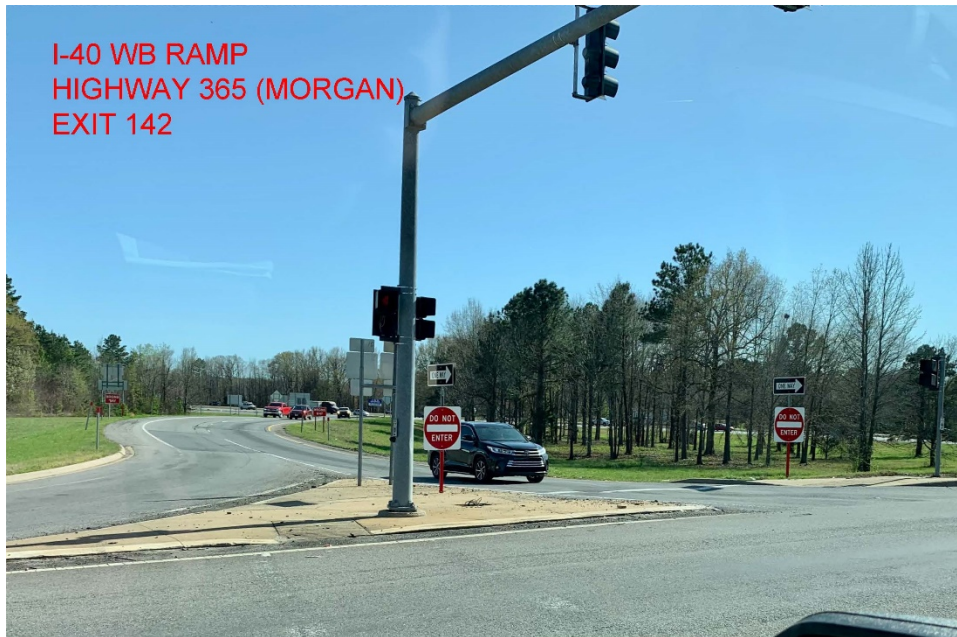
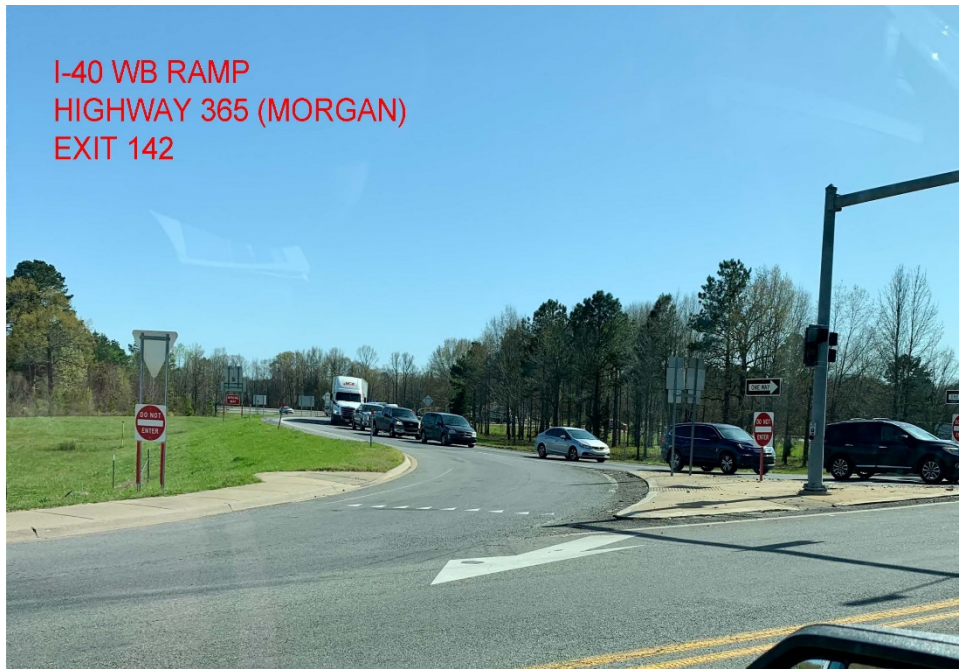
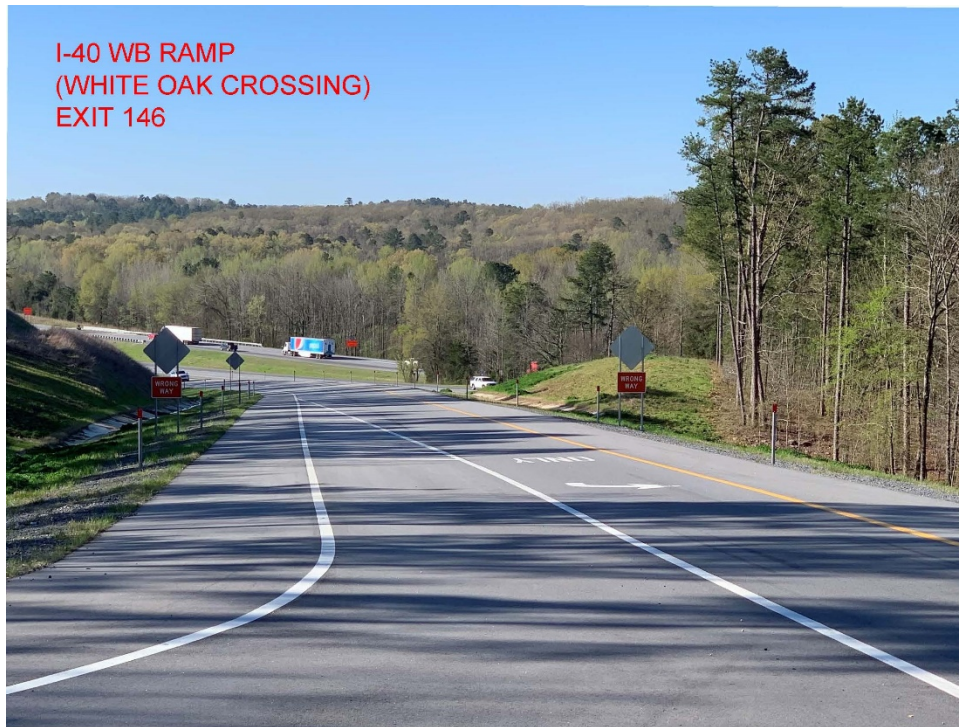
I-40 WB RAMP
(WHITE OAK CROSSING)
EXIT 146

The interchange at Exit 135 was reviewed. Pavement markings and signs were in place and in conformance with MUTCD requirements. However, the pavement arrow has faded and should be replaced to be consistent with current ARDOT requirements. These modifications will be implemented by district forces as soon as their schedule permits.

The interchange at Exit 142 was reviewed. Pavement markings and signs were in place and in conformance with MUTCD and ARDOT requirements.

The interchange at Exit 146 was reviewed. Pavement markings and signs were in place and in conformance with MUTCD requirements. However, the red vertical reflective strips need to be installed on all the "Wrong Way" and "Do Not Enter" signposts to be consistent with current ARDOT requirements. These modifications were completed on May 17, 2021.

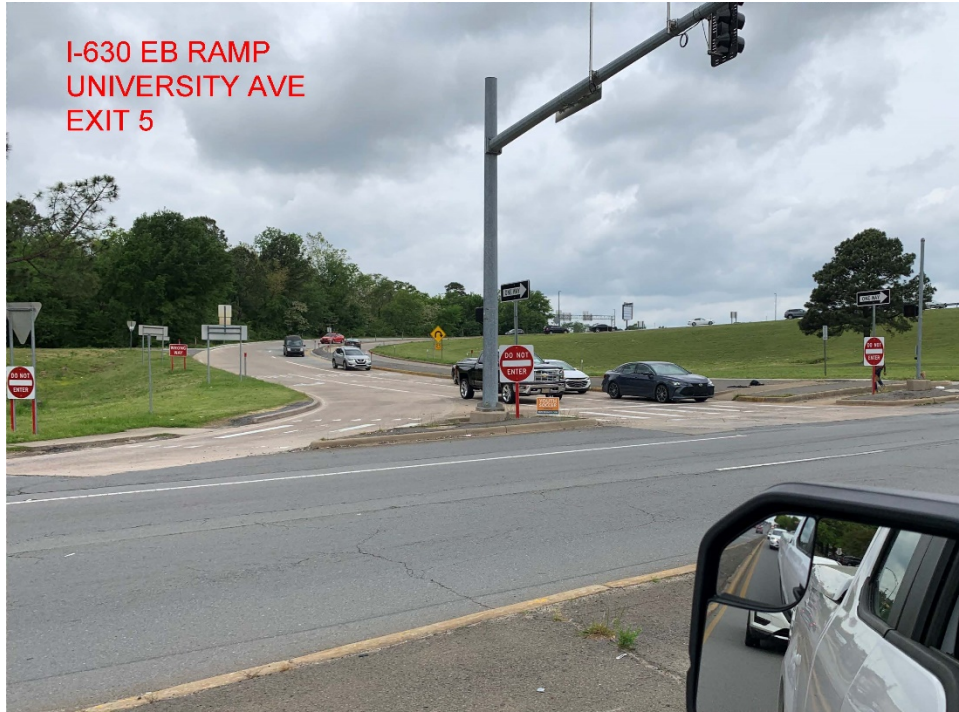
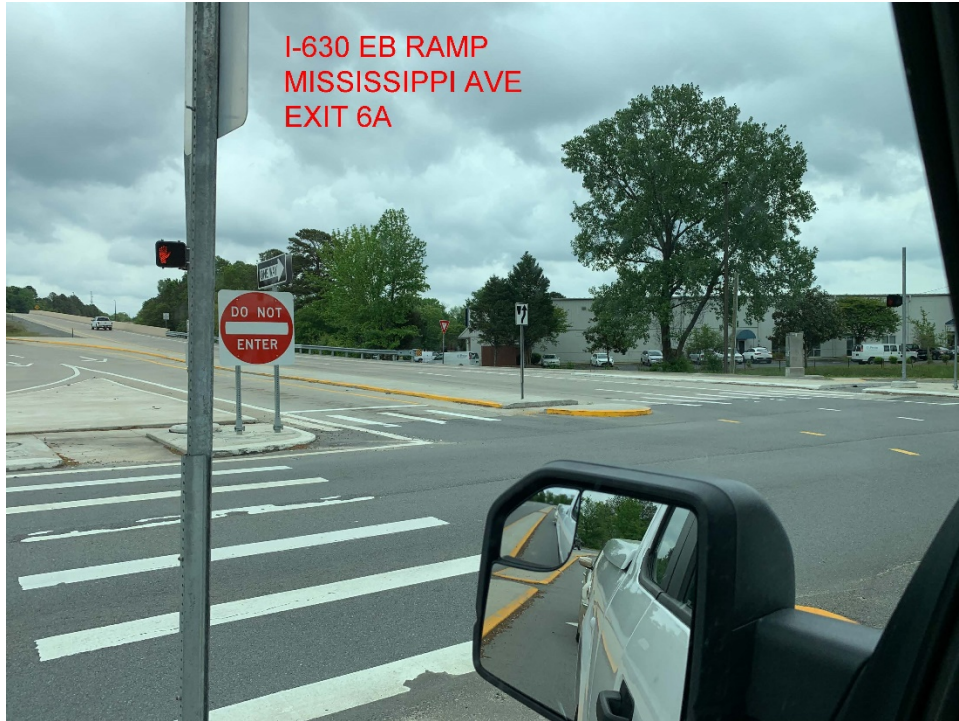
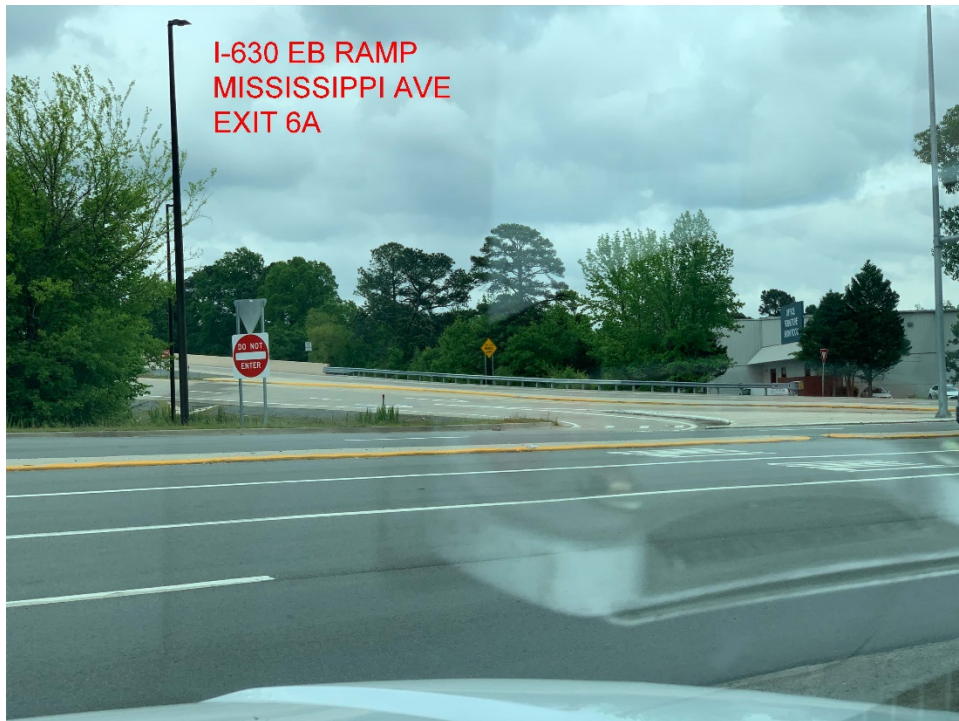
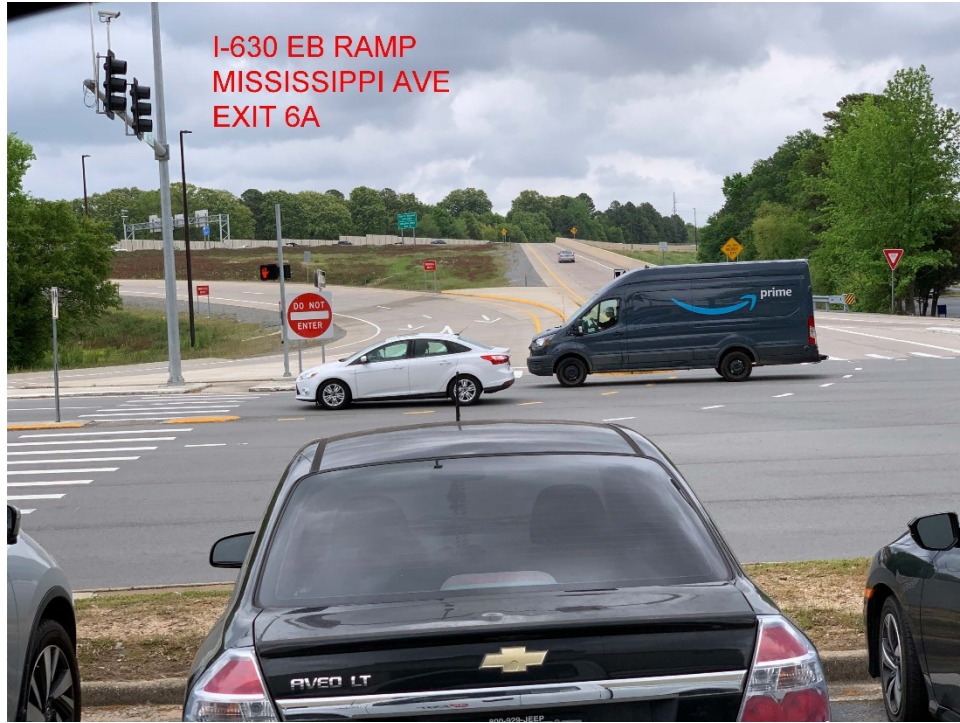
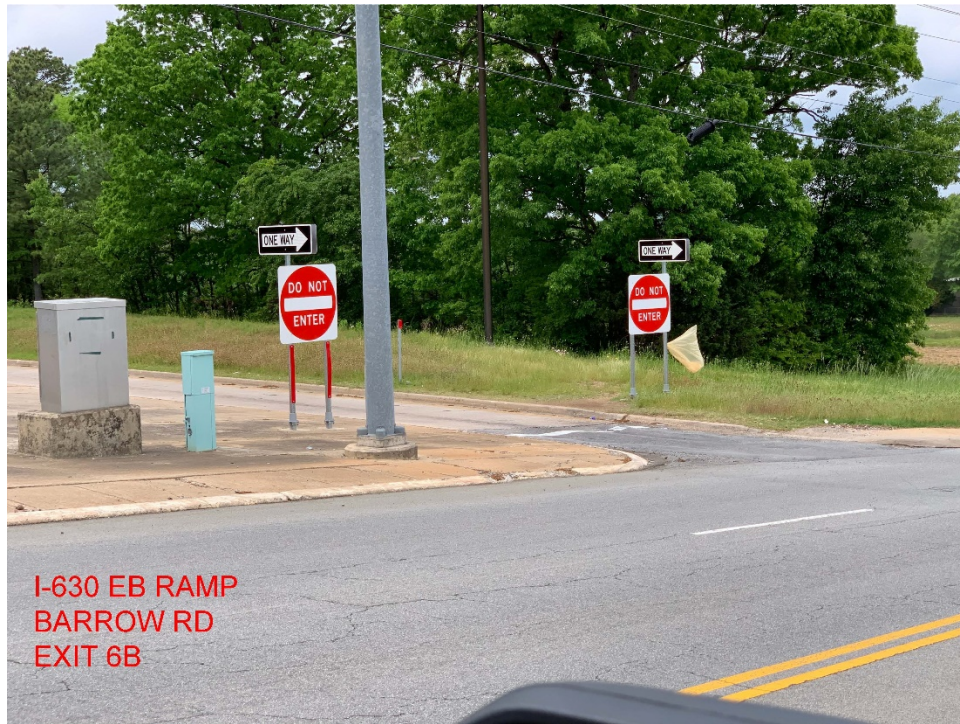
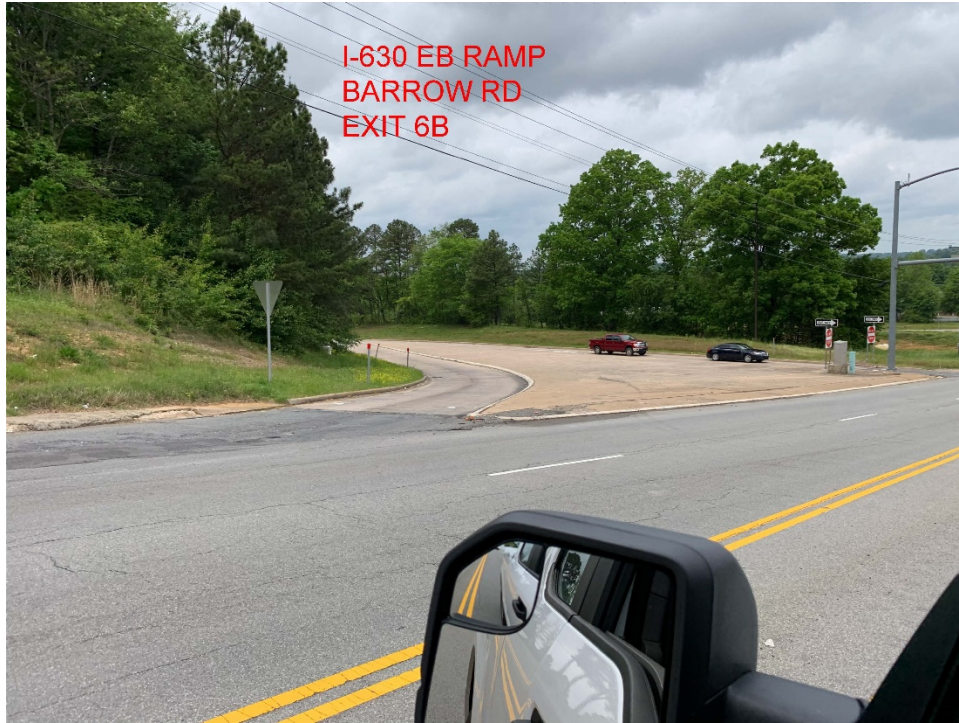
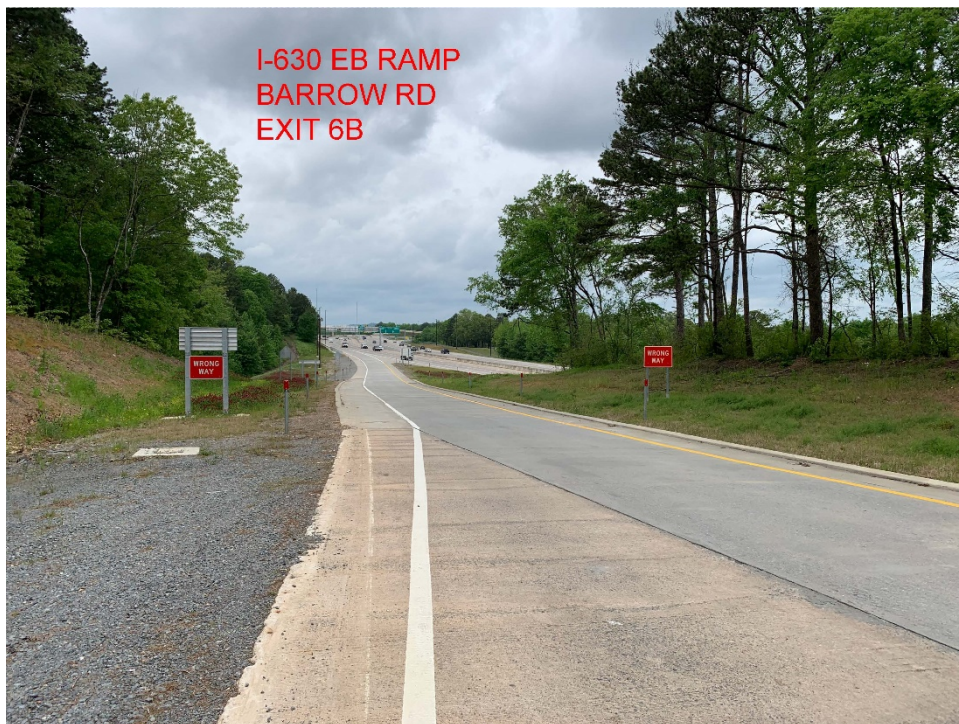
The interchange at Exit 6A was reviewed. Pavement markings and signs were in place and in conformance with MUTCD requirements. However, the red vertical reflective strips on all the "Wrong Way" and "Do Not Enter" signposts were installed to be consistent with current ARDOT requirements on May 17, 2021.

The interchange at Exit 6B was reviewed. Pavement markings and signs were in place and in conformance with MUTCD requirements. However, the 36"x36" Do Not Enter sign and the red vertical reflective strips on all the "Wrong Way" and "Do Not Enter" signposts were installed to be consistent with current ARDOT requirements on May 17, 2021.

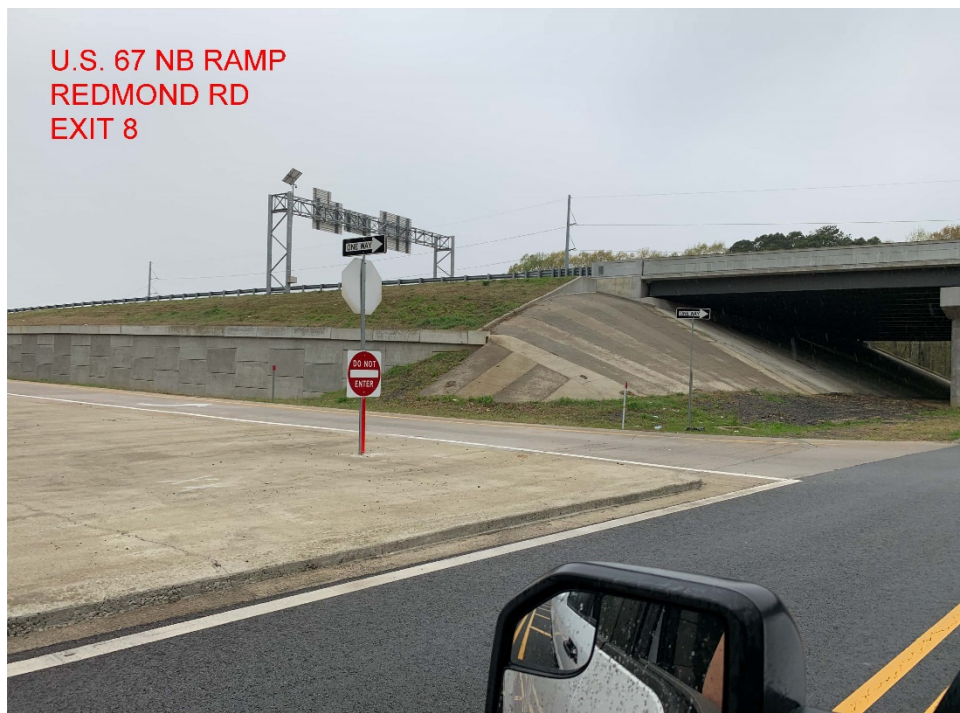
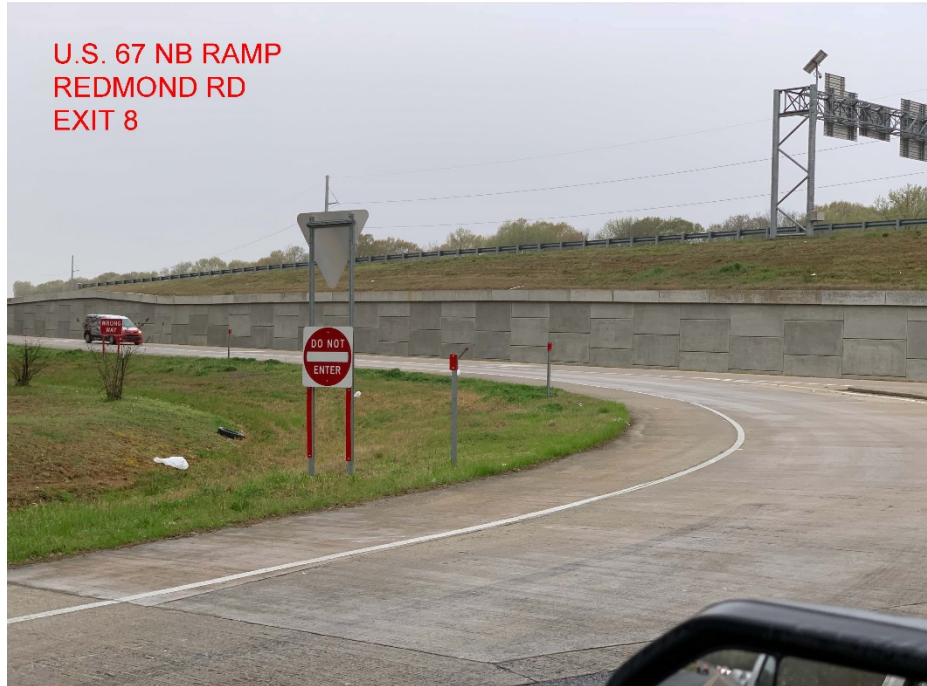
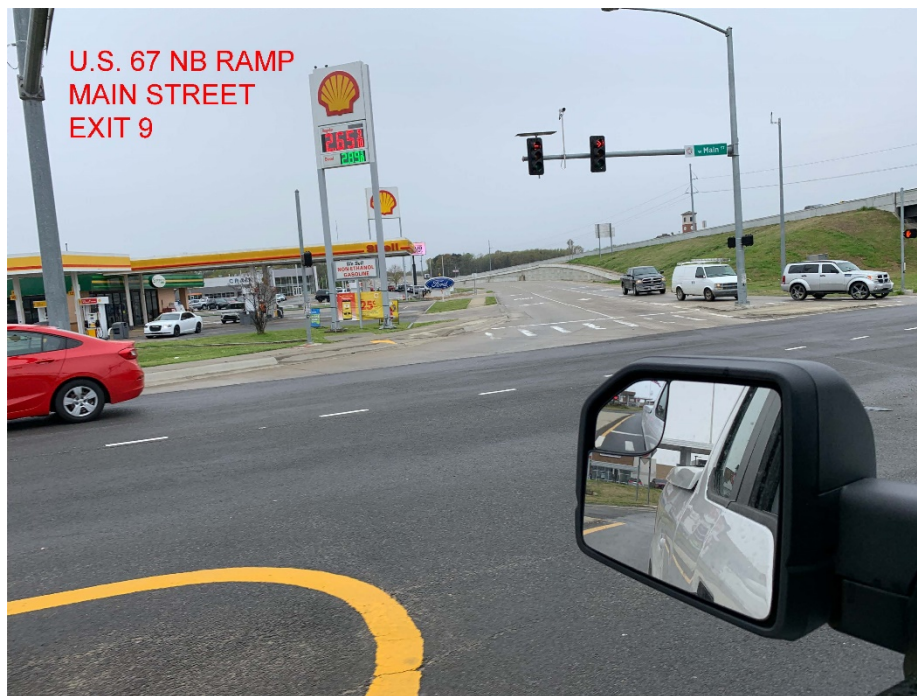
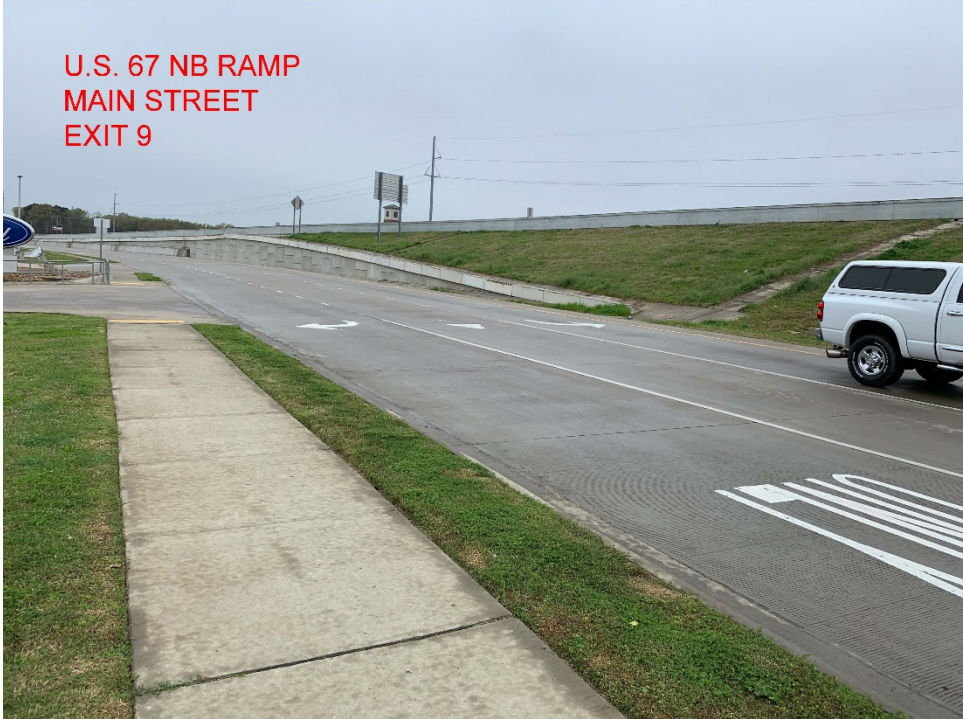
The interchange at Exit 12 was reviewed. Signs were in place and in conformance with MUTCD requirements. However, the 42"x30" Wrong Way sign was missing and installed to be consistent with current ARDOT requirements on May 17, 2021.

The interchange at Exit 8 was reviewed. Signs were in place and in conformance with MUTCD requirements. However, the 42"x 30" Wrong Way sign was missing and installed to be consistent with current ARDOT requirements on May 17, 2021. Pavement markings should be installed to meet current ARDOT requirements. These modifications will be implemented by district and statewide forces as soon as their schedule permits.

The interchange at Exit 9 was reviewed. All signs required to bring this ramp in conformance with MUTCD and ARDOT requirements were completed on May 18, 2021.

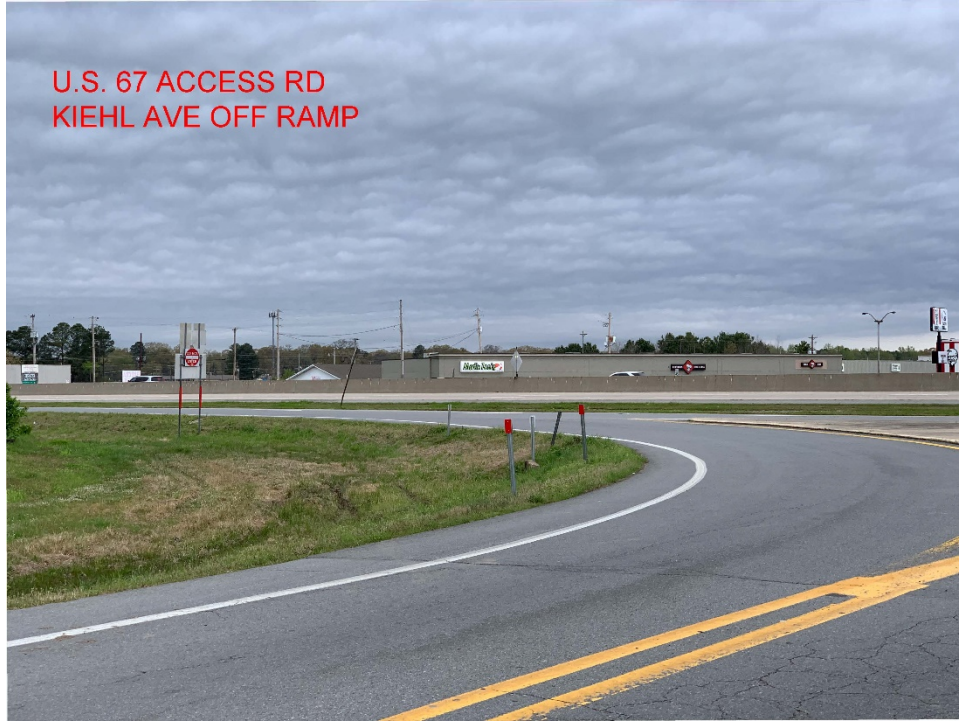
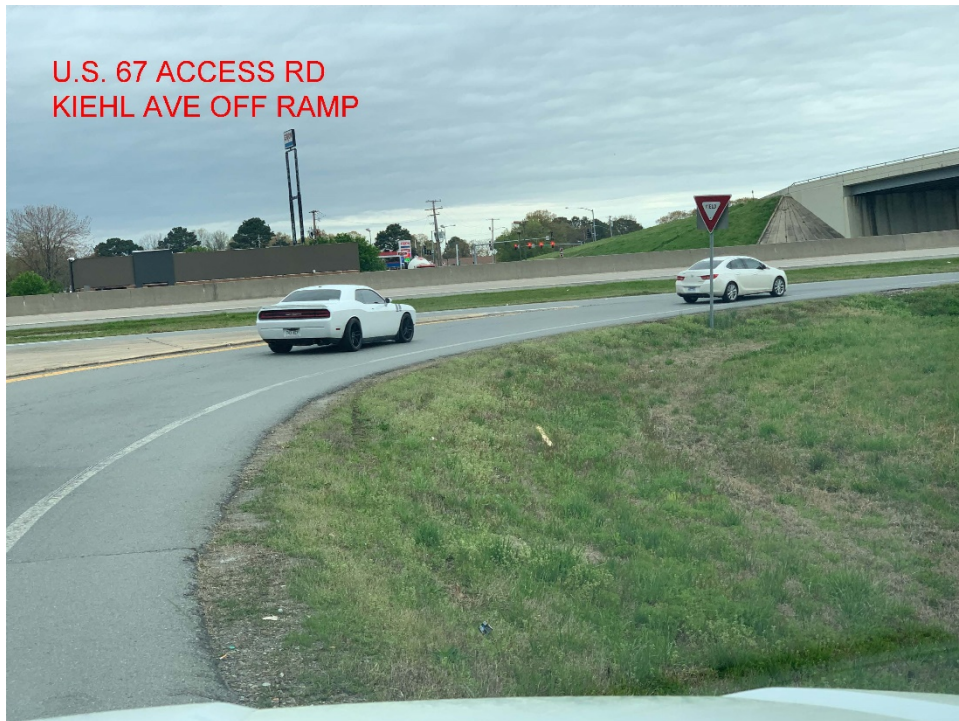
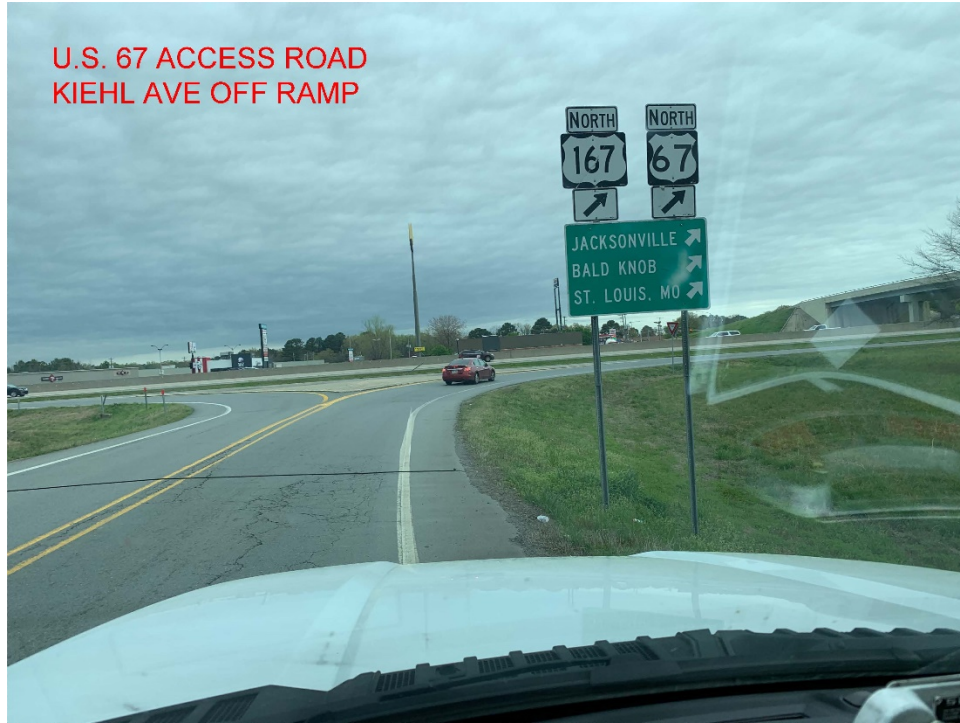
The interchange was reviewed. Signs were in place and in conformance with MUTCD requirements. However, additional signage of 24"x30" Keep Right, 24"x30" One Way and 36"x36" Do Not Enter sign was installed to be consistent with current ARDOT requirements on May 18, 2021.

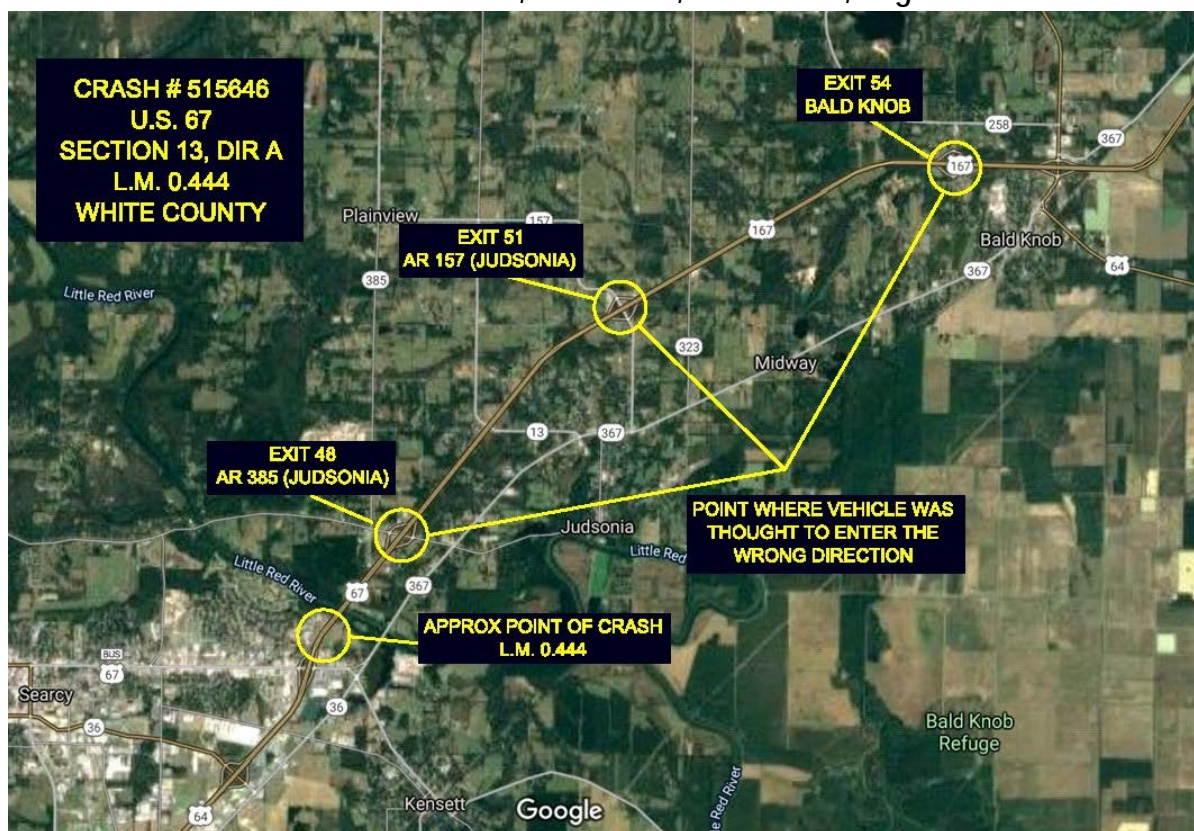
Crash # 2019515646 US 67, Section 13, Direction A, Log Mile 0.444

The driver accessed US 67 possibly at Exit 48 (AR 385, Judsonia), Exit 51 (AR 157, Judsonia) or Exit 54 (Bald Knob) and travelled southbound in the northbound traffic lane on US 67. The driver ran off the roadway to the left and struck a ditch. The vehicle came to final rest in the ditch facing southwest. The driver was under the influence of alcohol.
