WRONG-WAY CRASH STUDY

INTERSTATES AND FREEWAYS | CALENDAR YEAR 2018

June 2020

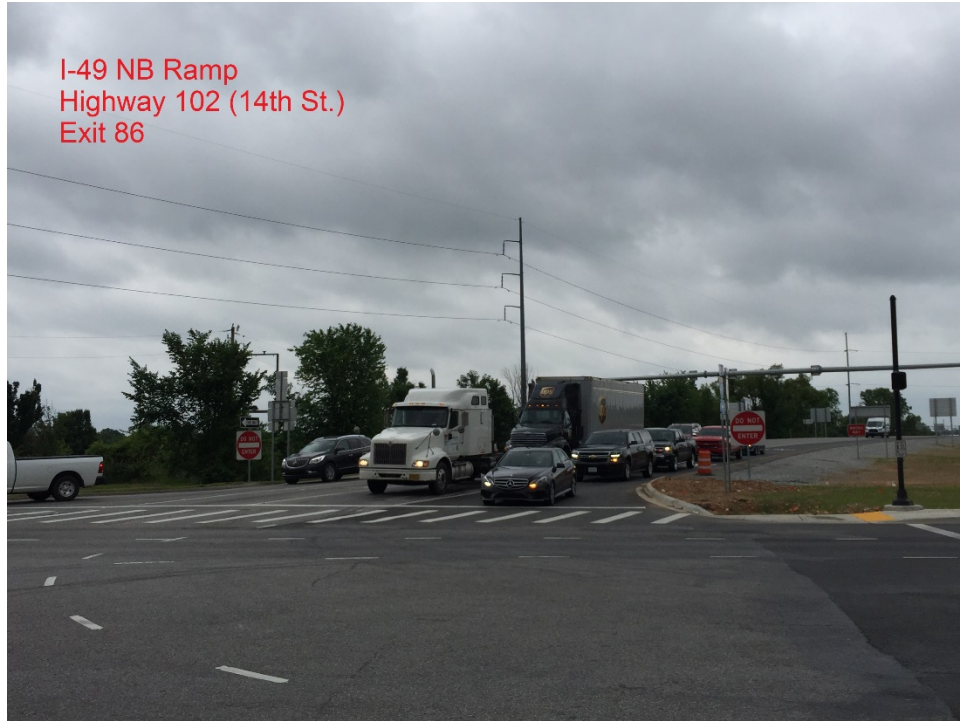
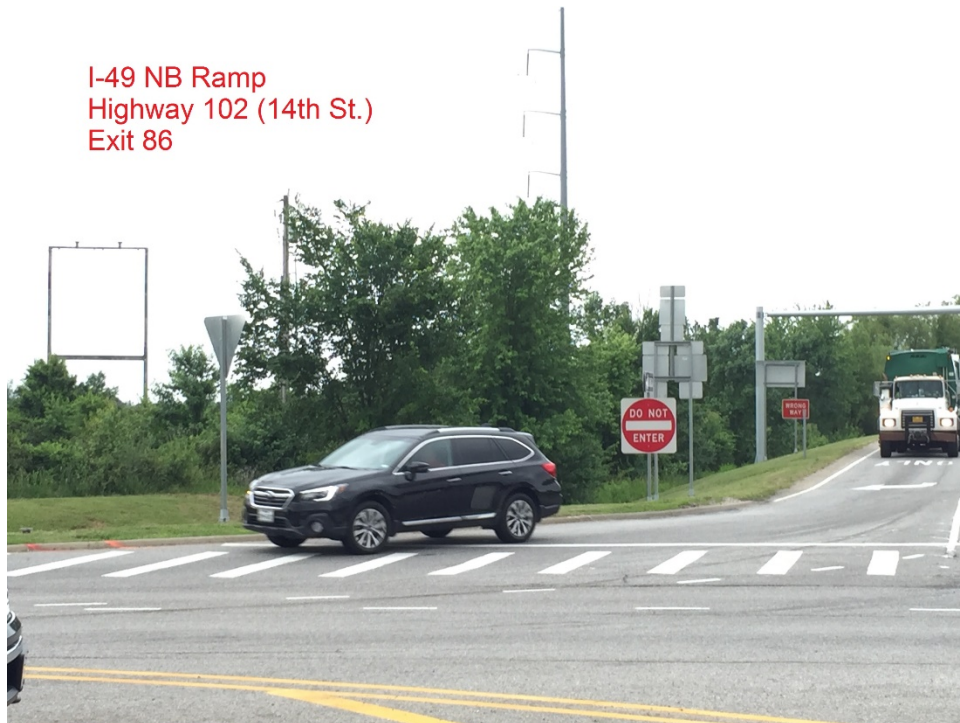
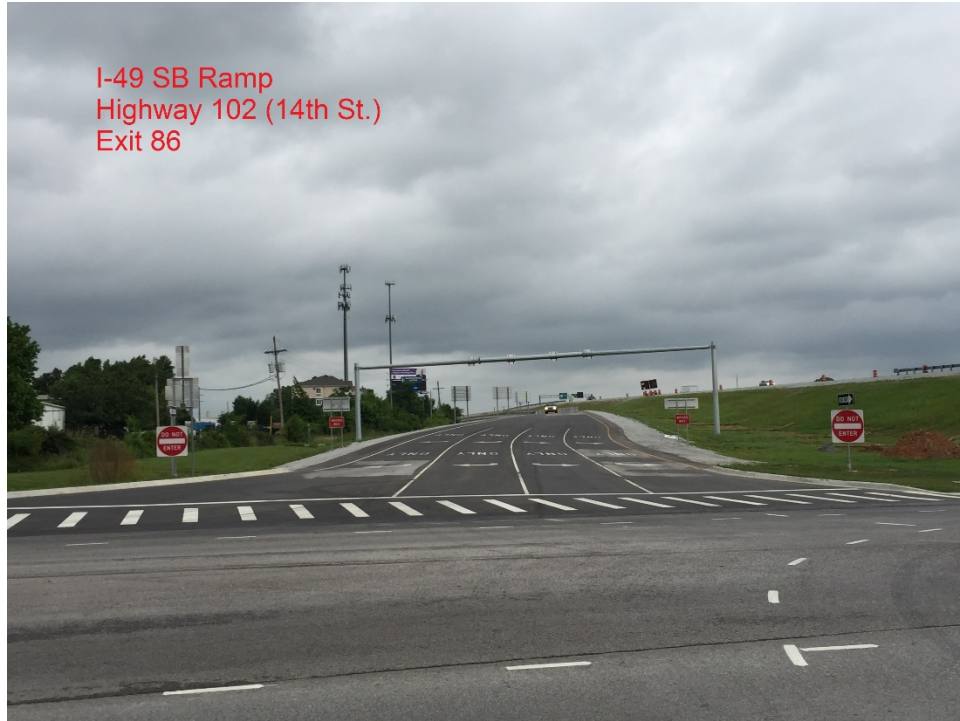
Crash# 2018566310 I-49, Section 29, Log Mile 86.255

The driver accessed I-49 at Exit 86 (Highway 102) (SE 14th St.) and travelled northbound in the southbound traffic lane on Interstate 49. The wrong-way driver was in a head on collision with another vehicle traveling south on I-49. The wrong-way driver was later interviewed and told the officer that she was on her way to the area of Southeast 14th Street for a physical rehabilitation appointment but she did not remember the crash or driving on the interstate. The interchange was under construction at the time of the wrong-way crash.

The interchange at Exit 86 was reviewed. Pavement markings and signs were in place and in conformance with MUTCD and ARDOT standards.

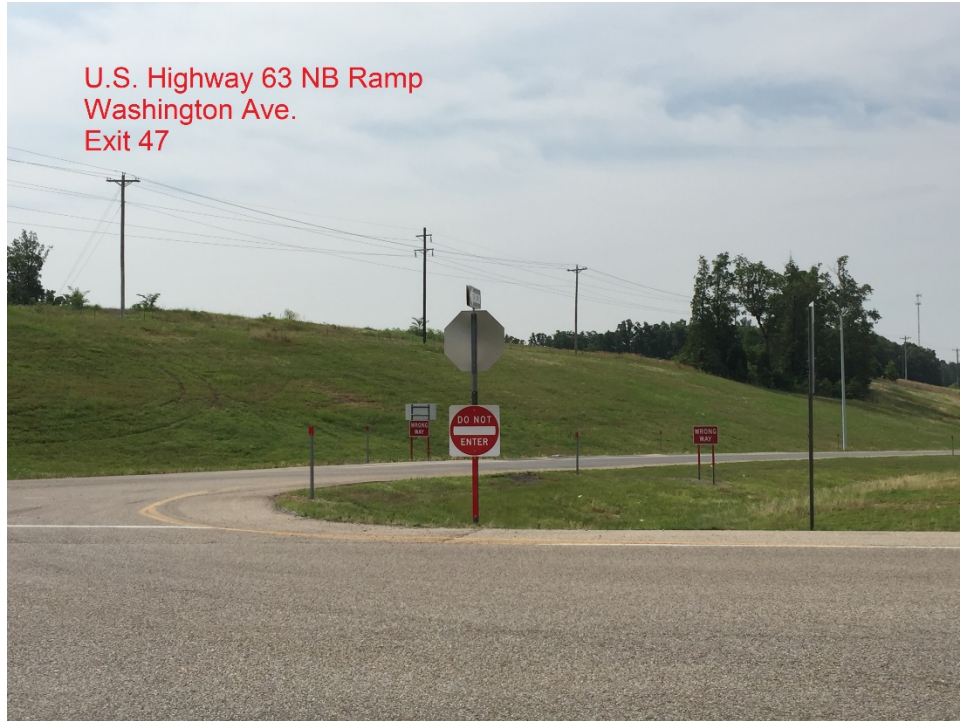
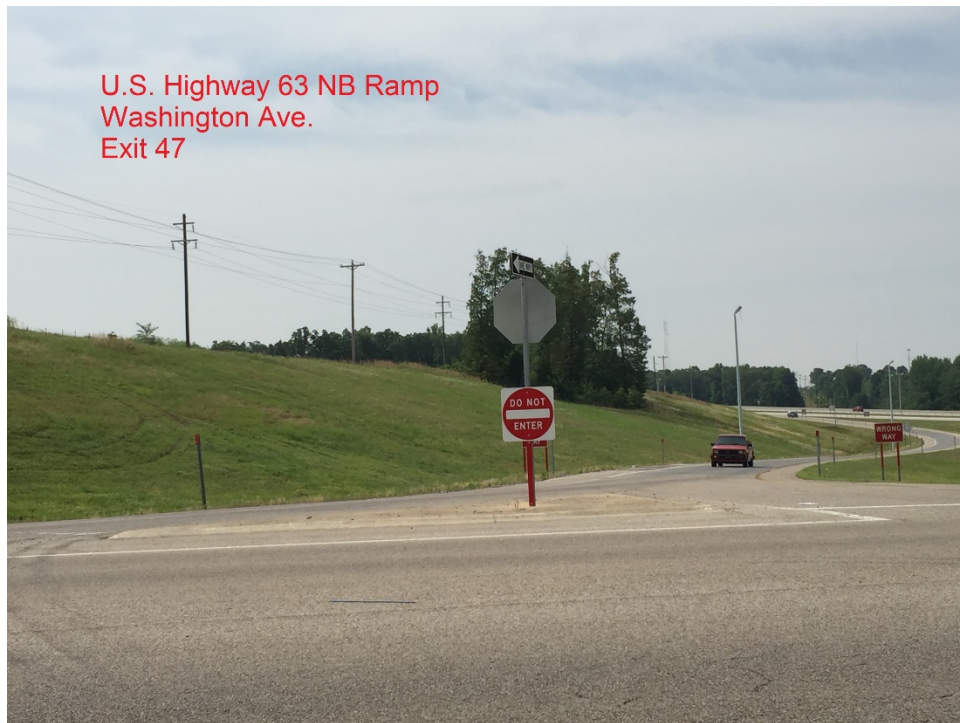
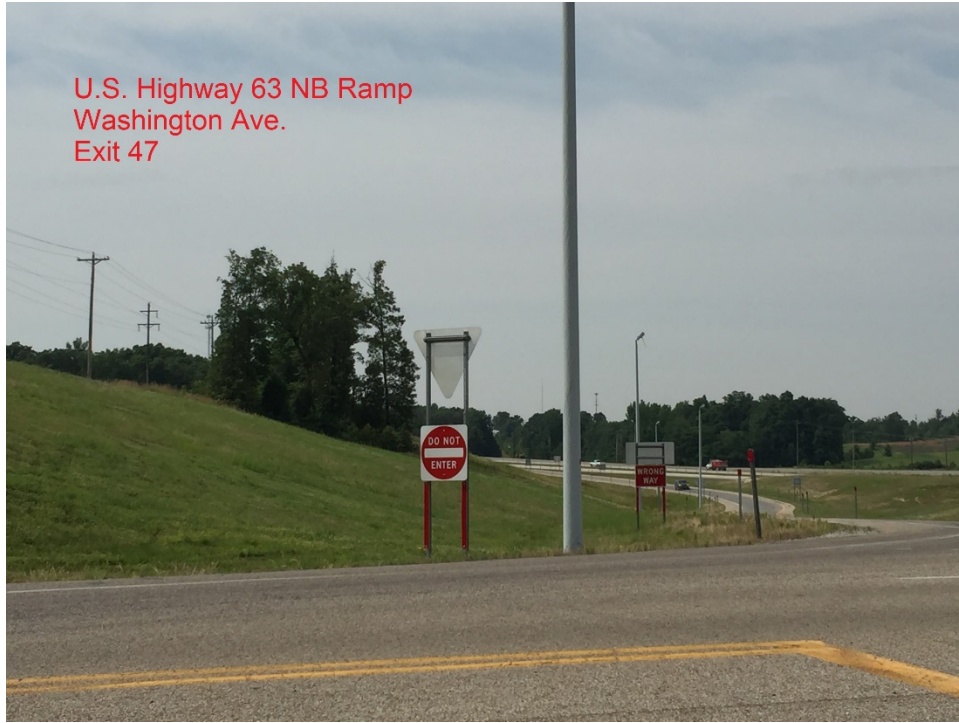
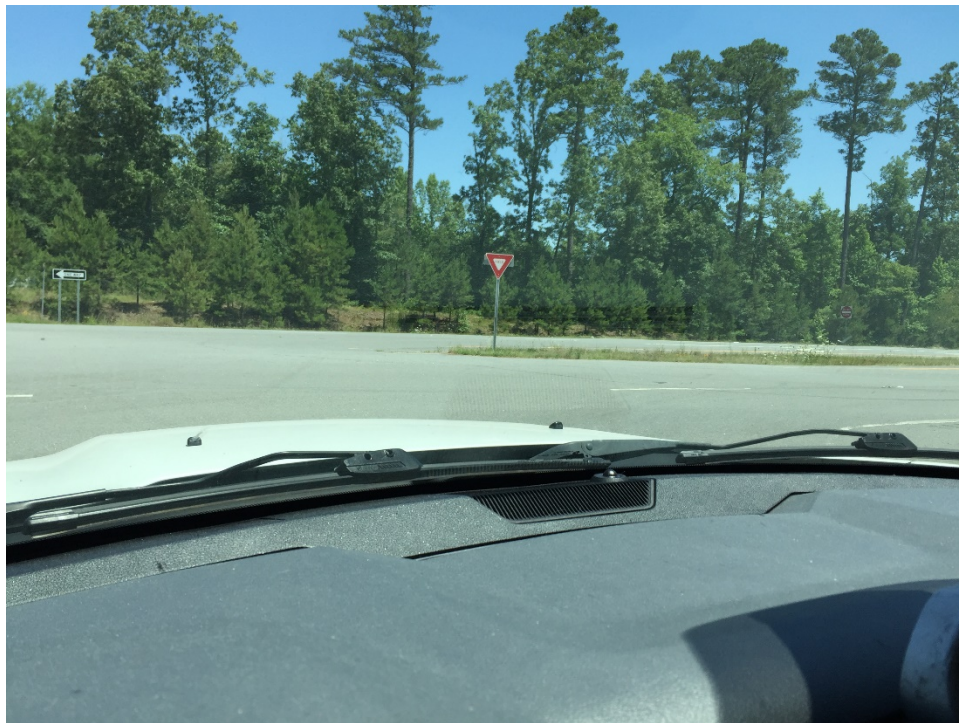
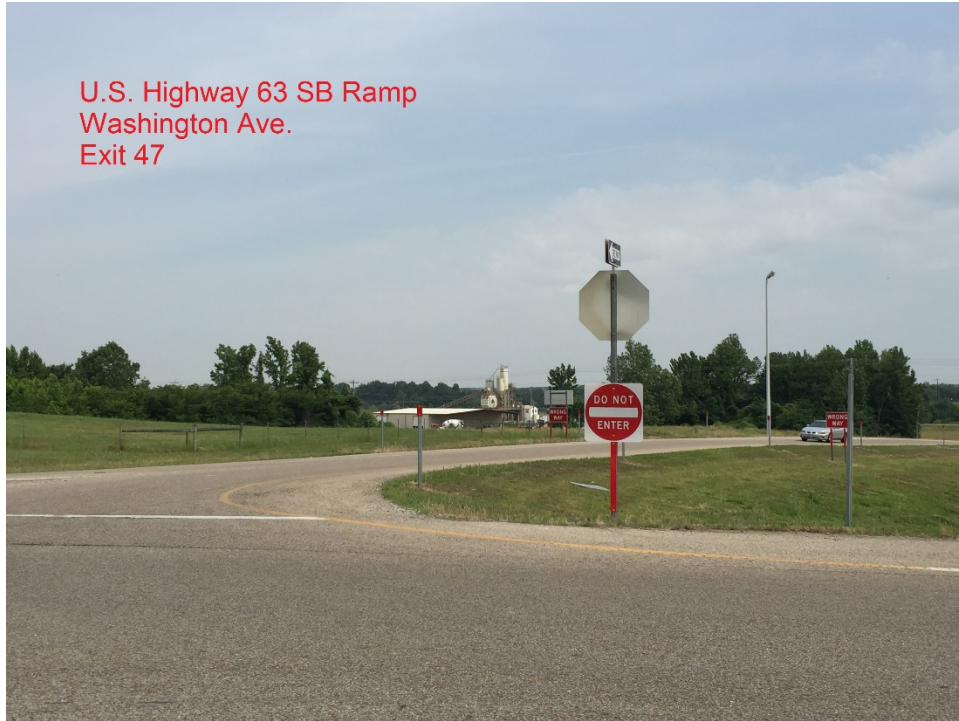
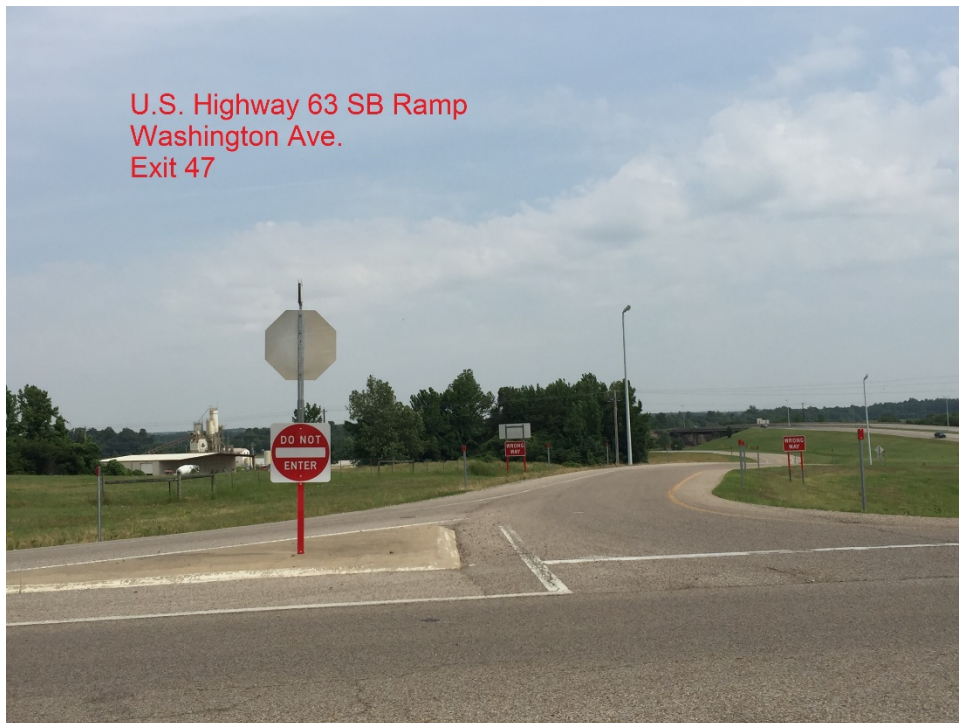
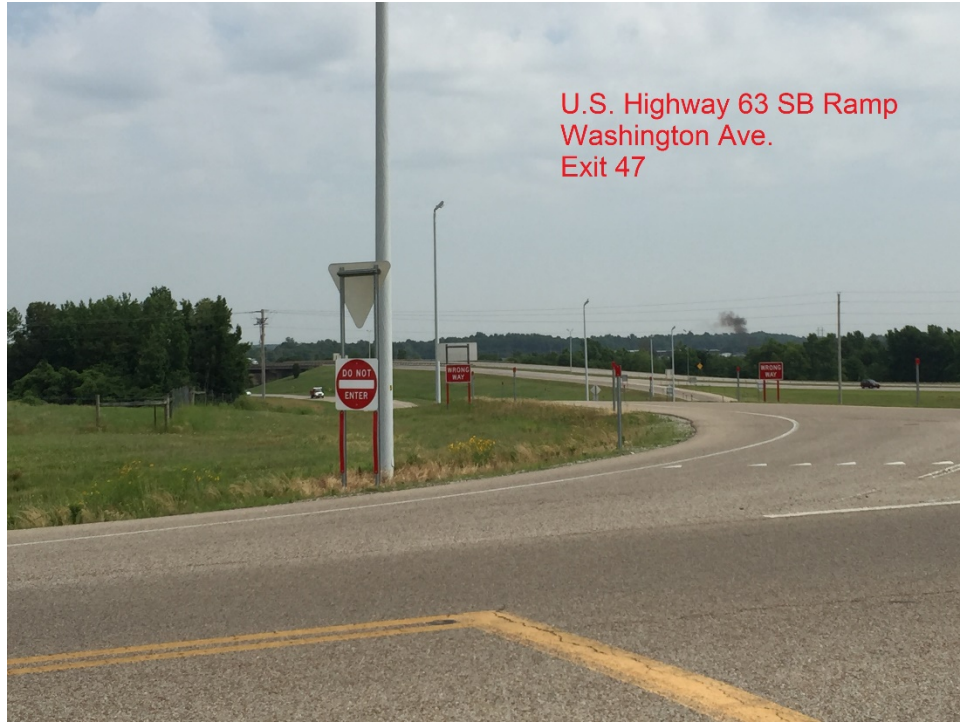
Crash # 2018002440 U.S. Highway 63, Section 6, Log Mile 11.102

The driver accessed U.S. Highway 63 at Exit 47 and was traveling north on the southbound ramp when the driver side swiped another vehicle on the off ramp. A field sobriety test was performed on the wrong-way driver and was found not to be impaired. Later a third party advised the officer that the wrong-way driver has recently been diagnosed with dementia.

The interchange at Exit 47 was reviewed. Pavement markings and signs were in place and in conformance with MUTCD and ARDOT standards.

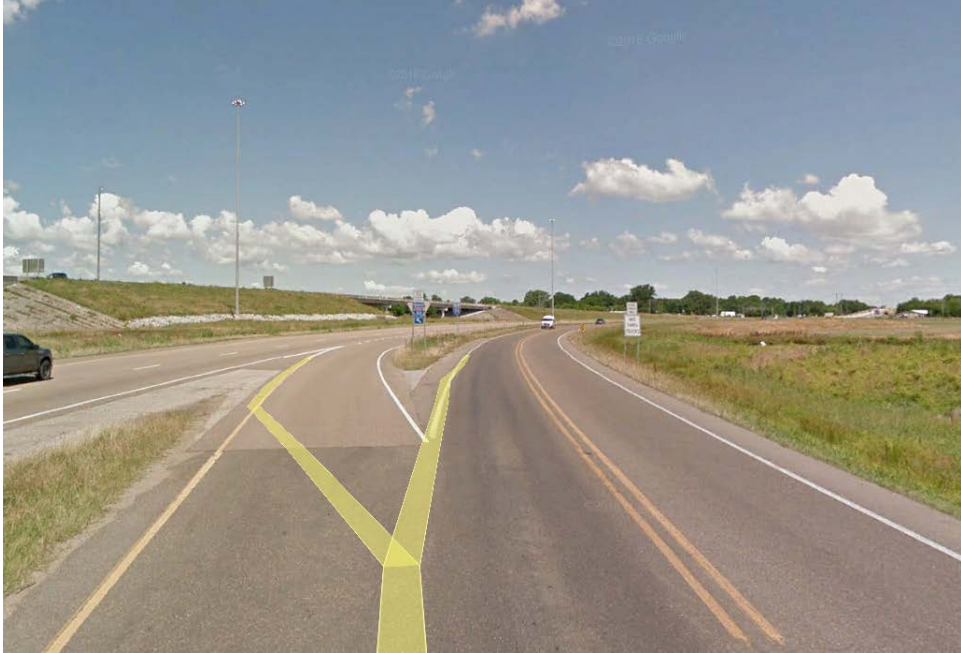
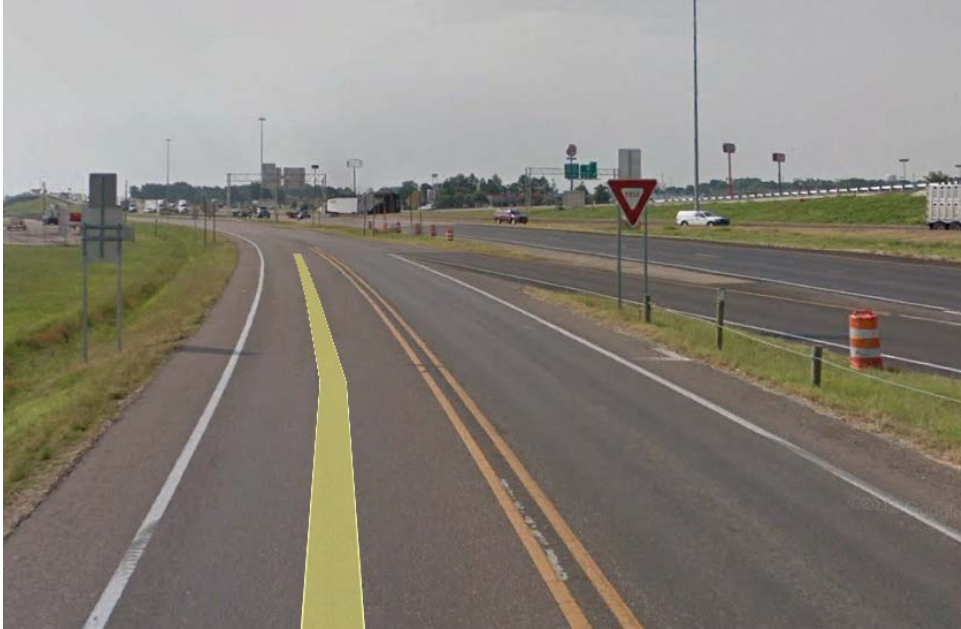
Crash# 2018510117 I-40, Section 52, Log Mile 277.357

The driver entered the one-way ramp of the two-way service road from Interstate 40. As the driver entered the ramp of the two-way service road the driver struck another vehicle who was trying to enter I-55.

The two-way service road ramp was reviewed. Pavement markings and signs were in place and in conformance with MUTCD and ARDOT standards.

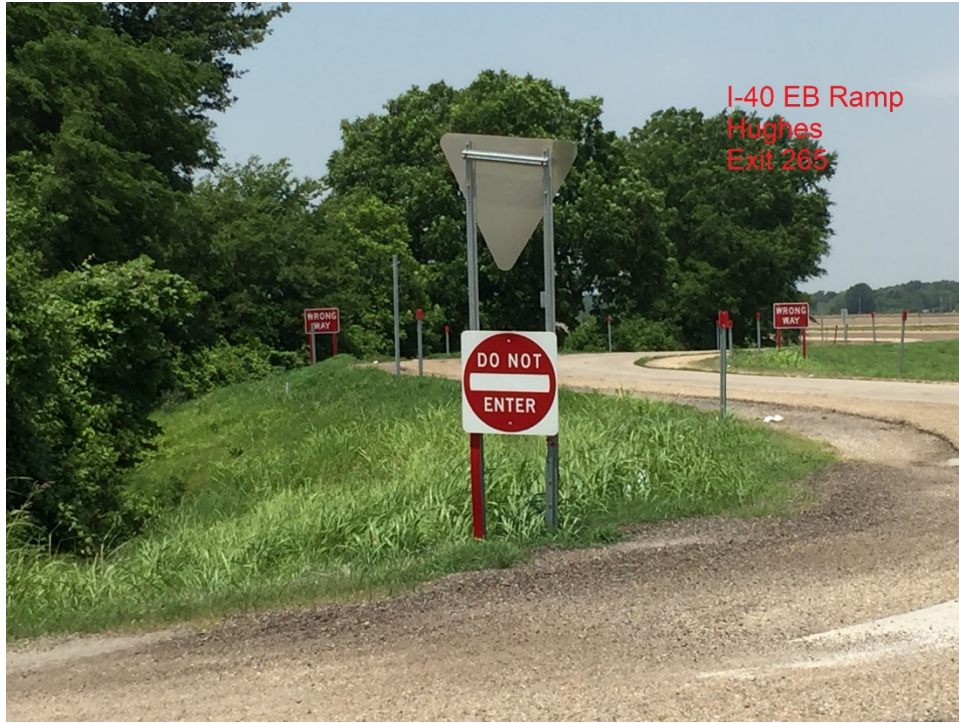
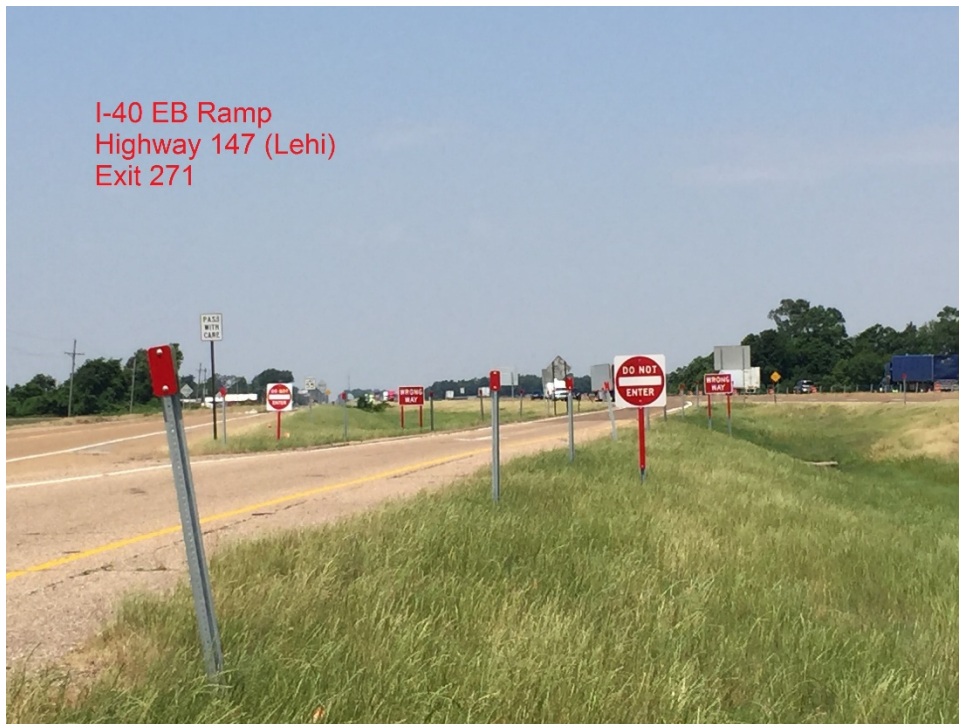
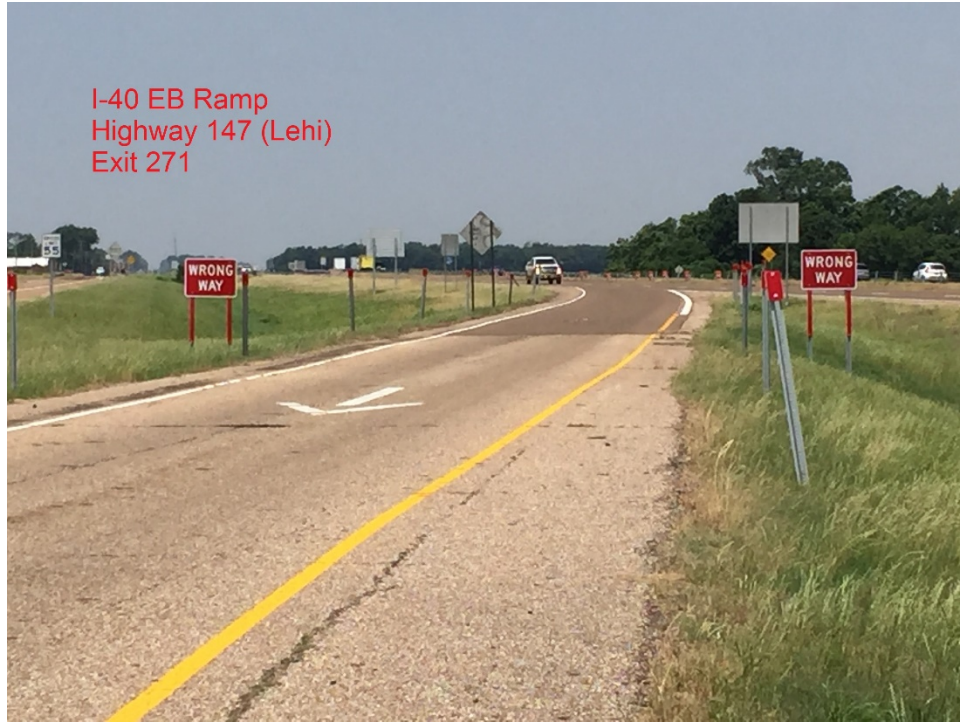
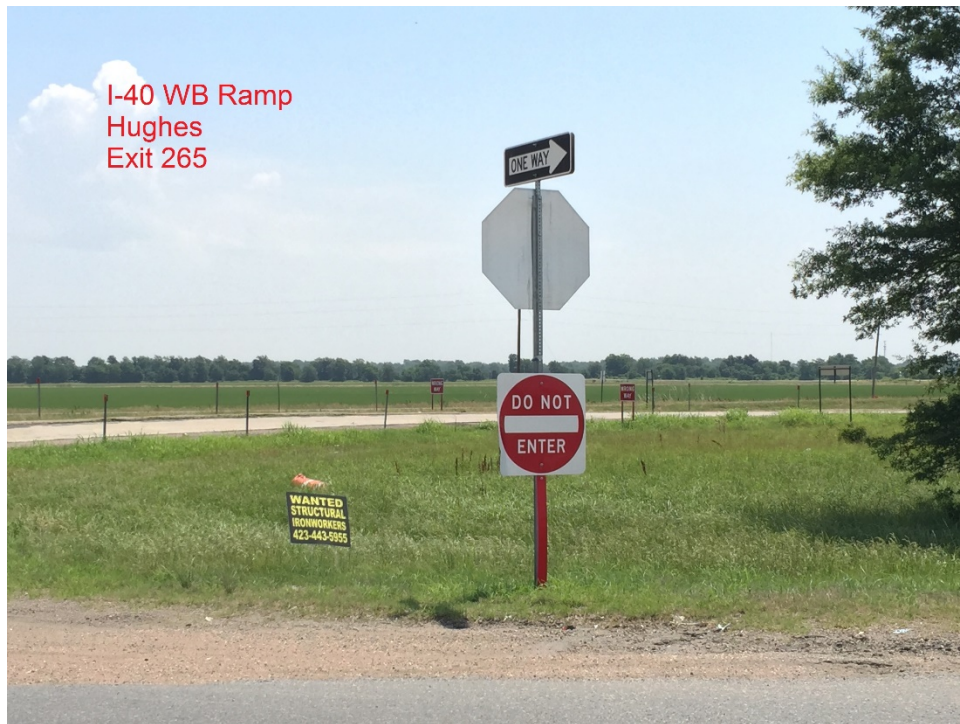
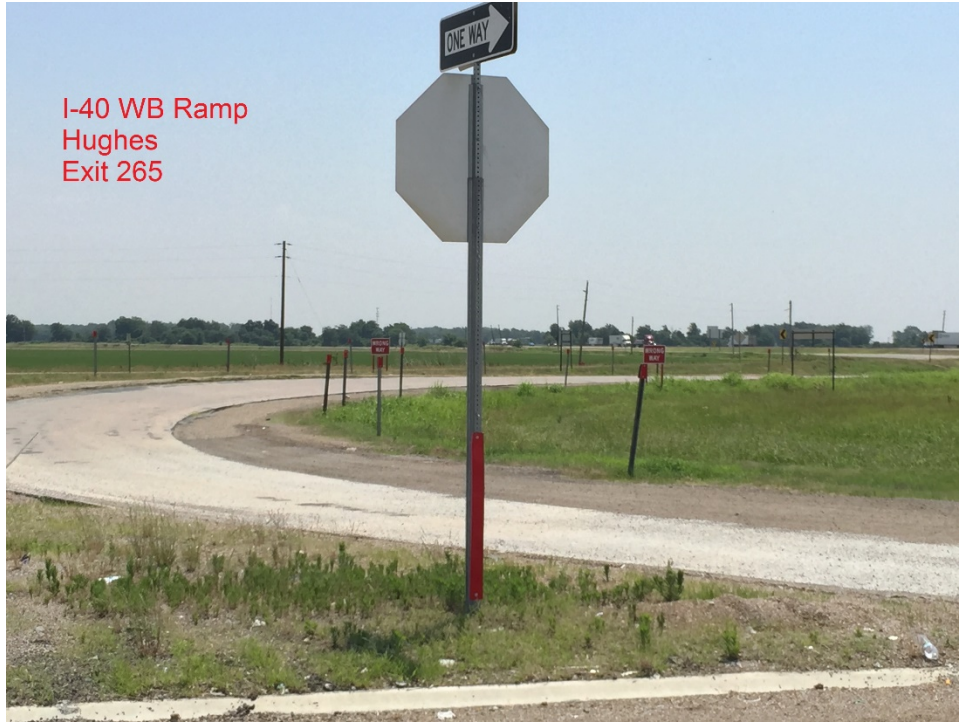
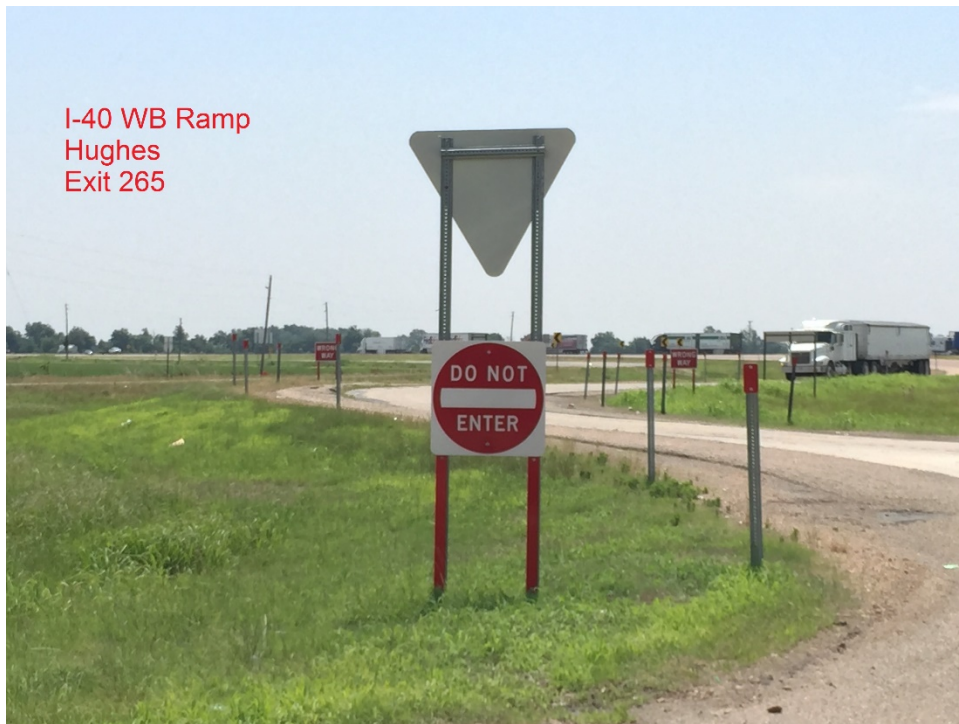
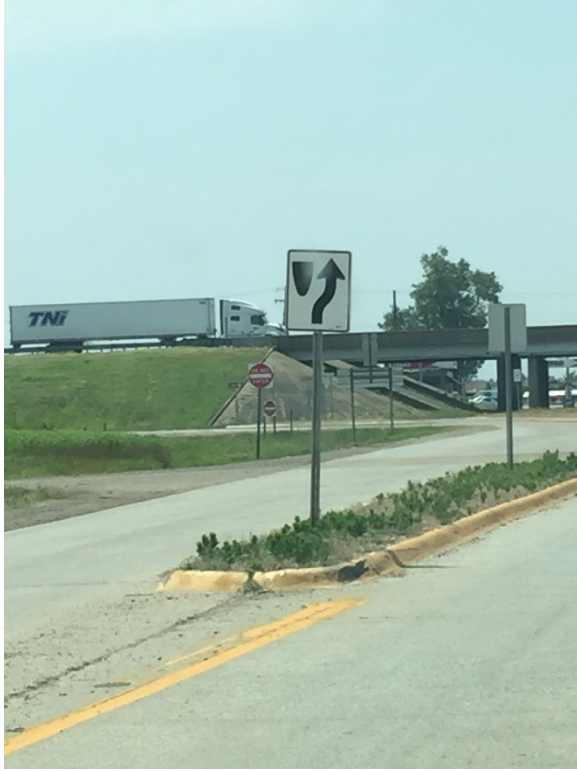
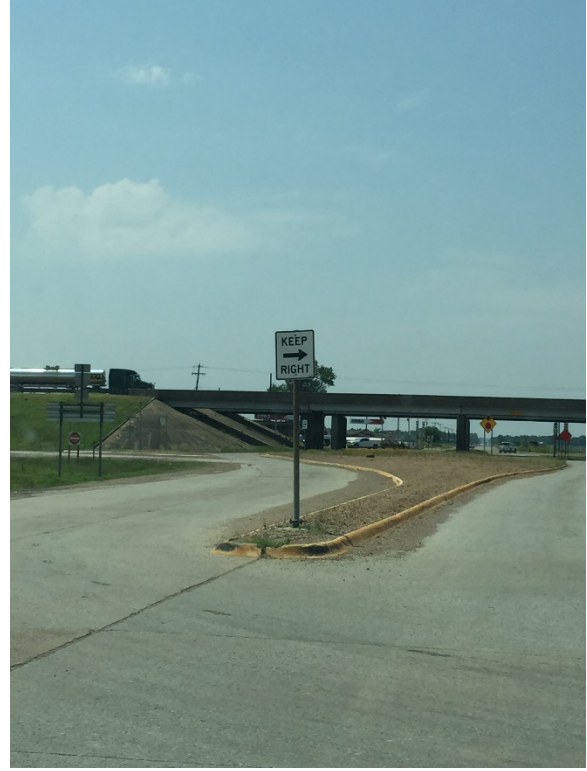
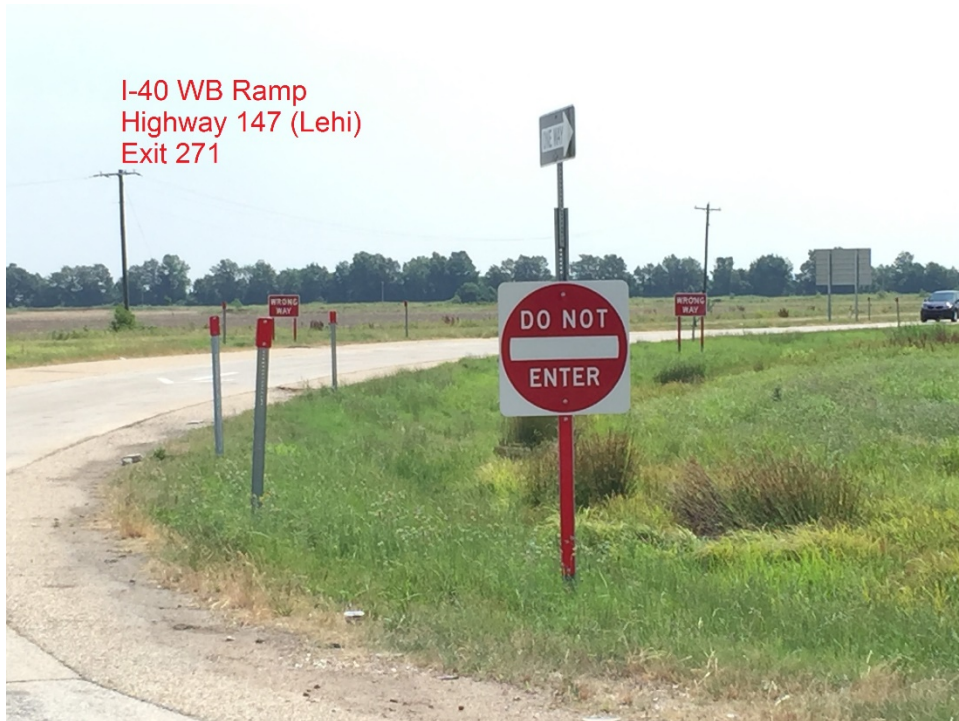
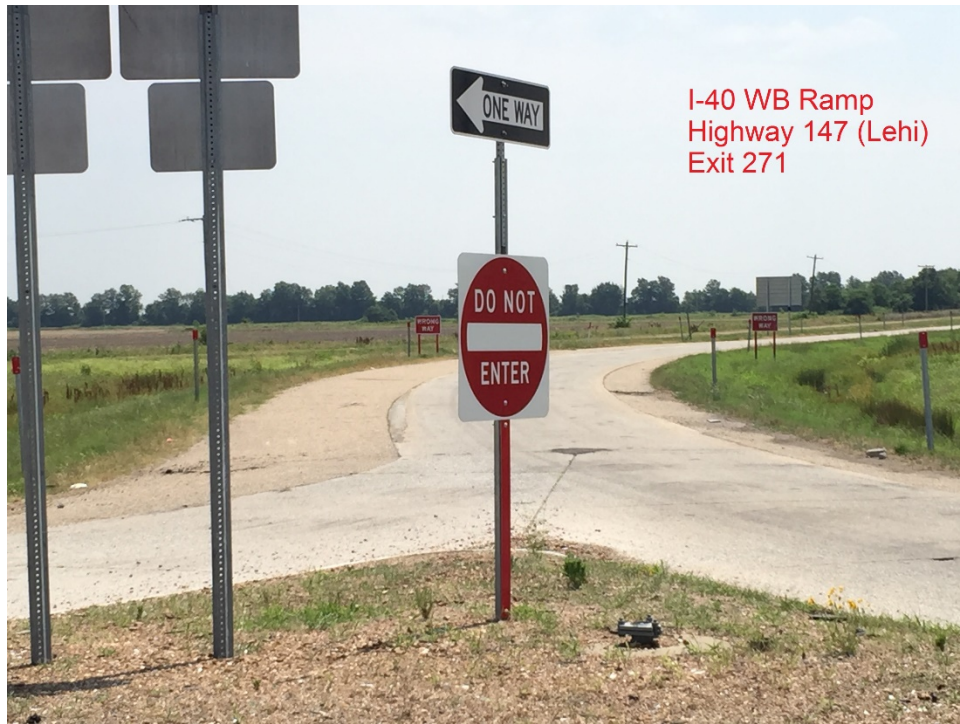
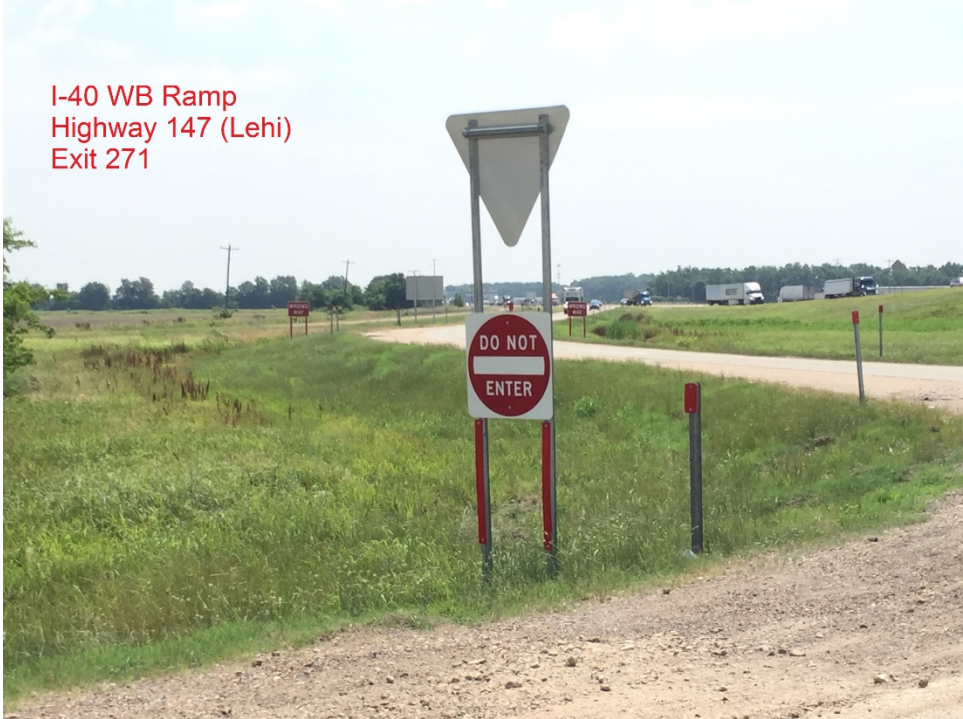
Crash # 2018545847 I-40, Section 52, Log Mile 272.607

The driver accessed I-40 possibly at Exit 265 (Highway 218 Hughes), or Exit 271 (Highway 147 Lehi) and travelled eastbound in the westbound traffic lane on Interstate 40. The wrong-way driver sideswiped a trailer that another vehicle traveling west was hauling causing minor damage. Both vehicles were moved out of the roadway before the officer reached the scene.

The interchange at Exit 265 was reviewed. Pavement markings and signs were in place and in conformance with MUTCD standards. However, two 30"x30 "DO NOT ENTER" signs are missing and will be installed to be consistent with current ARDOT standards. These modifications will be implemented by statewide forces as soon as their schedule permits.

The interchange at Exit 271 was reviewed. Pavement markings and signs were in place and in conformance with MUTCD and ARDOT standards.

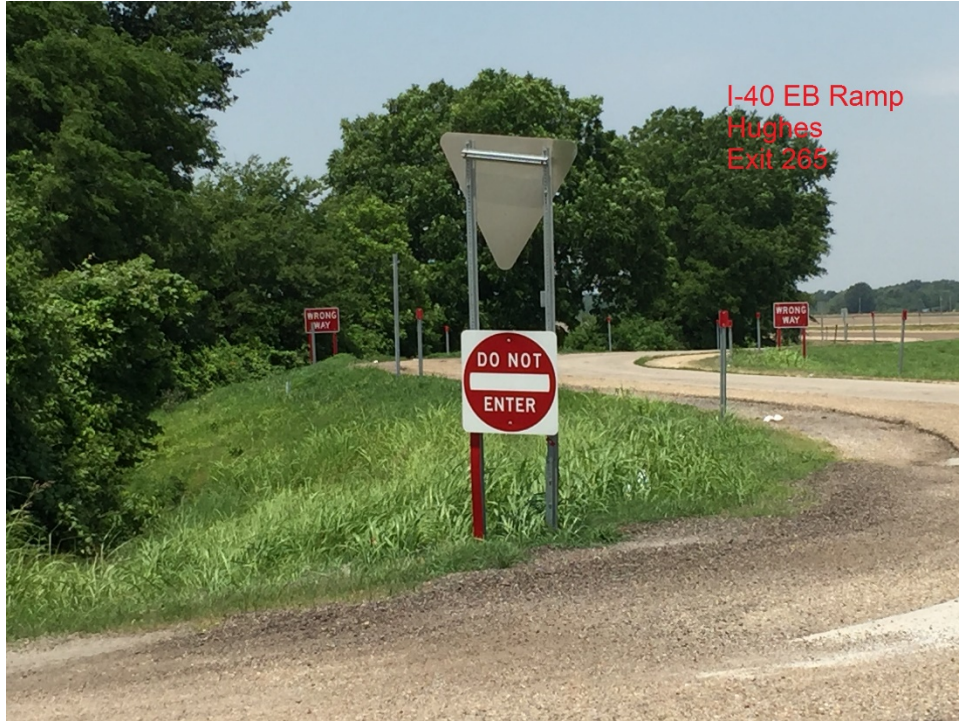
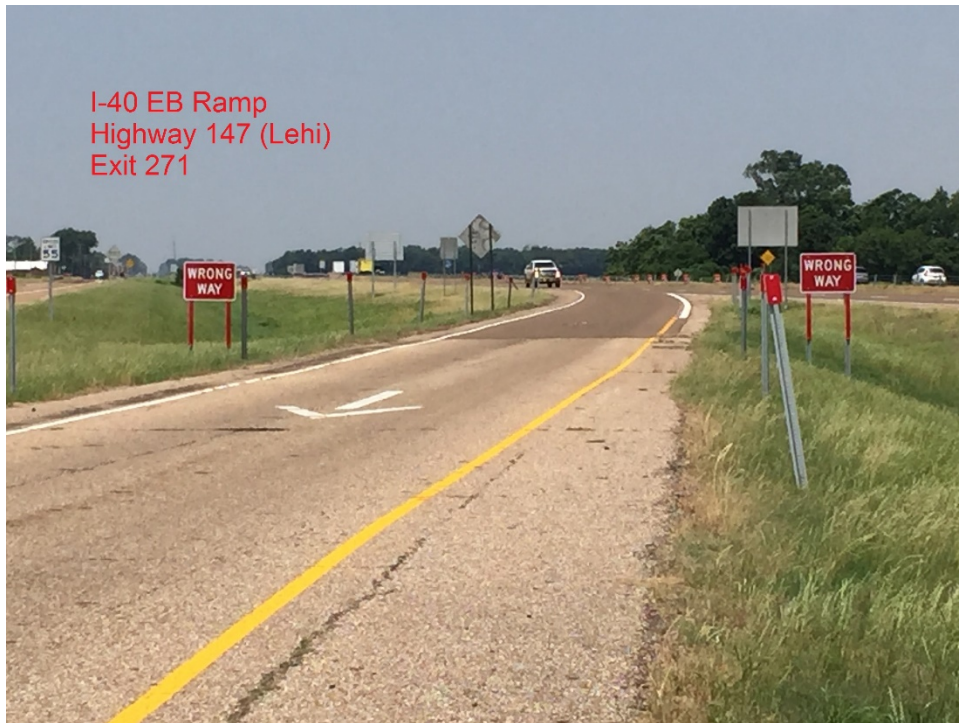
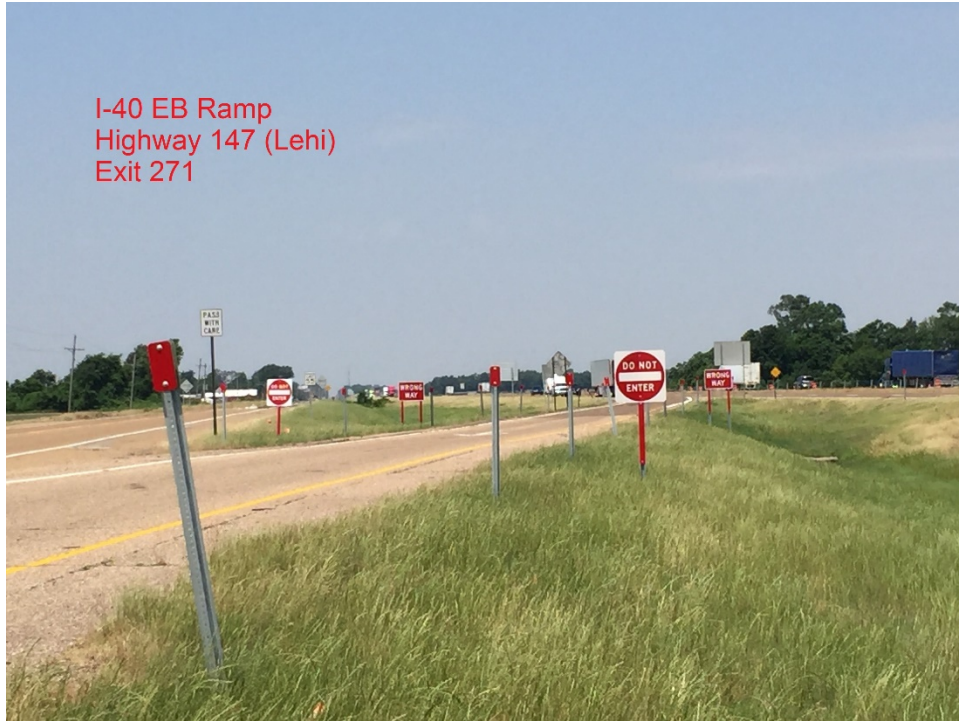
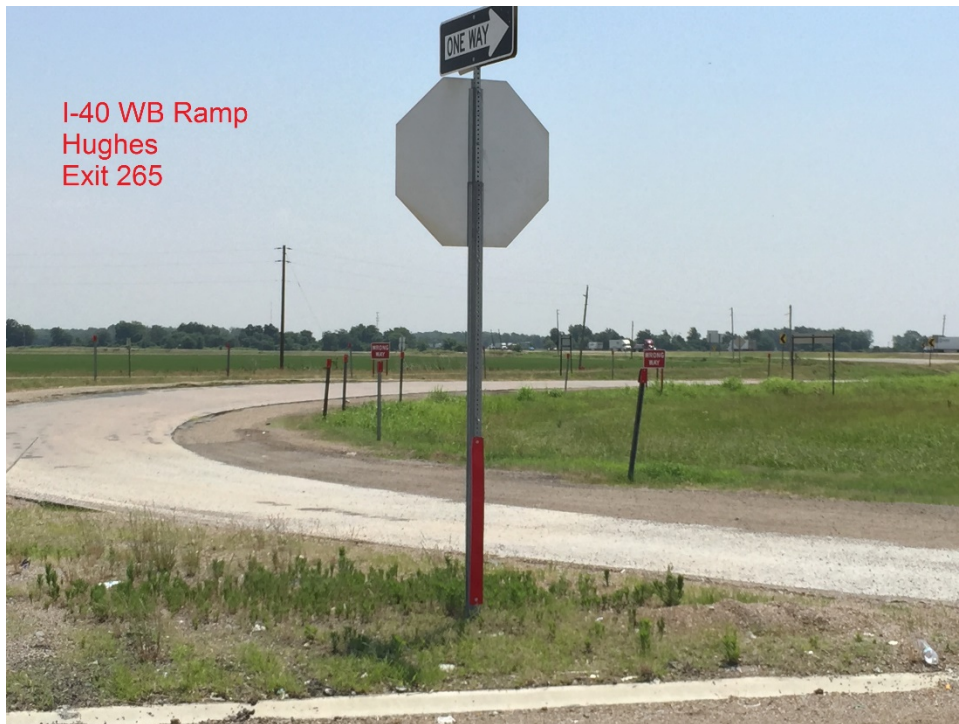
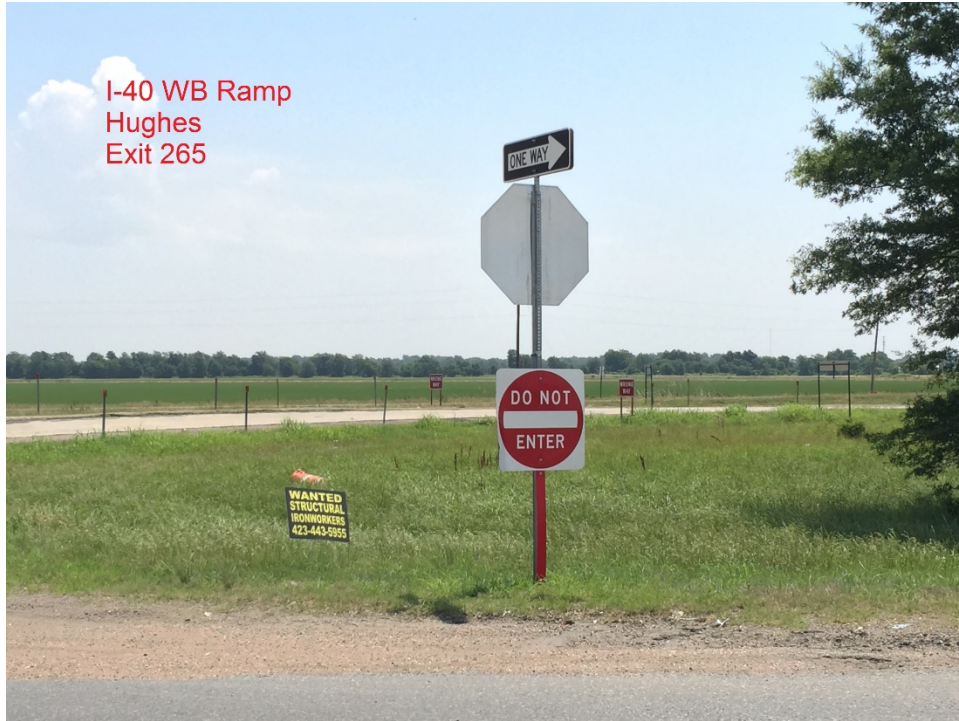
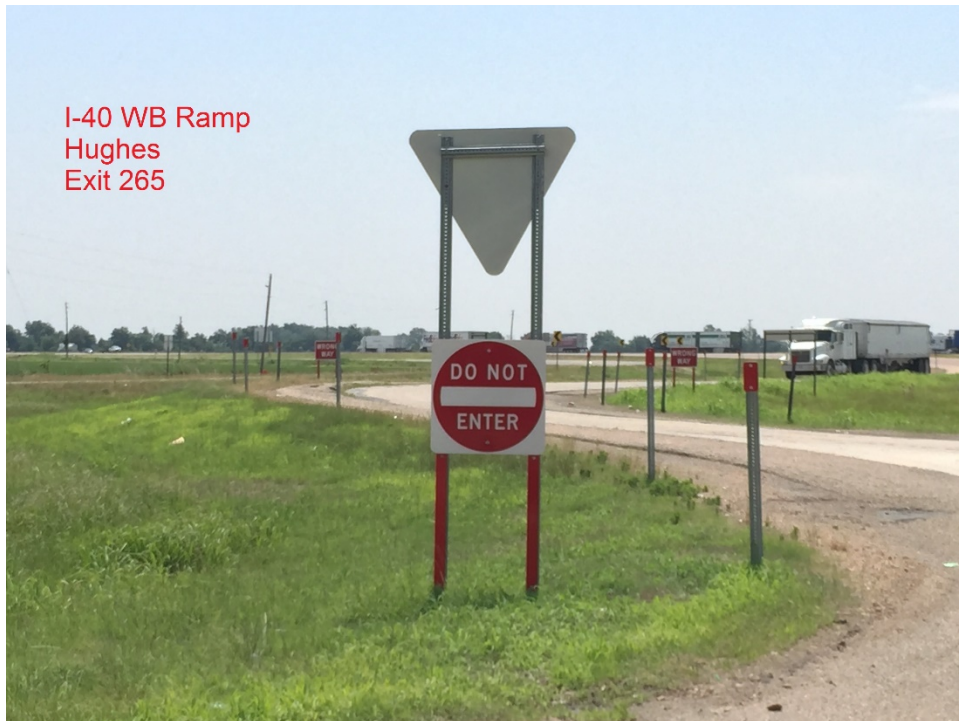
Crash # 2018546182 I-40, Section 52, Log Mile 272.835

The driver accessed I-40 possibly at Exit 265 (Highway 218 Hughes), or Exit 271 (Highway 147 Lehi) and travelled eastbound in the westbound traffic lane on Interstate 40. The wrong-way driver lost control of the vehicle and struck a cable barrier on the south side of the roadway and continued eastbound causing damage to approx. 201 ft. of cable barrier before striking the concrete barrier of Ditch No. 10. Then the vehicle became airborne before coming to a final rest on the east side of Ditch No. 10. The driver of the vehicle was pronounced dead at the scene.

The interchange at Exit 265 was reviewed. Pavement markings and signs were in place and in conformance with MUTCD. However, two 30"x30 "DO NOT ENTER" signs are missing and will be installed to be consistent with current ARDOT standards. These modifications will be implemented by statewide forces as soon as their schedule permits.

The interchange at Exit 271 was reviewed. Pavement markings and signs were in place and in conformance with MUTCD and ARDOT standards.

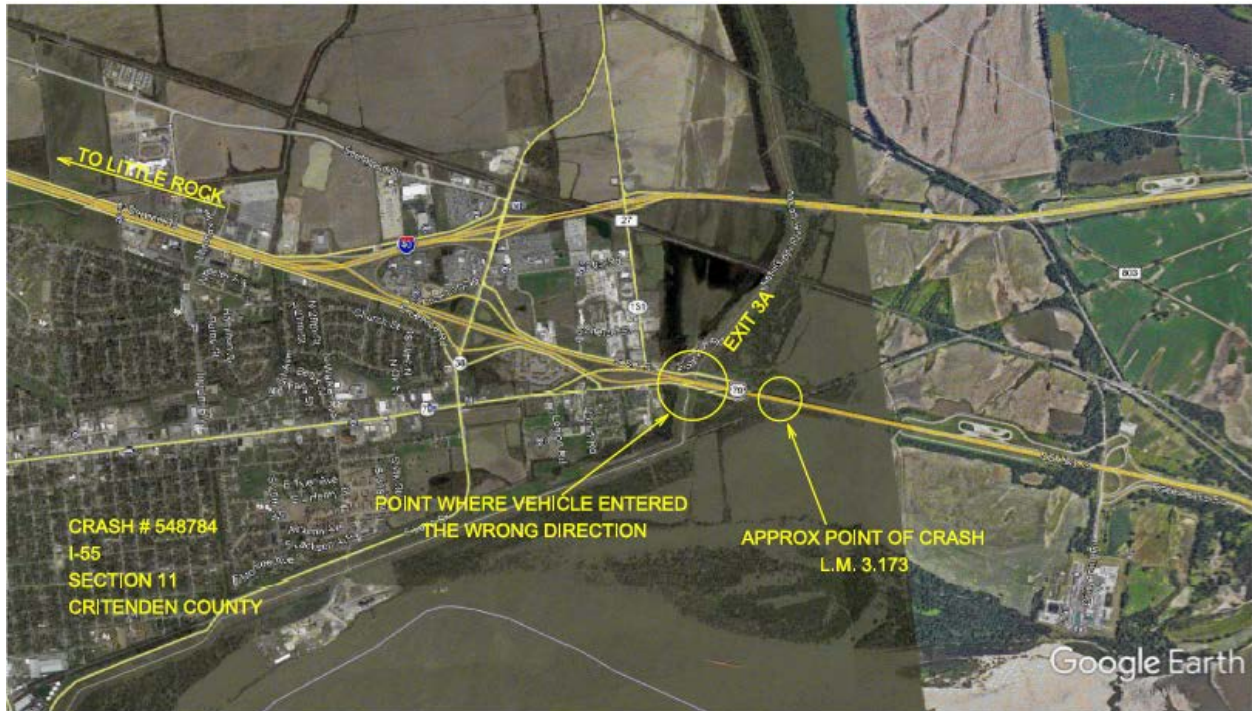
Crash # 2018548784 I-55, Section 11, Log Mile 3.173

The driver accessed I-55 at Exit 3A (Mound City Road) and travelled southbound in the northbound traffic lane on Interstate 55. Another vehicle traveling north swerved left to avoid colliding with the wrong-way driver. After this, the front right side bumper of the wrong-way driver collided with the front right side bumper of the northbound driver. The northbound driver rotated clockwise and left the roadway.

The interchange at Exit 3A was reviewed. Pavement markings and signs were in place and in conformance with MUTCD standards. However, the 36"x36" "DO NOT ENTER" sign along with two 18"x54" "ONE WAY" signs were missing and will be installed to be consistent with current ARDOT standards. These modifications will be implemented by statewide forces as soon as their schedule permits.

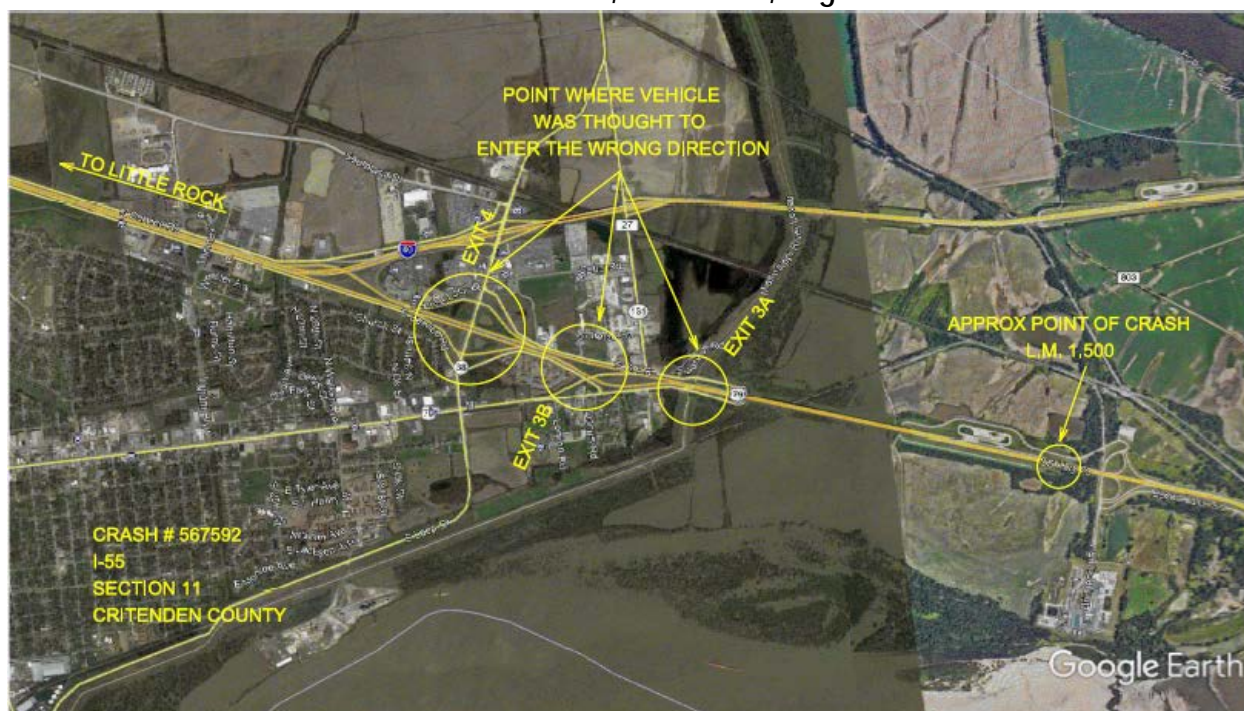
Crash # 2018567592 I-55, Section 11, Log Mile 1.500

The driver accessed I-55 possibly at Exit 3A (Mound City Road), Exit 3B (Broadway Blvd.), or Exit 4 (MLK Drive) and travelled southbound in the northbound traffic lane on Interstate 55. The driver was in a head on crash with another vehicle traveling north. The passenger of the vehicle traveling north was pronounced dead at the Regional 1 Trauma Center in Memphis. The wrong-way driver was suspected of alcohol and drug usage.

The interchange at Exit 3A was reviewed. Pavement markings and signs were in place and in conformance with MUTCD standards. However, the 36"x36" "DO NOT ENTER" sign along with two 18"x54" "ONE WAY" signs are missing and will be installed to be consistent with current ARDOT standards. These modifications will be implemented by statewide forces as soon as their schedule permits.

The interchange at Exit 3B was reviewed. Pavement markings and signs were in place and in conformance with MUTCD standards. However, six 18"x54" "ONE WAY" signs are missing and will be installed to be consistent with current ARDOT standards. These modifications will be implemented by statewide forces as soon as their schedule permits.

The interchange at Exit 4 was reviewed. Pavement markings and signs were in place and in conformance with MUTCD and ARDOT standards.
